## FIELD INSPECTION REPORT

| Project Name: | Mountain Valley Pipeline | Inspector: | Marshall Willis |
| Spread H:<br>Roanoke County | STA 12942+00 – 12981+86<br>MVP-RO-287/288 | Weather: | Rainy |

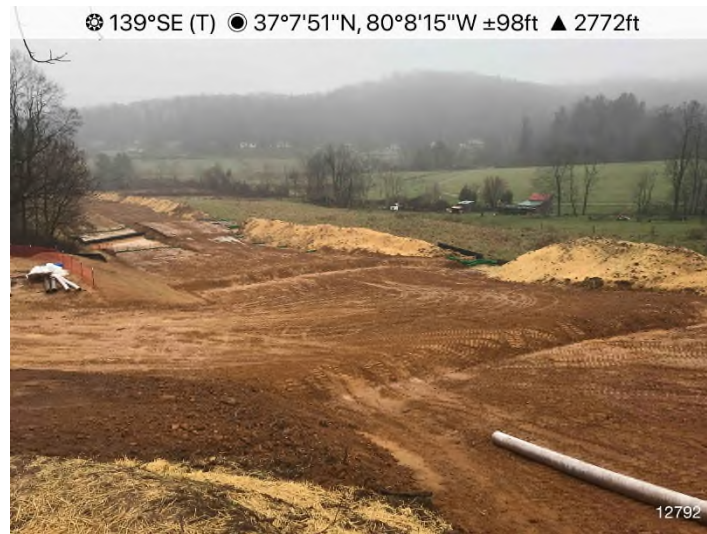
**Figure 1: STA 12972+00** – Controls in place functioning properly.

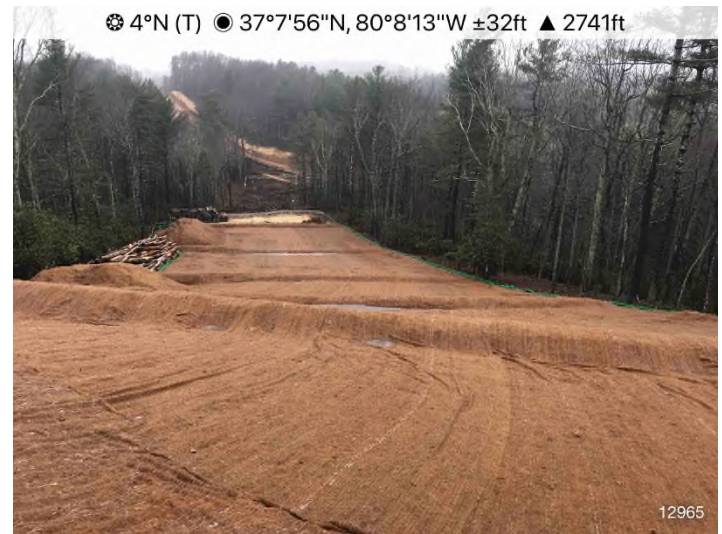
**Figure 2: STA 12965+00** – Controls in place functioning properly.

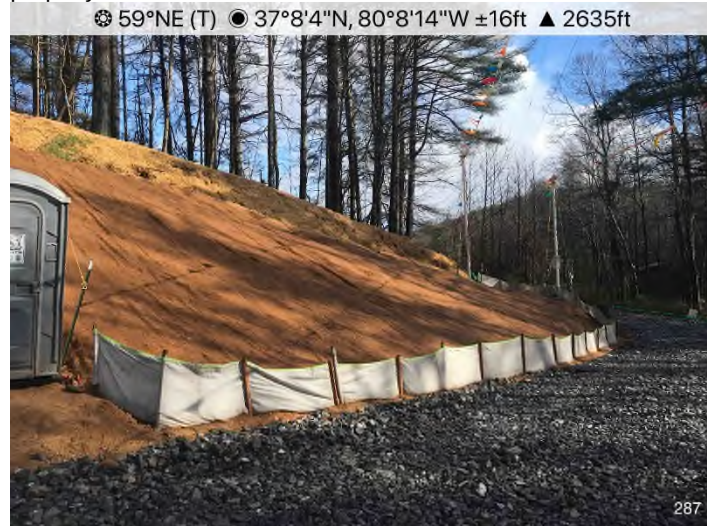
**Figure 3: MVP-RO-287** – Controls in place and functioning properly.

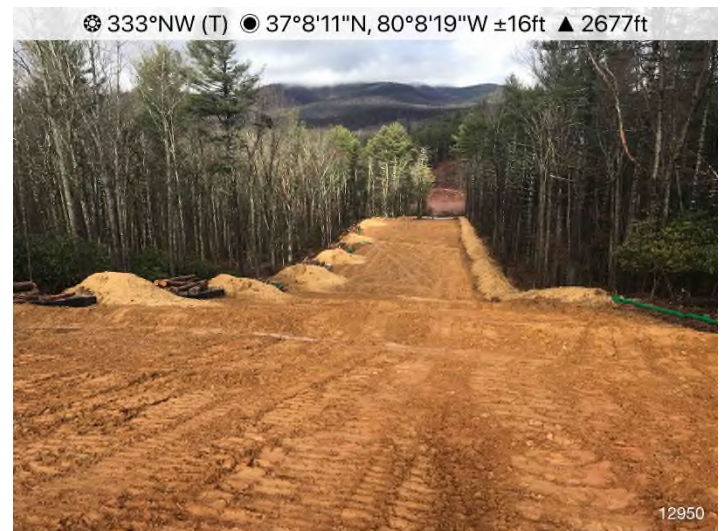
**Figure 4: STA 12950+00** – Controls in place functioning properly.
