## FIELD INSPECTION REPORT

| Project Name: | Mountain Valley Pipeline | Inspector: | Marshall Willis |
| Inspection Date: | Friday, November 20, 2020 | Project Contact: | Brian Clauto, Cory Chalmers |
| Spread I:<br>Pittsylvania County | STA 15370+62 – 15480+67<br>ATWS 492/493/548/549/494 | Weather: | Dry |

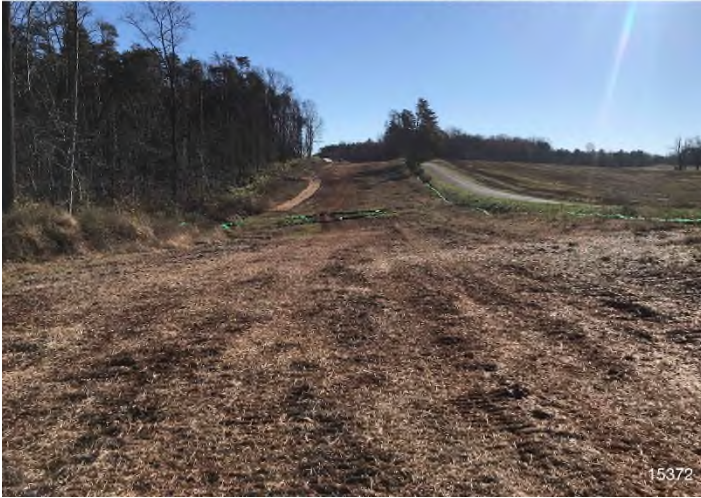
**Figure 1: STA 15372+00** – Controls in place and functioning properly. Area stabilized with straw.

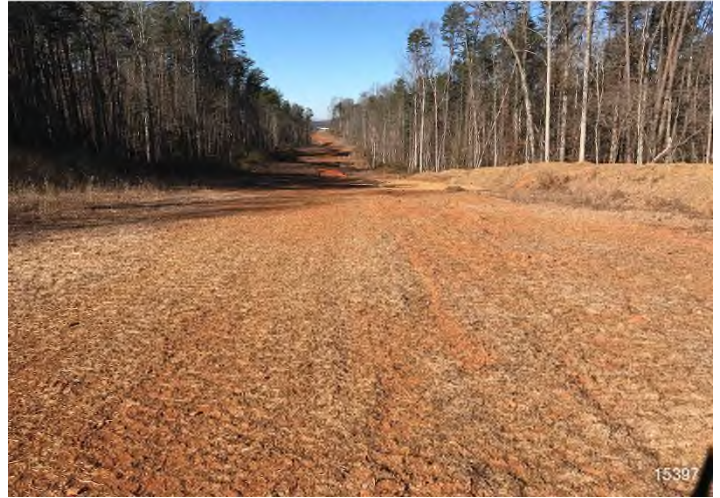
**Figure 2: STA 15397+00** – Controls in place and functioning properly. Area stabilized with straw.

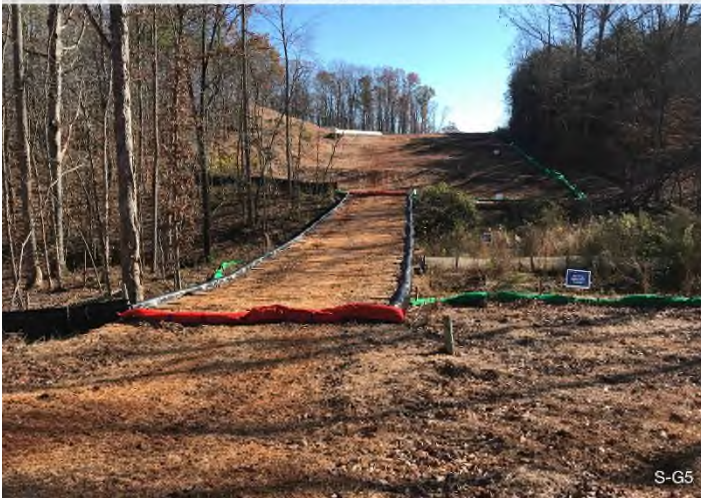
**Figure 3: Stream S-G5** – Controls in place and functioning properly around S-G5 crossing. Area stabilized with straw.

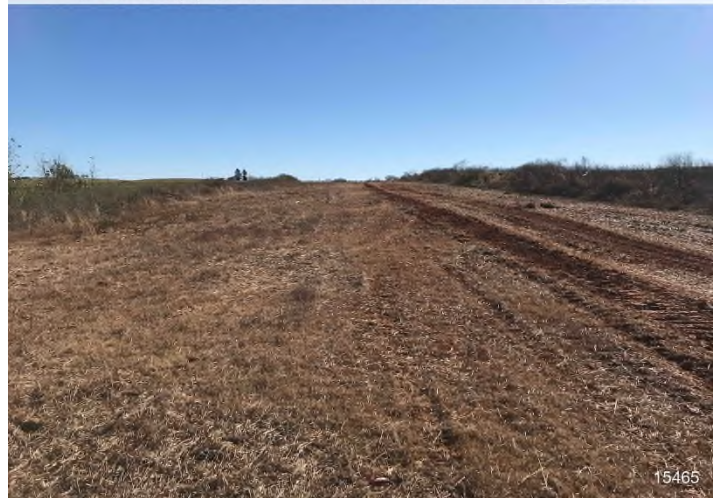
**Figure 4: STA 15465+00** – Controls in place and functioning properly. Area stabilized with straw.
