## FIELD INSPECTION REPORT

| <b>Project Name:</b> | Mountain Valley Pipeline | <b>Inspector:</b> | Marshall Willis |
| <b>Spread I:<br/>Franklin County</b> | STA 13992+00 – 14002+00<br>MVP-FR-306.02<br>ATWS 1466 | <b>Weather:</b> | Dry |

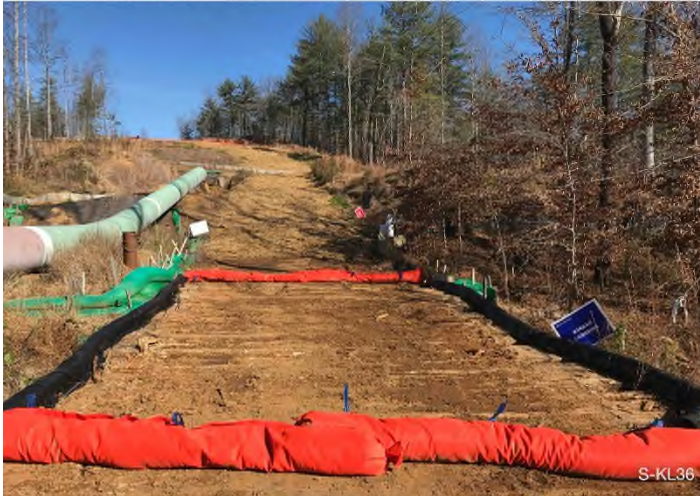
**Figure 1: Stream S-KL36** – Controls in place and functioning properly around S-KL36 crossing. Area stabilized straw.

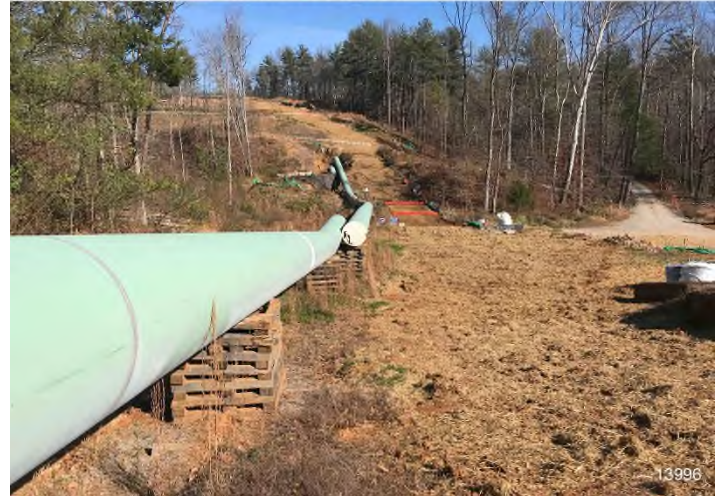
**Figure 2: STA 13996+00** – Controls in place and functioning properly. Area stabilized with straw.

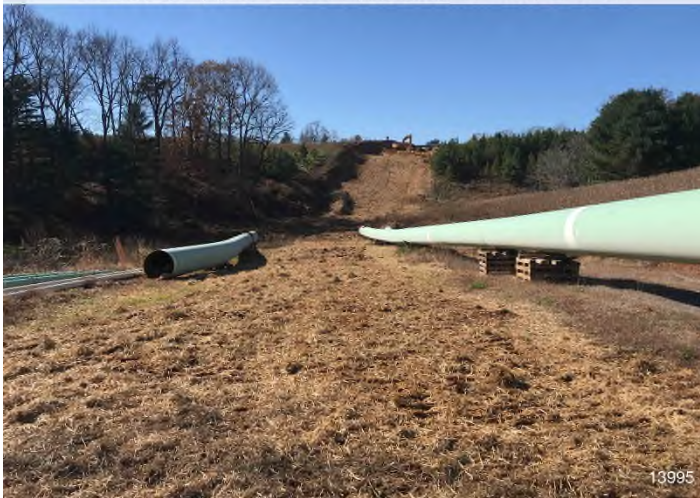
**Figure 3: STA 13995+00** – Controls in place and functioning properly. Area stabilized with straw.
