## FIELD INSPECTION REPORT

| Project Name: | Mountain Valley Pipeline | Inspector: | Marshall Willis |
| Inspection Date: | Thursday, January 14, 2021 | Project Contact: | Brian Clauto, Cory Chalmers |
| Spread H:<br>Montgomery County | STA 12151+00 – 12200+00<br>MVP-MN-273/274/275 | Weather: | Dry |

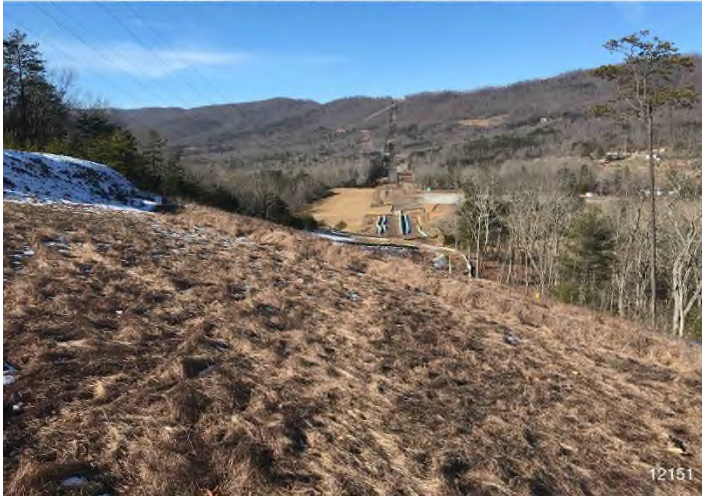
**Figure 1: STA 12151+00** – Controls in place and functioning properly.

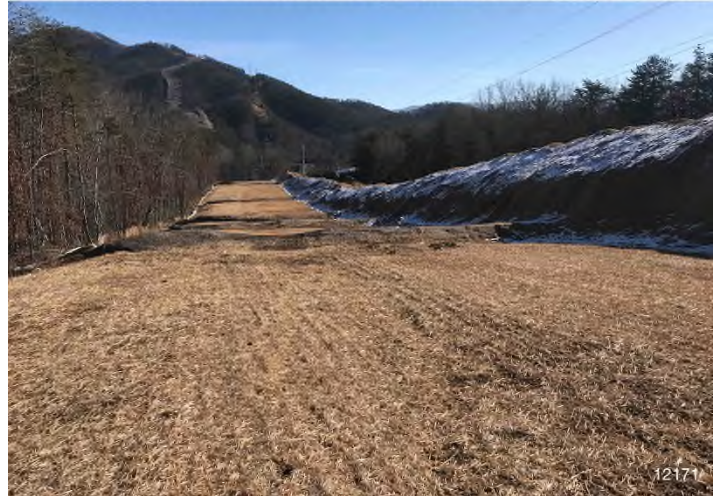
**Figure 2: STA 12171+00** – Controls in place and functioning properly. Area stabilized with straw.

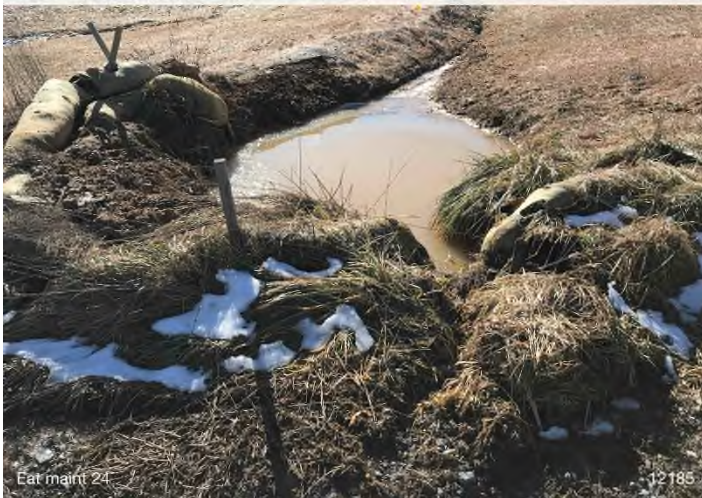
- STA 12185+00: End-treatment repair needed.

**Figure 3: STA 12185+00** – End-treatment repair needed.

**Recommended Corrective Action:** Maintain and install all controls per the approved PSS&S.

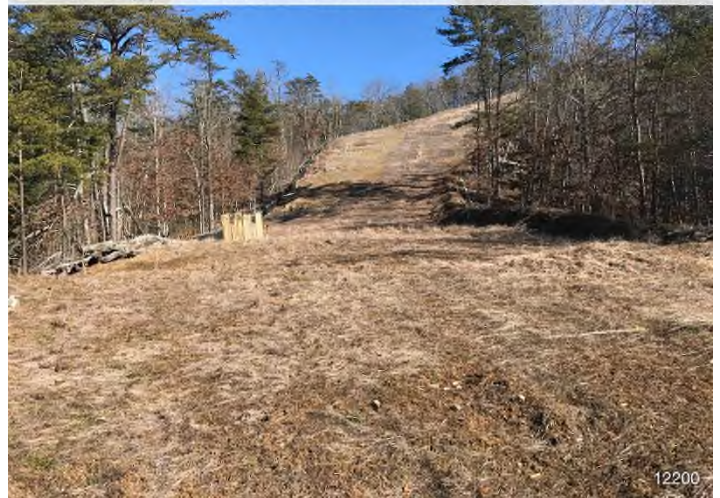
**Figure 4: STA 12200+00** – Controls in place and functioning properly.
