## FIELD INSPECTION REPORT

| <b>Project Name:</b> | Mountain Valley Pipeline | <b>Inspector:</b> | Marshall Willis |
| <b>Inspection Date:</b> | Wednesday, January 13, 2021 | <b>Project Contact:</b> | Brian Clauto, Cory Chalmers |
| <b>Spread I:<br/>Franklin County<br/>Pittsylvania County</b> | STA 14981+55 – 15080+84<br>MVP-PI-325 | <b>Weather:</b> | Dry |

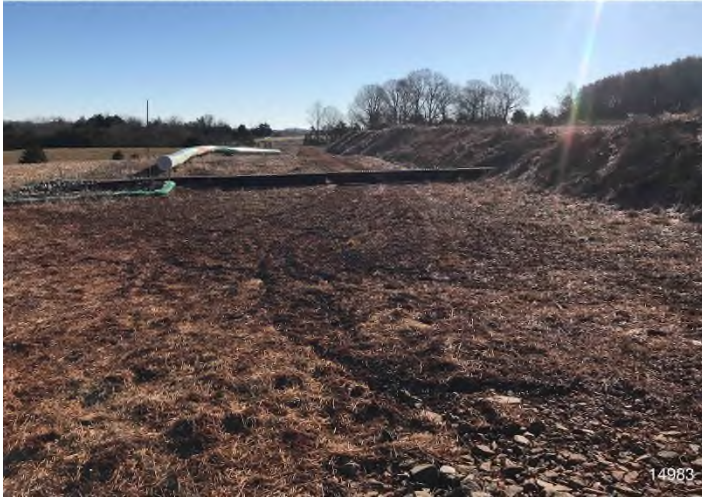
**Figure 1: STA 14983+00** – Controls in place and functioning properly. Area stabilized with straw.

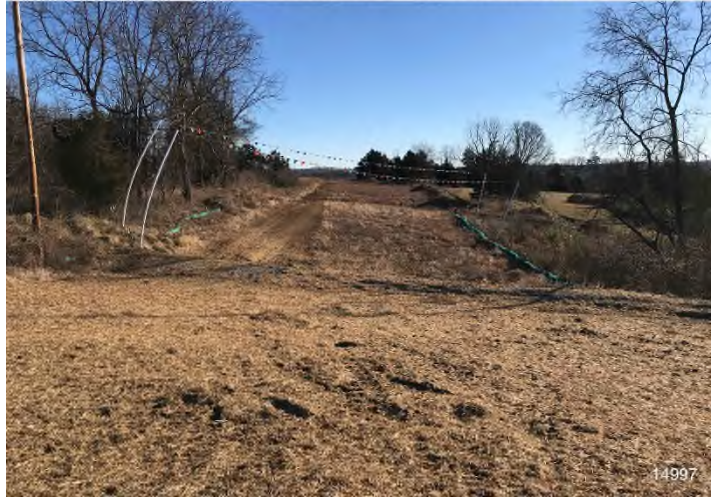
**Figure 2: STA 14997+00** – Controls in place and functioning properly. Area stabilized with straw.

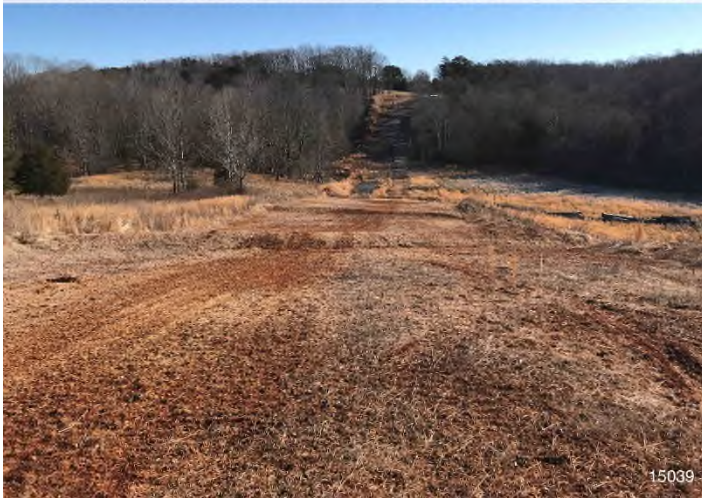
**Figure 3: STA 15039+00** – Controls in place and functioning properly. Area stabilized with straw.

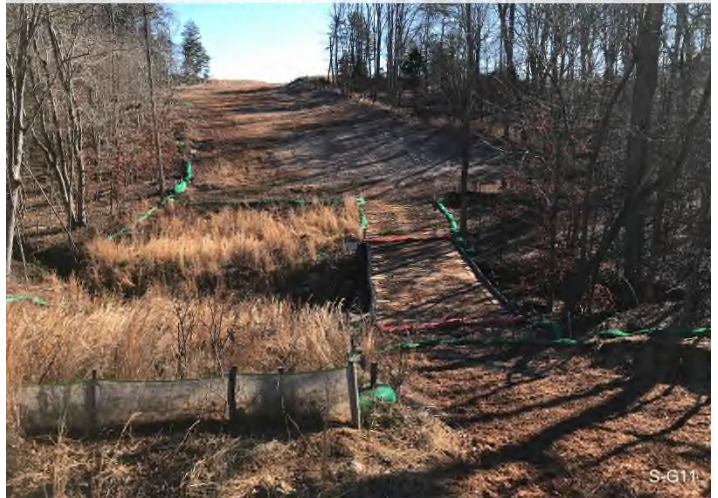
**Figure 4: Stream S-G11** – Controls in place and functioning properly.
