## FIELD INSPECTION REPORT

| <b>Project Name:</b> | Mountain Valley Pipeline | <b>Inspector:</b> | Marshall Willis |
| <b>Inspection Date:</b> | Tuesday, January 12, 2021 | <b>Project Contact:</b> | Brian Clauto, Cory Chalmers |
| <b>Spread H:<br/>Roanoke County</b> | MVP-RO-287/288<br>MVP-RO-286/281<br>STA 12994+02 – 13012+63 | <b>Weather:</b> | Wet |

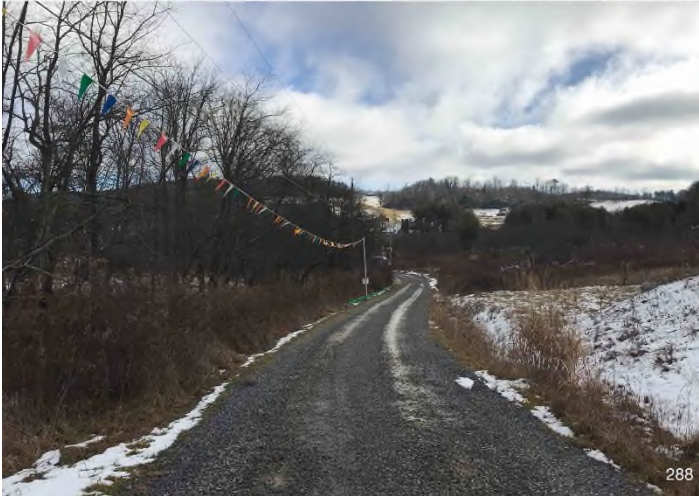
**Figure 1: MVP-RO-287** – Controls in place and functioning properly.

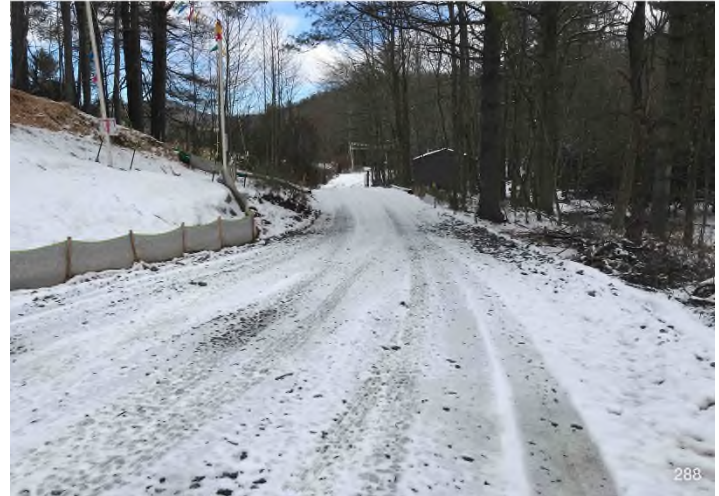
**Figure 2: MVP-RO-287** – Controls in place and functioning properly.

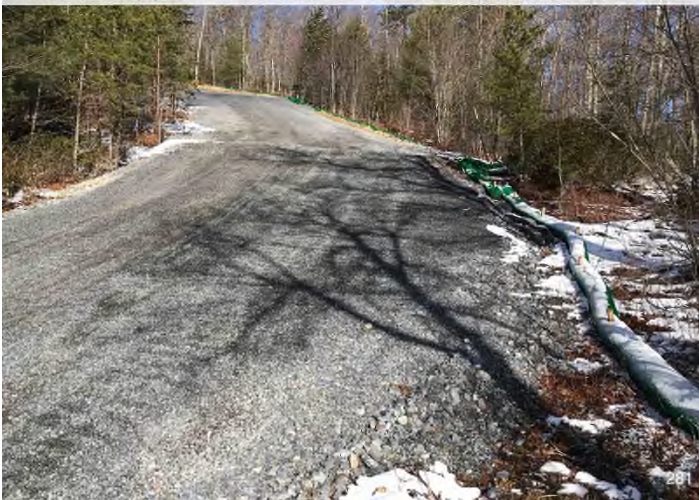
**Figure 3: MVP-RO-281** – Controls in place and functioning properly.

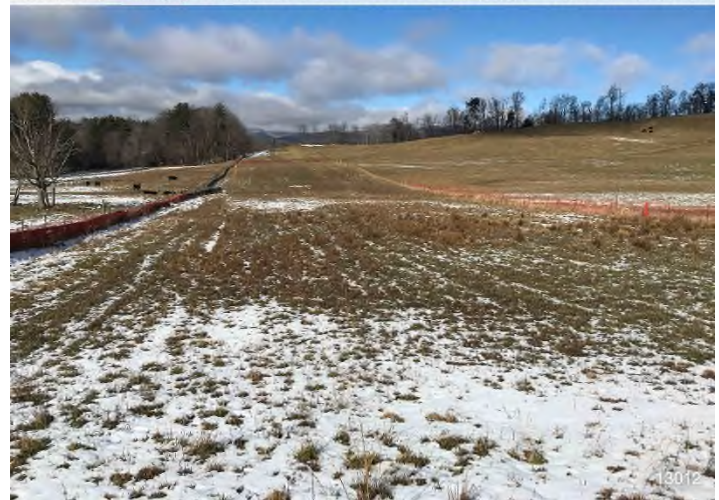
**Figure 4: STA 13012+00** – Controls in place and functioning properly.
