FIELD INSPECTION REPORT

Project Name:	Mountain Valley Pipeline	Inspector:	Marshall Willis
Inspection Date:	Monday, January 11, 2021	Project Contact:	Brian Clauto, Cory Chalmers
Spread I: Pittsylvania County	STA 15221+11 – 15274+98 MVP-PI-328	Weather:	Wet

FIELD INSPECTION PHOTO LOG

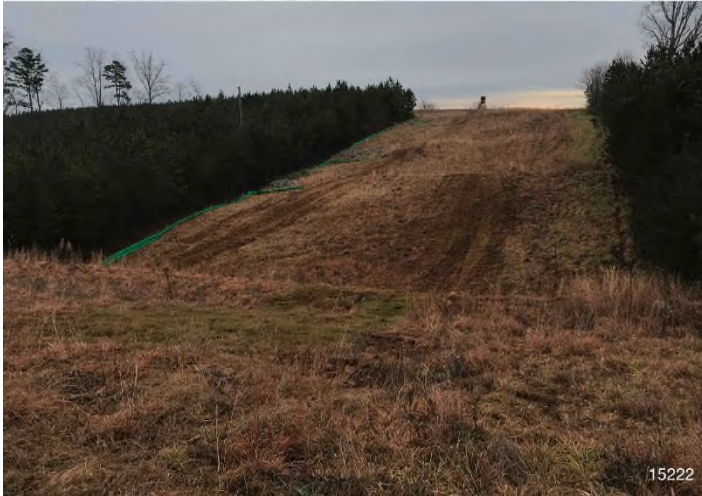
Figure 1: STA 15222+00 – Controls in place and functioning properly.

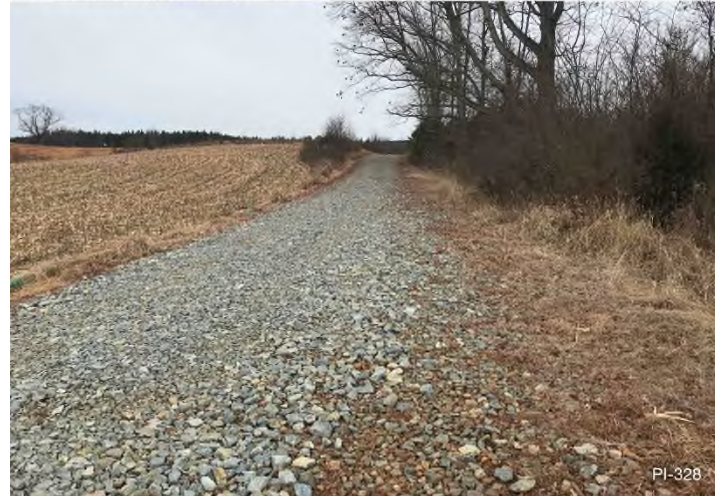
Figure 2: MVP-PI-328 – Controls in place and functioning properly.

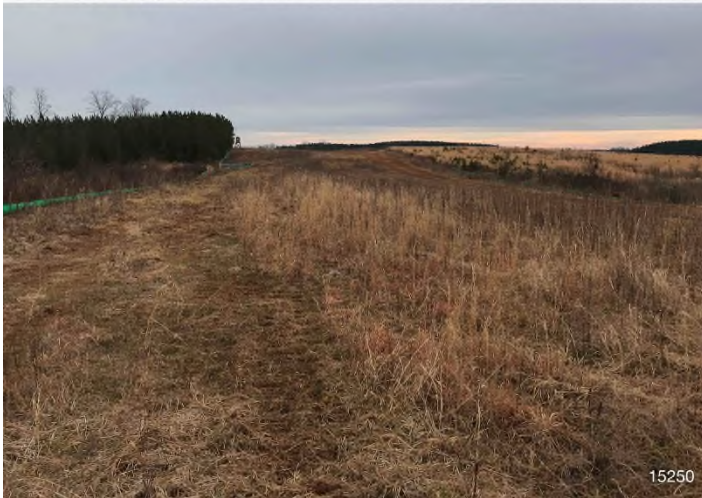
Figure 3: STA 15250+00 – Controls in place and functioning properly.

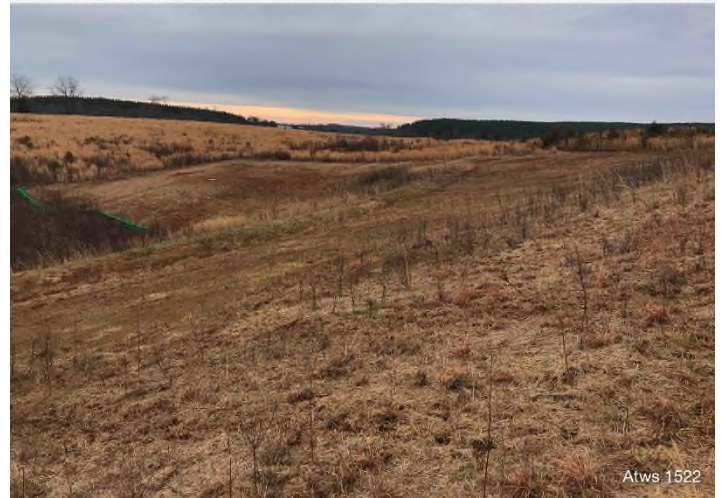
Figure 4: ATWS 1522 – Controls in place and functioning properly. Area stabilized with straw.
