FIELD INSPECTION REPORT

Project Name:	Mountain Valley Pipeline	Inspector:	Marshall Willis
Inspection Date:	Thursday, January 7, 2021	Project Contact:	Brian Clauto, Cory Chalmers
Spread I: Franklin County	STA 14250+00 – 14311+57 MVP-FR-313	Weather:	Wet

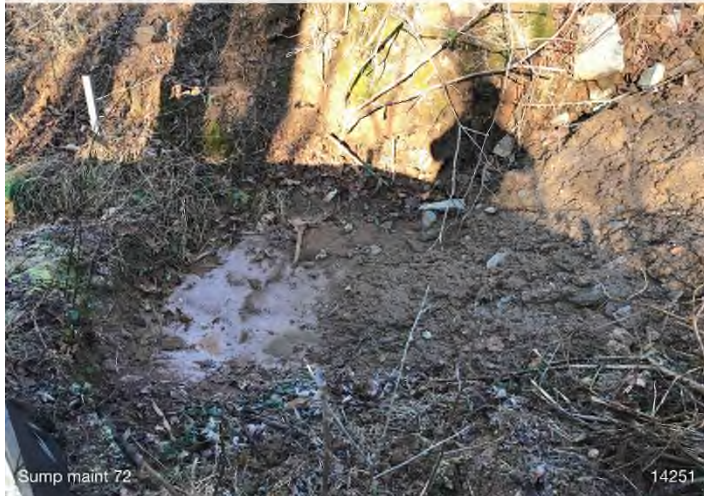
Figure 1: STA 14251+00 – Sump maintenance needed.

Recommended Corrective Action: Maintain and install all controls per the approved PSS&S.

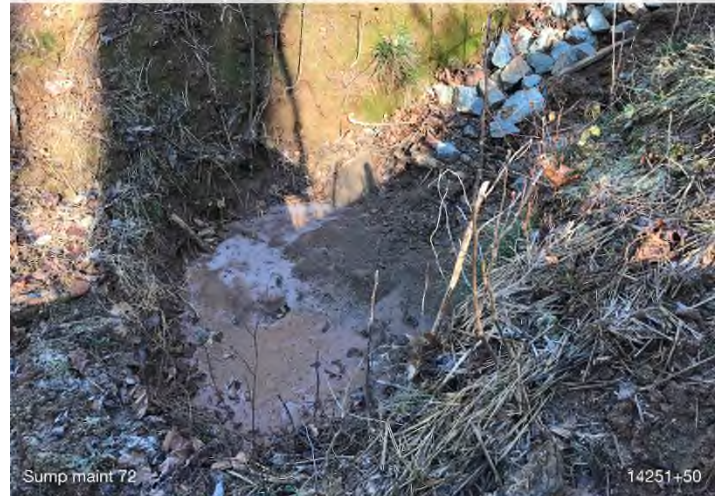
Figure 2: STA 14251+50 – Sump maintenance needed.

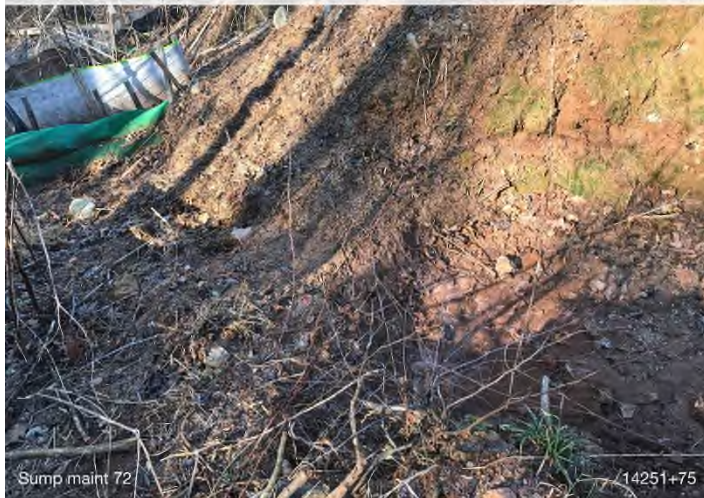
Figure 3: STA 14251+75 – Sump maintenance needed.

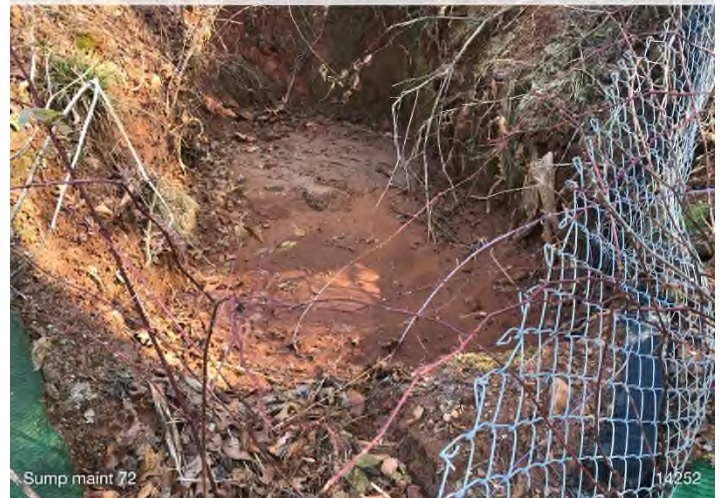
Figure 4: STA 14252+00 – Sump maintenance needed.

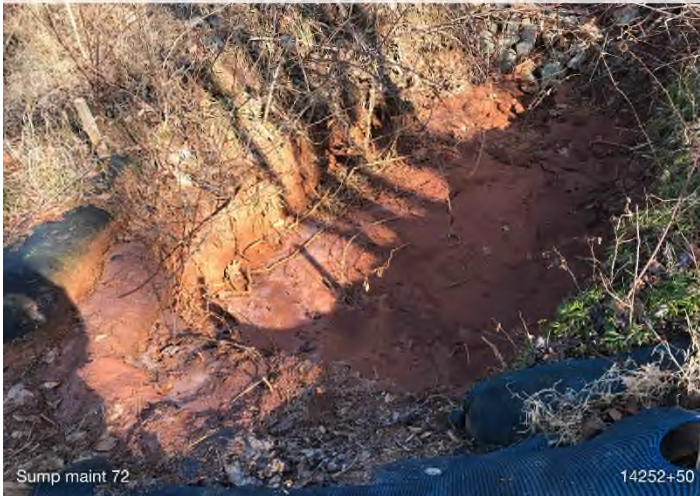
Figure 5: STA 14252+50 – Sump maintenance needed.

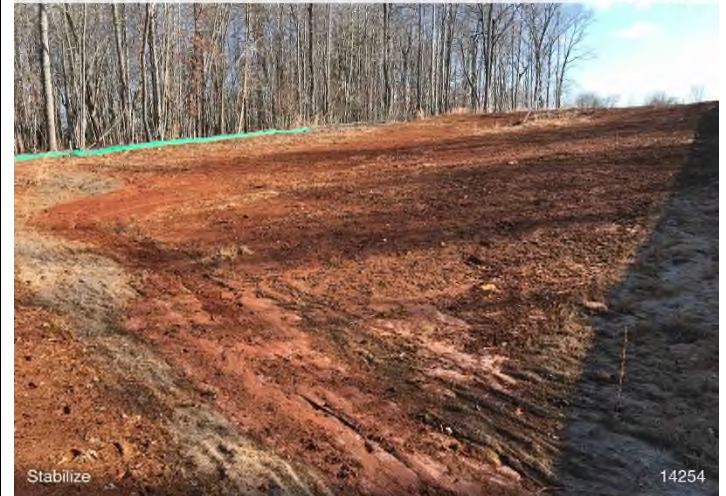
Figure 6: STA 14252+00 to 14256+00 – Re-stabilize ROW and stockpiles.

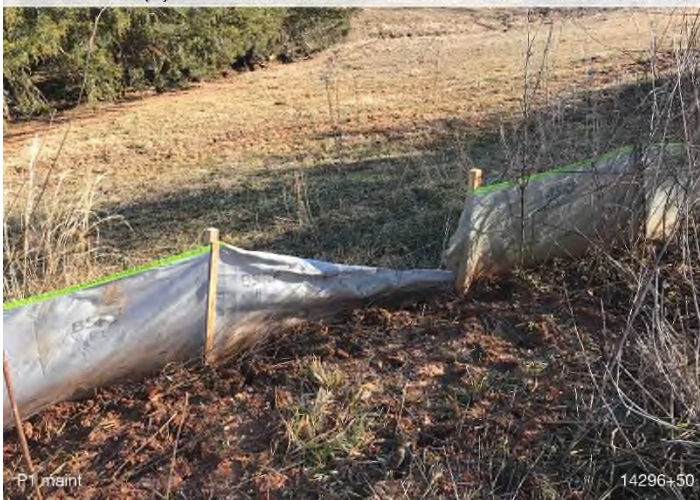
- STA 14296+50: P1 repair needed.

Figure 7: STA 14296+50 – P1 repair needed.
