## FIELD INSPECTION REPORT

| Project Name: | Mountain Valley Pipeline | Inspector: | Marshall Willis |
| Inspection Date: | Wednesday, January 6, 2021 | Project Contact: | Brian Clauto, Cory Chalmers |
| Spread H:<br>Franklin County | STA 13415+51 – 13487+00<br>STA 14010+58 – 14018+47<br>MVP-FR-293.02 | Weather: | Wet |

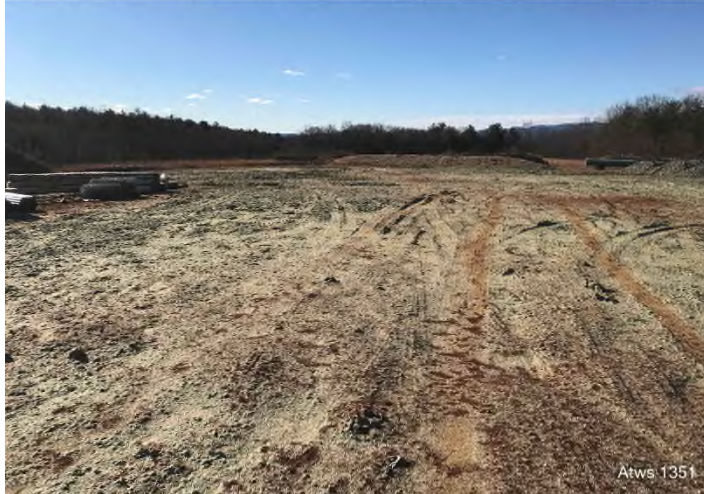
**Figure 1: ATWS 1351** – Controls in place functioning properly. Area stabilized with hydro-hulch.

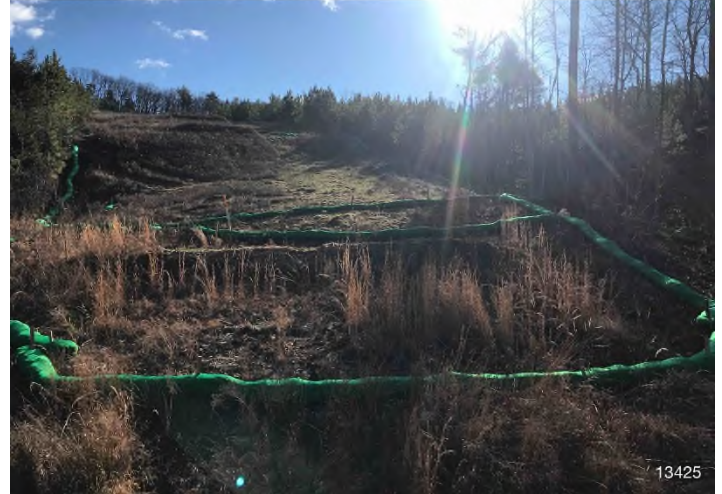
**Figure 2: STA 13425+00** – Controls in place functioning properly. Area stabilized with straw.

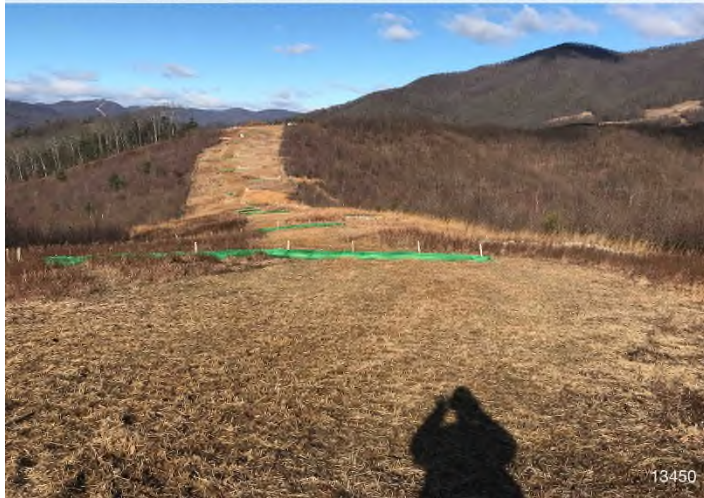
**Figure 3: STA 13450+00** – Controls in place functioning properly. Area stabilized with straw.

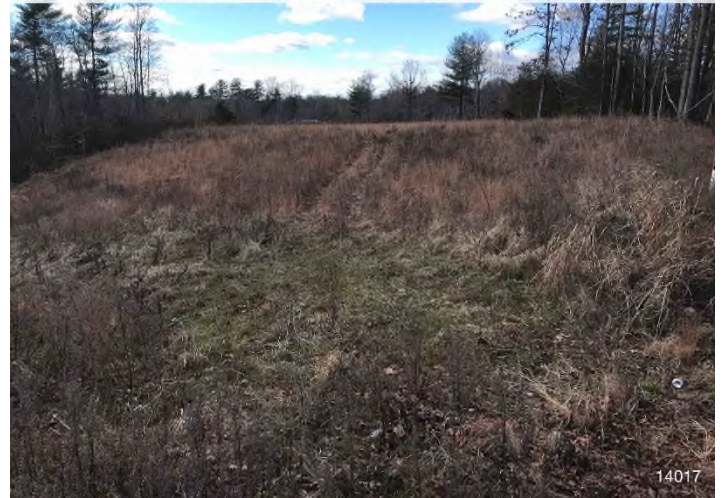
**Figure 4: STA 14017+00** – Controls in place functioning properly.
