## FIELD INSPECTION REPORT

| <b>Project Name:</b> | Mountain Valley Pipeline | <b>Inspector:</b> | Marshall Willis |
| <b>Spread H:<br/>Roanoke County</b> | STA 12690+43 – 12713+62<br>MVP-RO-280<br>MVP-RO-281 | <b>Weather:</b> | Snow |

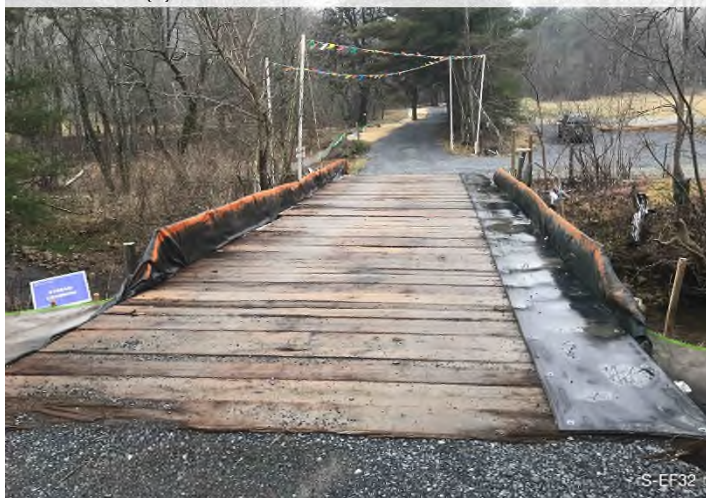
**Figure 1: Stream S-EF32** – Controls in place functioning properly along S-EF32 crossing.

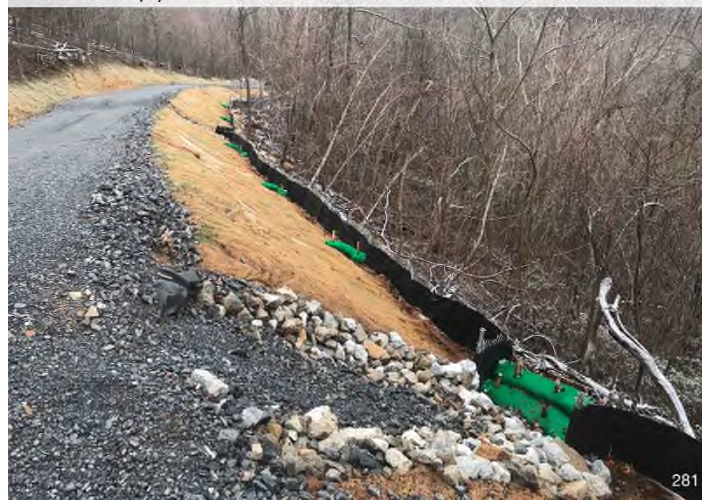
**Figure 2: MVP-RO-281** – Controls in place functioning properly.

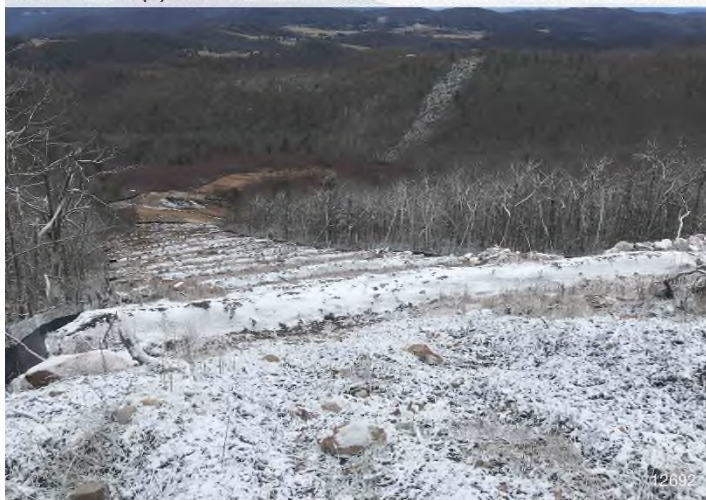
**Figure 3: STA 12692+00** – Controls in place functioning properly.

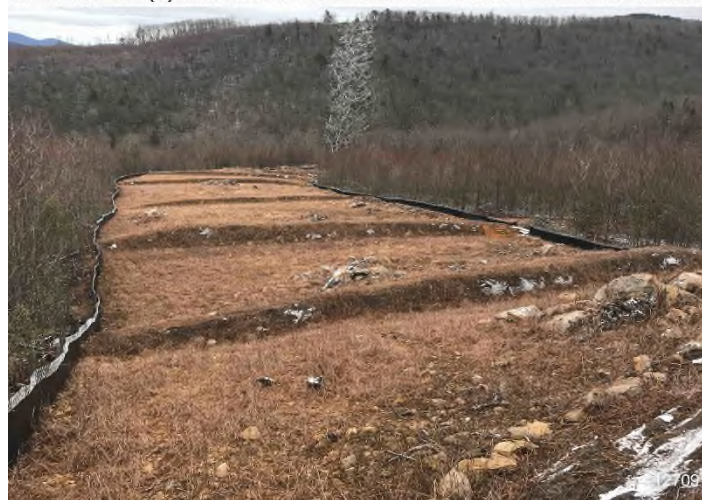
**Figure 4: STA 12709+00** – Controls in place functioning properly.
