## FIELD INSPECTION REPORT

| Project Name: | Mountain Valley Pipeline | Inspector: | Marshall Willis |
| Inspection Date: | Tuesday, January 19, 2021 | Project Contact: | Brian Clauto, Cory Chalmers |

## FIELD INSPECTION PHOTO LOG

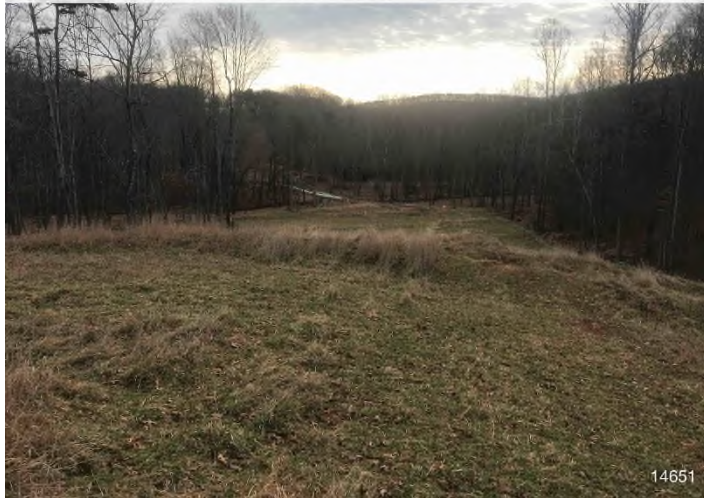
14651

**Figure 1: STA 14651+00** – Controls in place and functioning properly.

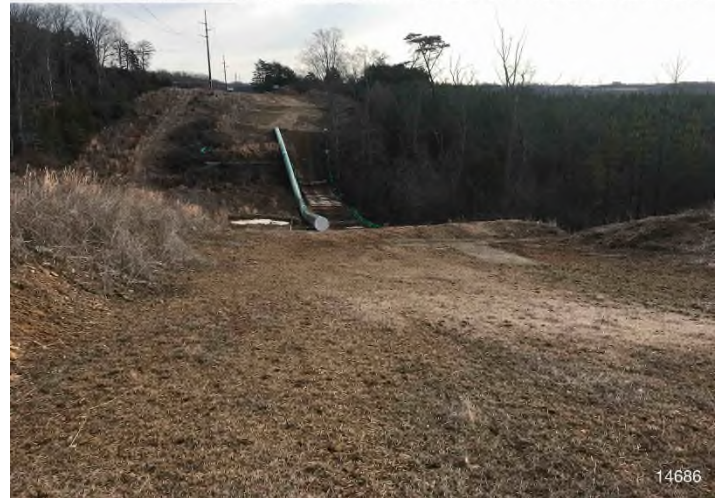
14686

**Figure 2: STA 14686+00** – Controls in place and functioning properly. Area stabilized with straw.

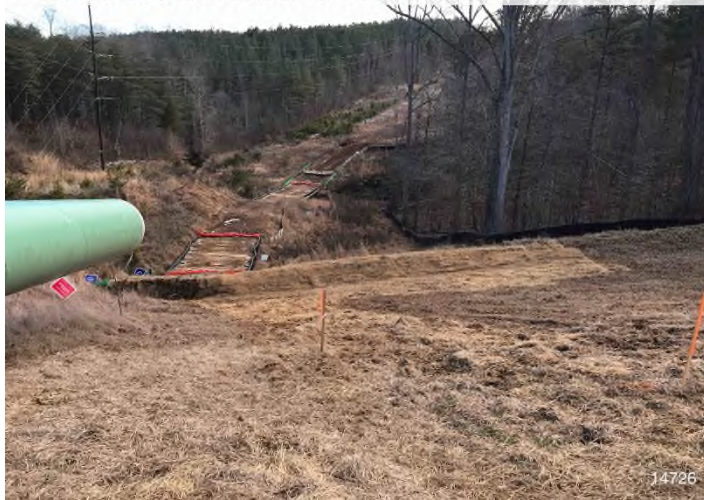
14726

**Figure 3: STA 14726+00** – Controls in place and functioning properly. Area stabilized with straw.

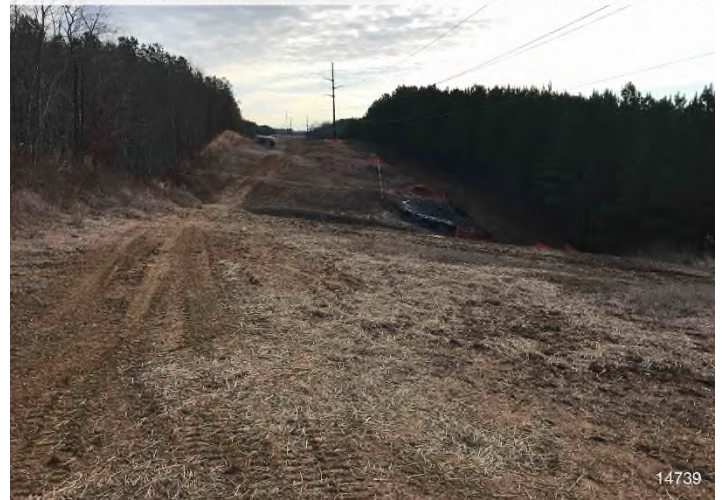
14739

**Figure 4: STA 14739+00** – Controls in place and functioning properly. Area stabilized with straw.
