FIELD INSPECTION REPORT

Project Name:	Mountain Valley Pipeline	Inspector:	Marshall Willis
Inspection Date:	Friday, February 26, 2021	Project Contact:	Brian Clauto, Cory Chalmers
Spread I: Franklin County Pittsylvania County	STA 13632+25 – 13660+00 STA 15470+00 – 15480+67	Weather:	Rainy

FIELD INSPECTION PHOTO LOG

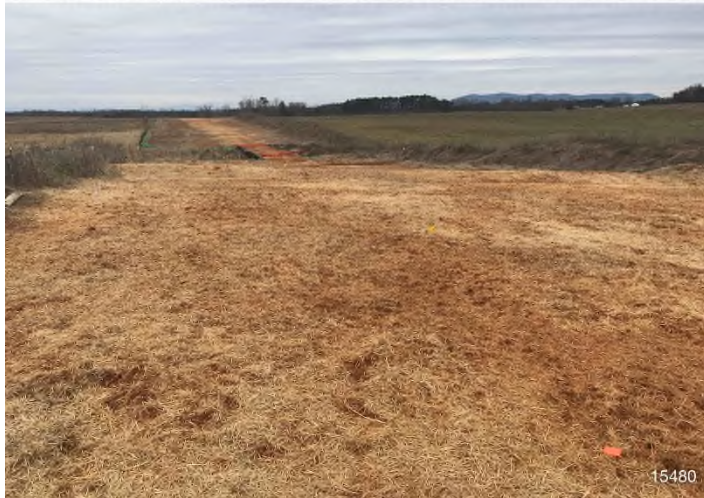
15480

Figure 1: STA 15480+00 – Controls in place and functioning properly. Area stabilized with straw mulch.

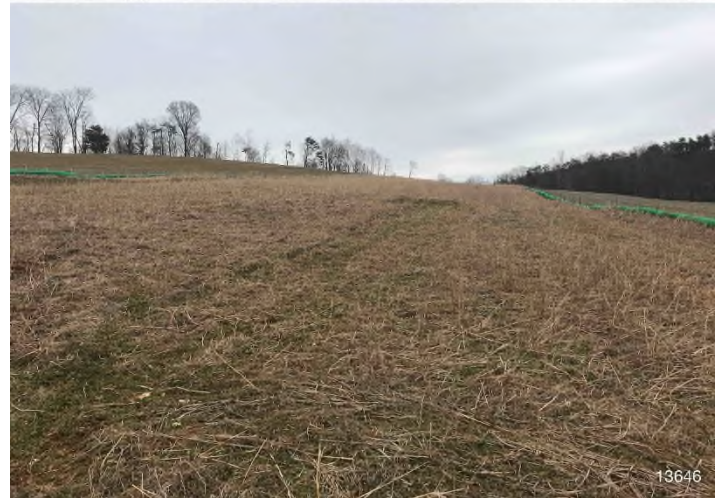
13646

Figure 2: STA 13646+00 – Controls in place and functioning properly.

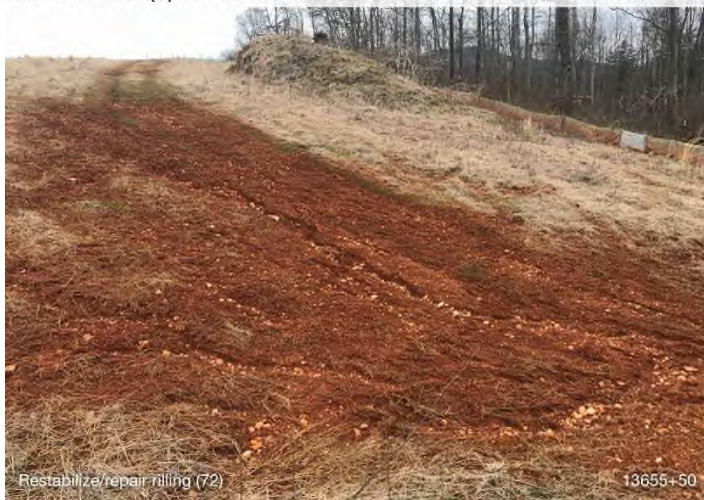
Figure 3: STA 13655+50 – Repair rill erosion and re-stabilization needed.

Restabilize/repair rilling (72)

- STA 13655+50: Repair rill erosion and re-stabilize.

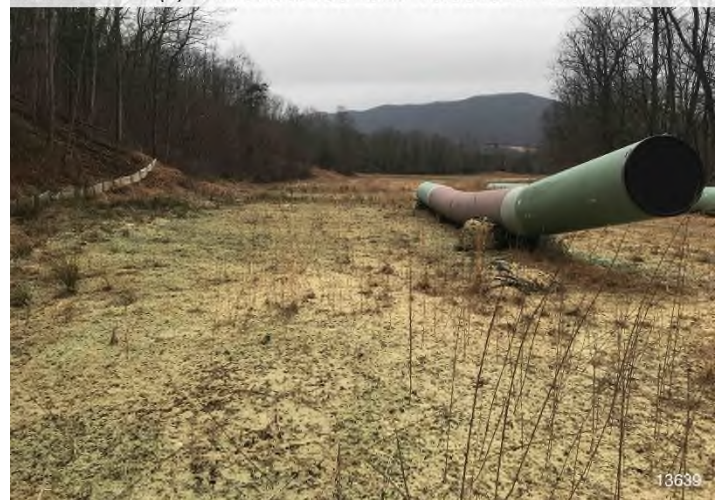
13639

Figure 4: STA 13639+00 – Controls in place and functioning properly. Area stabilized with hydro-mulch.
