FIELD INSPECTION REPORT

Project Name:	Mountain Valley Pipeline	Inspector:	Marshall Willis
Inspection Date:	Friday, February 19, 2021	Project Contact:	Brian Clauto, Cory Chalmers
Spread I: Pittsylvania County	STA 15435+00 – 15480+67 MVP-PI-332.01	Weather:	Snow

FIELD INSPECTION PHOTO LOG

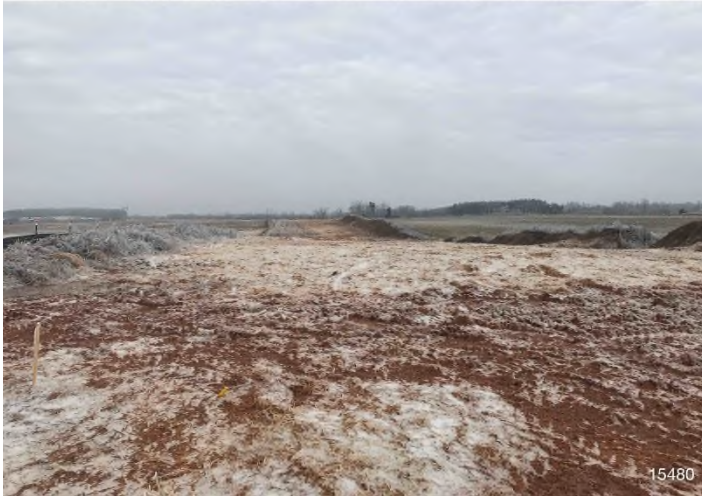
Figure 1: STA 15480+00 – Controls in place and functioning properly. Area stabilized with straw.

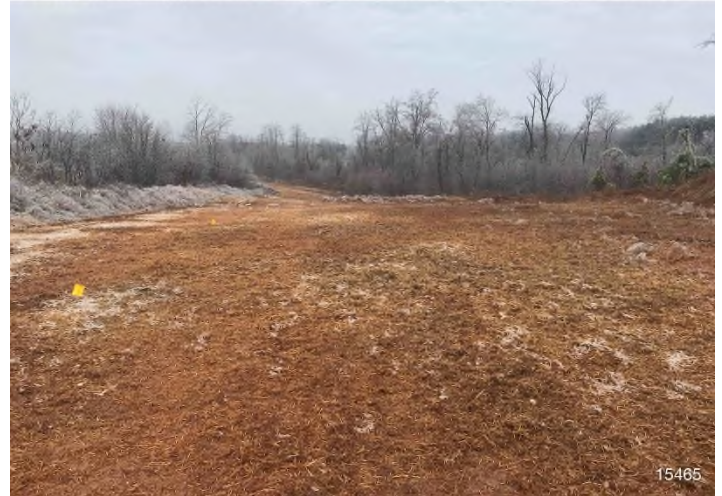
Figure 2: STA 15465+00 – Controls in place and functioning properly. Area stabilized with straw.

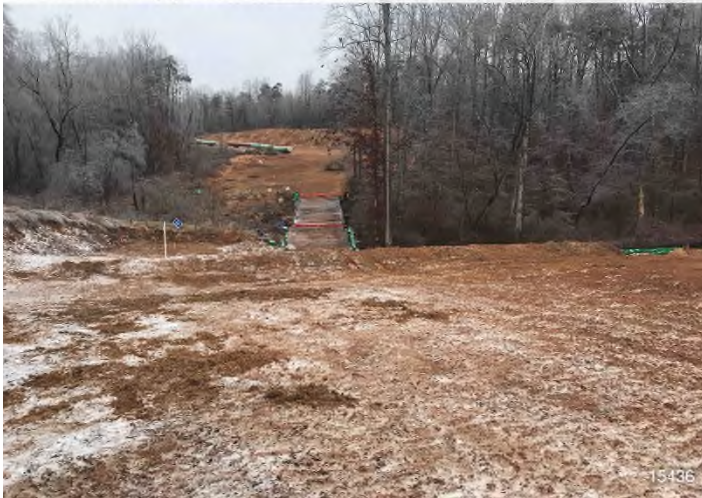
Figure 3: STA 15436+00 – Controls in place and functioning properly. Area stabilized with straw and erosion matting.

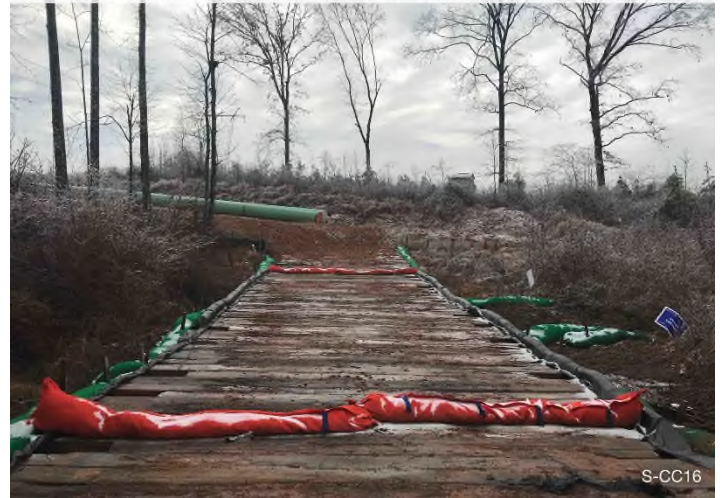
Figure 4: Stream S-CC16 – Controls in place and functioning properly around stream S-CC16.
