## FIELD INSPECTION REPORT

| <b>Project Name:</b> | Mountain Valley Pipeline | <b>Inspector:</b> | Marshall Willis |
| <b>Spread H:<br/>Montgomery County</b> | STA 12190+25 – 12235+00<br>MVP-MN-275<br>MVP-MN-276.03 | <b>Weather:</b> | Dry |

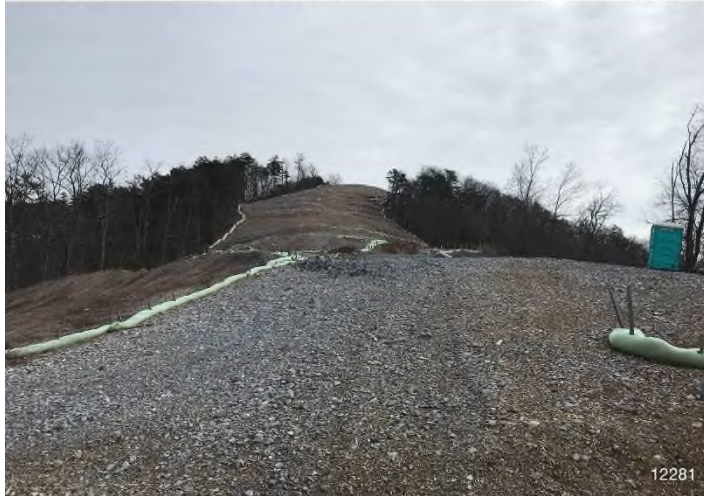
**Figure 1: STA 12232+00** – Controls in place and functioning properly. Area stabilized with straw and erosion matting.  
BRG: 64°NE (T) LAT: 37.242268 LON: -80.213276 ±22967ft ALT: 1300ft

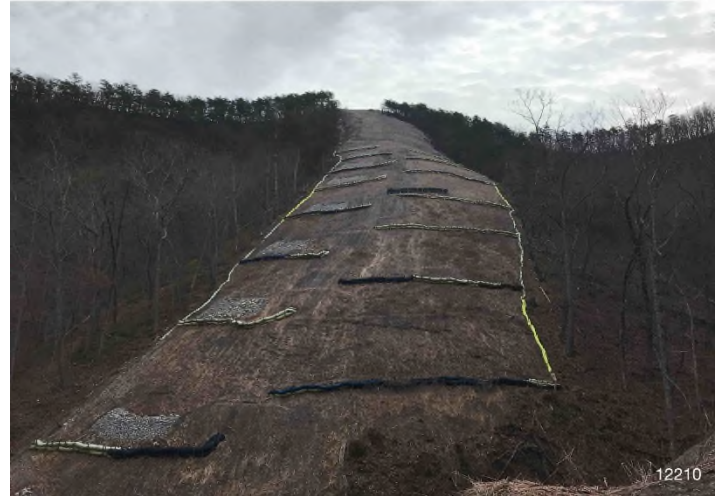
**Figure 2: STA 12210+00** – Controls in place and functioning properly. Area stabilized with straw and erosion matting.  
BRG: 91°E (T) LAT: 37.253189 LON: -80.253902 ±334ft ALT: 1437ft

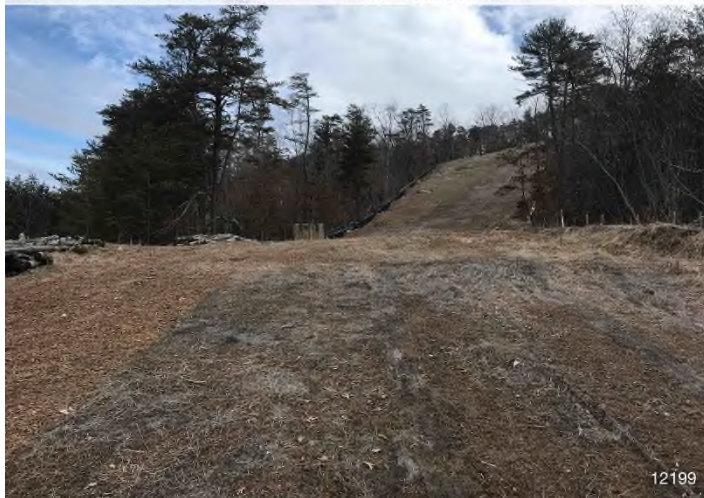
**Figure 3: STA 12199+00** – Controls in place and functioning properly. Area stabilized with straw and erosion matting.  
BRG: 36°NE (T) LAT: 37.245846 LON: -80.258165 ±7129ft ALT: 1378ft

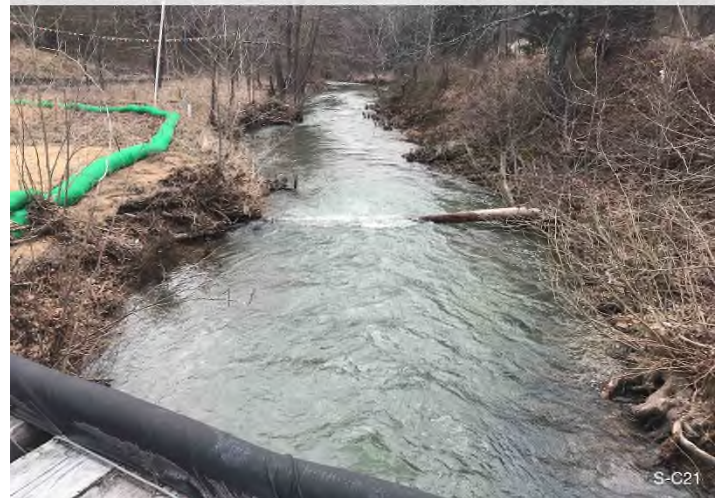
**Figure 4: Stream S-C21** – Controls in place and functioning properly around Bradshaw Creek.  
BRG: 196°S (T) LAT: 37.251870 LON: -80.259077 ±16ft ALT: 1270ft
