FIELD INSPECTION REPORT

Project Name:	Mountain Valley Pipeline	Inspector:	Marshall Willis
Inspection Date:	Thursday, February 11, 2021	Project Contact:	Brian Clauto, Cory Chalmers
Spread H: Roanoke County	STA 13012+62 – 12994+02 STA 12687+28 – 12692+47 MVP-FR-293.01 MVP-RO-280	Weather:	Rainy

FIELD INSPECTION PHOTO LOG

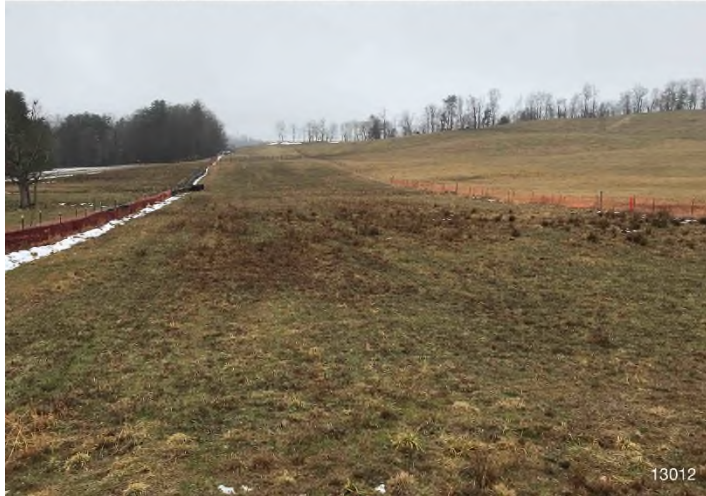
Figure 1: STA 13012+00 – Controls in place and functioning properly.

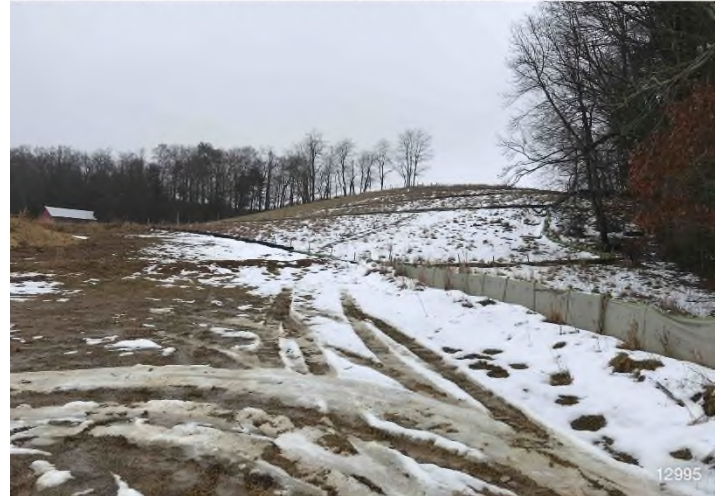
Figure 2: STA 12995+00 – Controls in place and functioning properly.

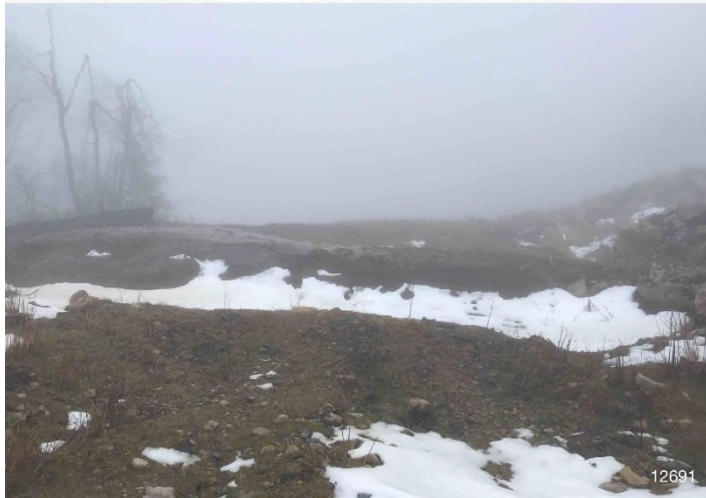
Figure 3: STA 12691+00 – Controls in place and functioning properly.

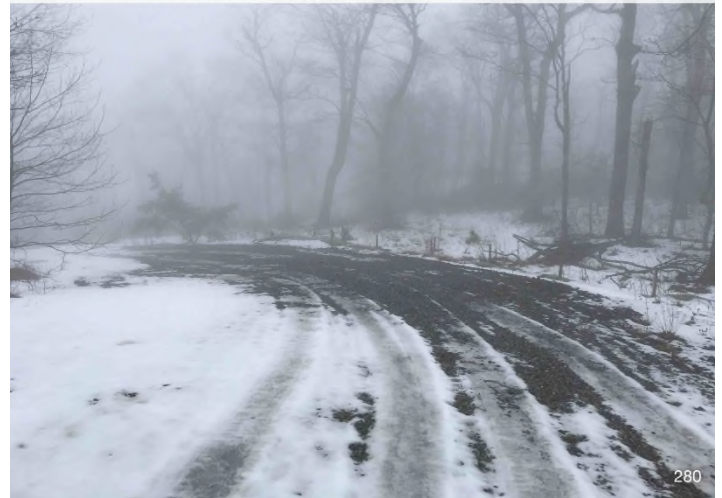
Figure 4: MVP-RO-280 – Controls in place and functioning properly.
