## FIELD INSPECTION REPORT

| Project Name: | Mountain Valley Pipeline | Inspector: | Marshall Willis |
| Spread I:<br>Franklin County | STA 14454+22 – 14546+75<br>MVP-FR-317.01 | Weather: | Wet |

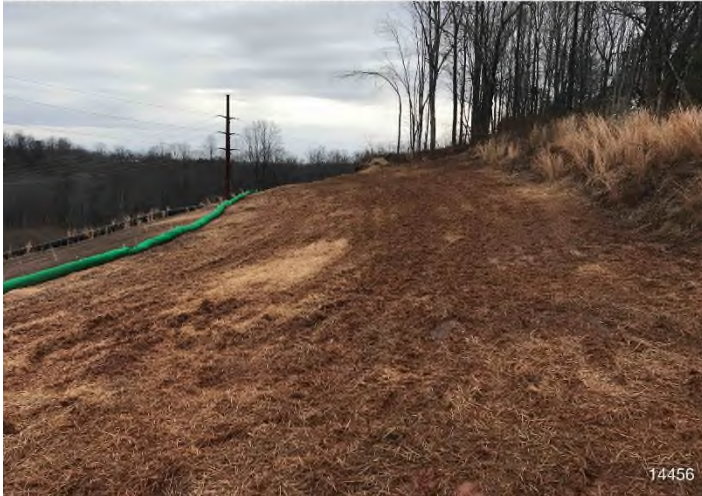
**Figure 1: STA 14456+00** – Controls in place and functioning properly. Area stabilized with straw.

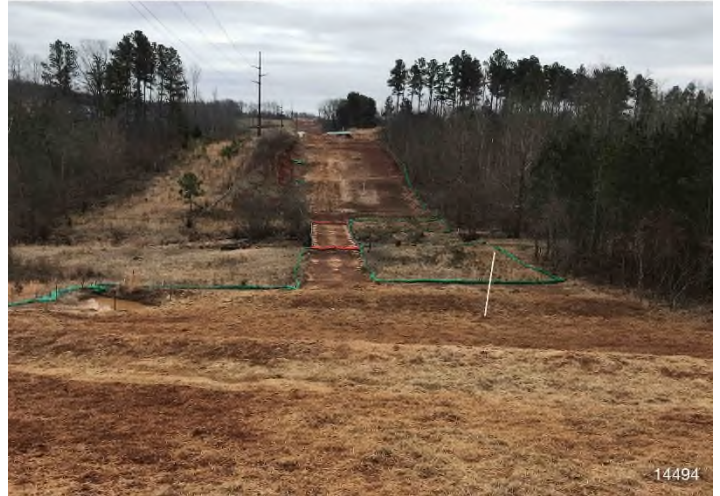
**Figure 2: STA 14494+00** – Controls in place and functioning properly. Area stabilized with straw.

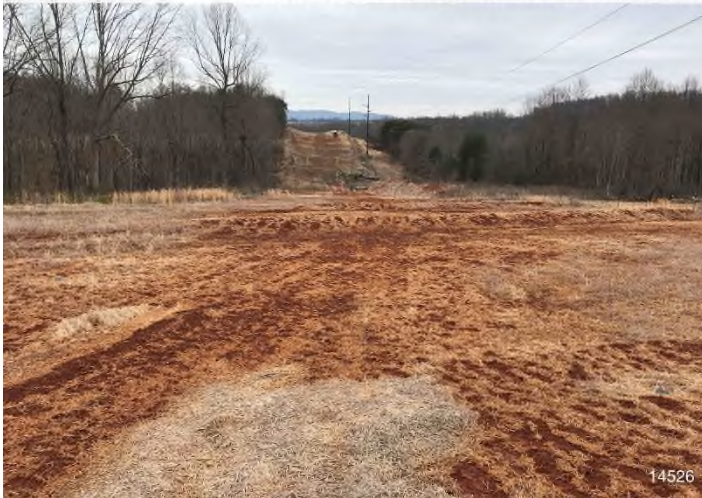
**Figure 3: STA 14526+00** – Controls in place and functioning properly. Area stabilized with straw.

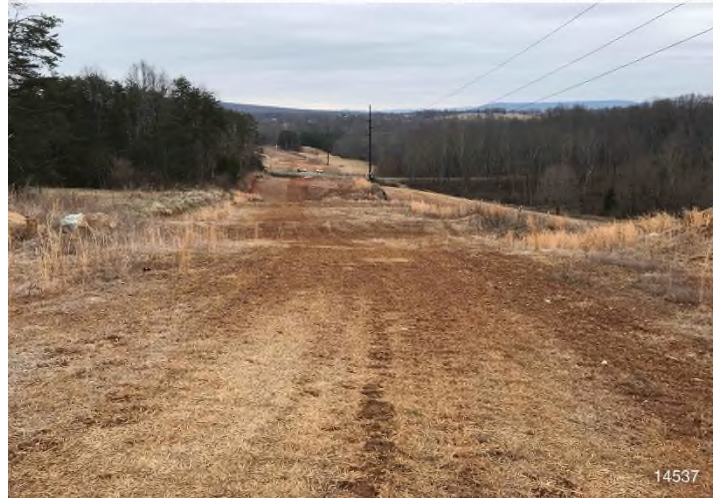
**Figure 4: STA 14537+00** – Controls in place and functioning properly. Area stabilized with straw.
