## FIELD INSPECTION REPORT

| <b>Project Name:</b> | Mountain Valley Pipeline | <b>Inspector:</b> | Marshall Willis |
| <b>Inspection Date:</b> | Tuesday, February 9, 2021 | <b>Project Contact:</b> | Brian Clauto, Cory Chalmers |
| <b>Spread H:<br/>Franklin County</b> | STA 13060+00 – 13115+00<br>STA 13162+95 – 13185+40<br>MVP-FR-290/291/292/292.01 | <b>Weather:</b> | Wet |

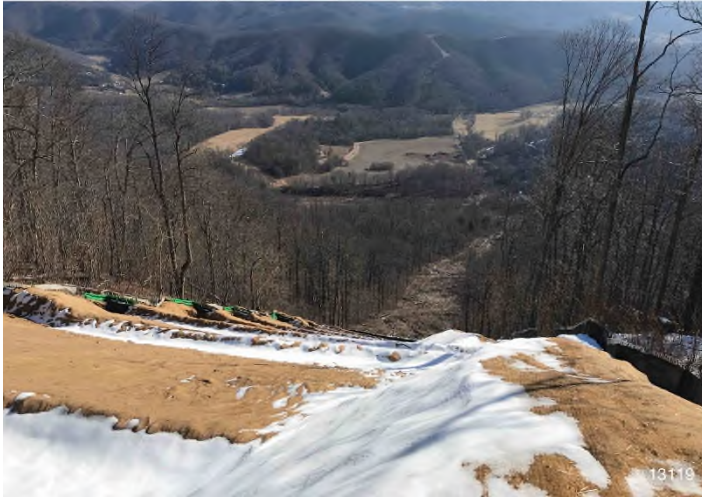
**Figure 1: STA 13119+00** – Controls in place and functioning properly.

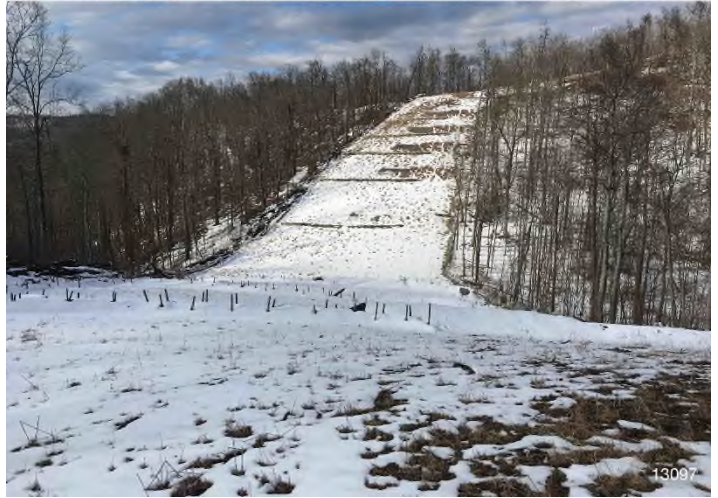
**Figure 2: STA 13097+00** – Controls in place and functioning properly.

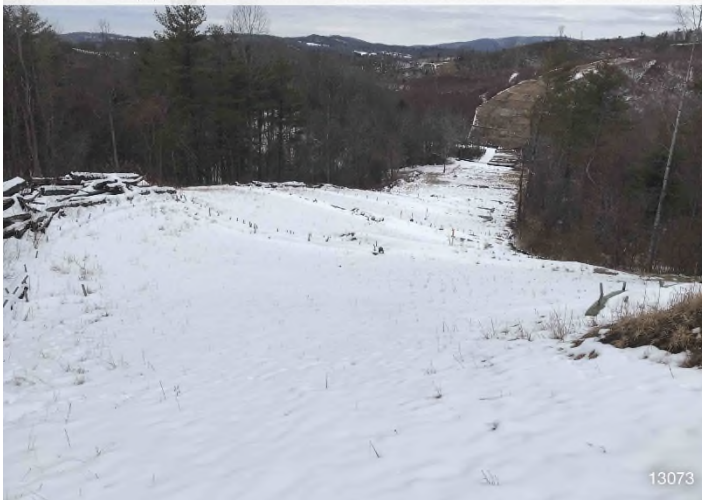
**Figure 3: STA 13073+00** – Controls in place and functioning properly.

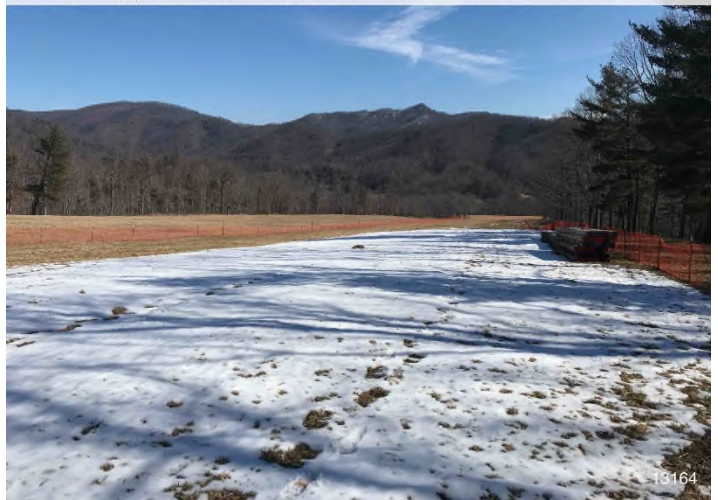
**Figure 4: STA 13164+00** – Controls in place and functioning properly.
