## FIELD INSPECTION REPORT

| Project Name: | Mountain Valley Pipeline | Inspector: | Marshall Willis |
| Spread I:<br>Franklin County | STA 14273+62 – 14333+27<br>MVP-FR-313 | Weather: | Wet |

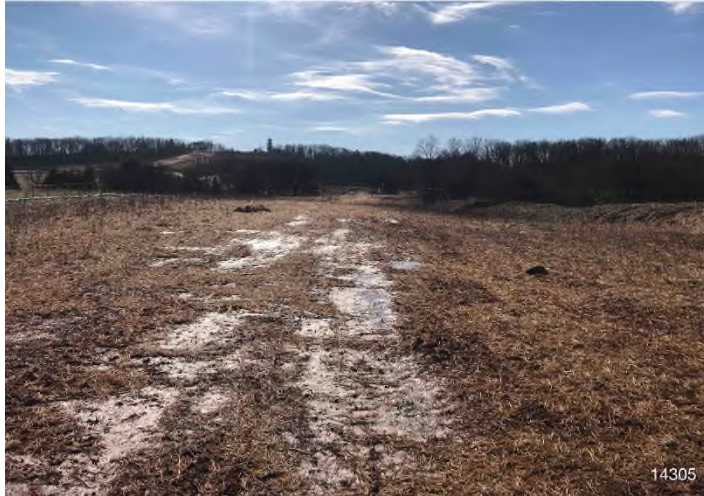
14305

**Figure 1: STA 14305+00** – Controls in place and functioning properly. Area stabilized with straw.

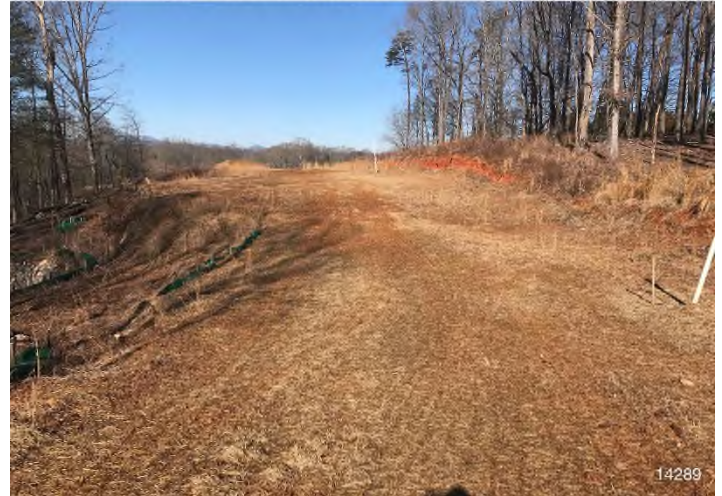
14289

**Figure 2: STA 14289+00** – Controls in place and functioning properly. Area stabilized with straw.

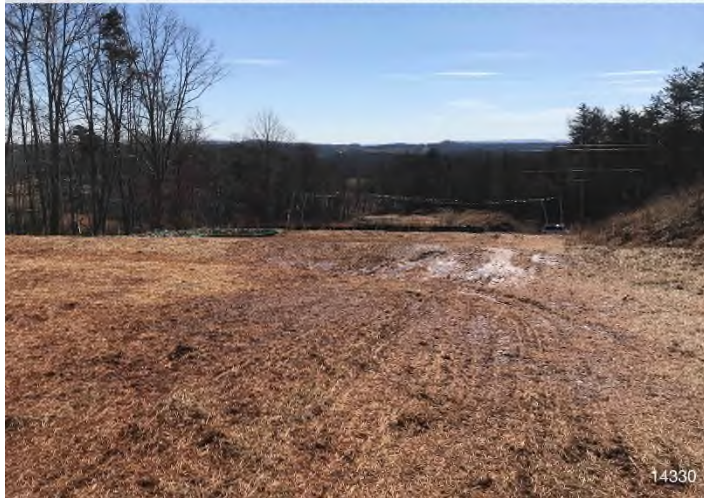
14330

**Figure 3: STA 14330+00** – Controls in place and functioning properly. Area stabilized with straw.

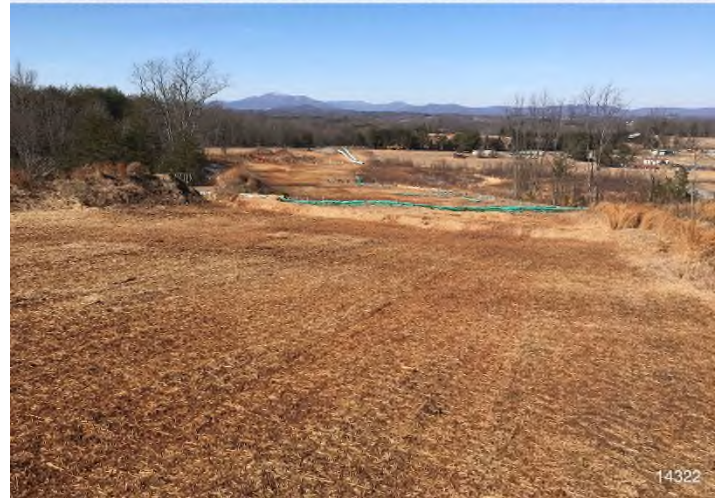
14322

**Figure 4: STA 14322+00** – Controls in place and functioning properly. Area stabilized with straw.
