FIELD INSPECTION REPORT

Project Name:	Mountain Valley Pipeline	Inspector:	Marshall Willis
Inspection Date:	Thursday, February 4, 2021	Project Contact:	Brian Clauto, Cory Chalmers
Spread H: Montgomery County	STA 12008+79 – 12036+00 MVP-MN-268 MVP-MN-268.01	Weather:	Snow

FIELD INSPECTION PHOTO LOG

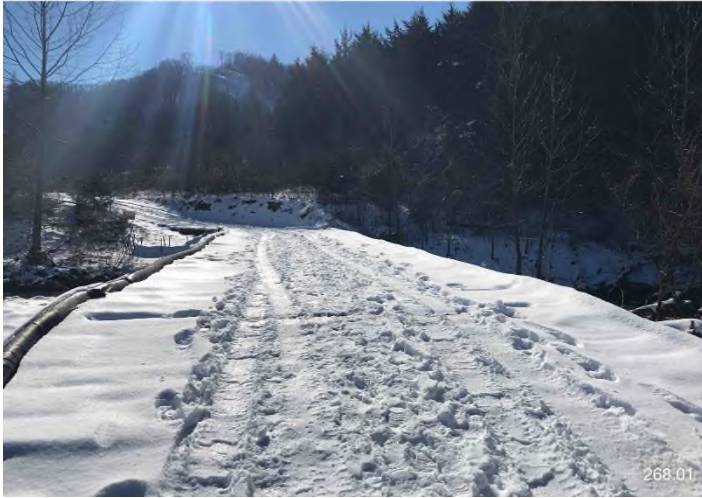
Figure 1: MVP-MN-268.01 – Controls in place and functioning properly.

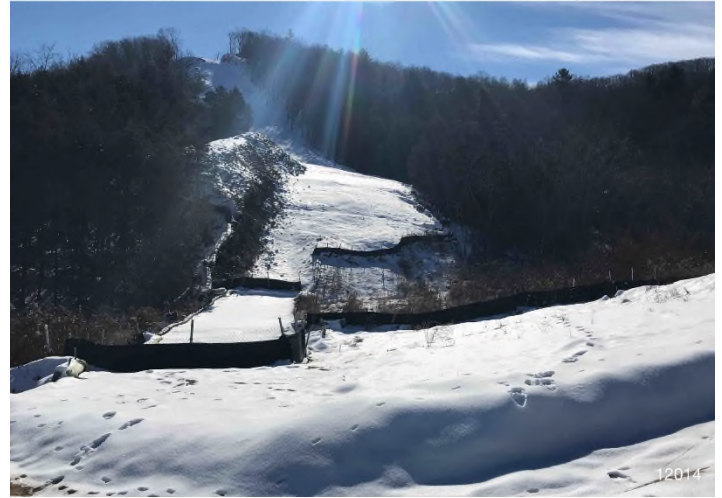
Figure 2: STA 12014+00 – Controls in place and functioning properly.

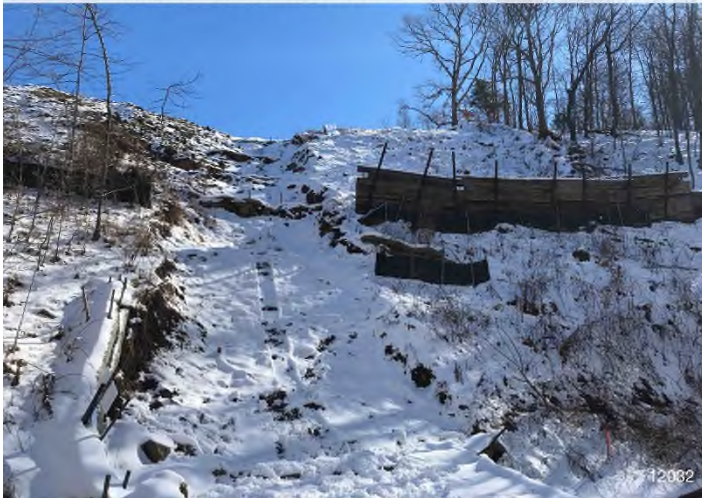
Figure 3: STA 12032+00 – Controls in place and functioning properly.

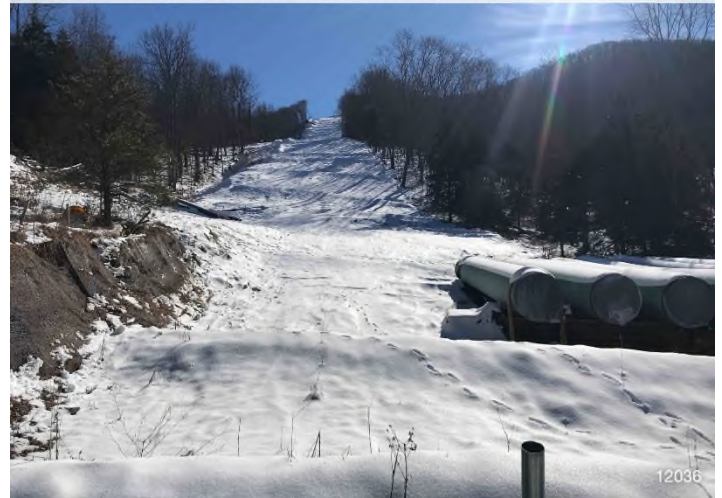
Figure 4: STA 12036+00 – Controls in place and functioning properly.
