## FIELD INSPECTION REPORT

<b>Project Name:</b>	<b>Mountain Valley Pipeline</b>	<b>Inspector:</b>	<b>Marshall Willis</b>
<b>Inspection Date:</b>	<b>Friday, January 29, 2021</b>	<b>Project Contact:</b>	<b>Brian Clauto, Cory Chalmers</b>
<b>Spread I: Franklin County</b>	<b>STA 13541+50 – 13575+21 ATWS 1417/1416</b>	<b>Weather:</b>	<b>Snow</b>

## FIELD INSPECTION PHOTO LOG

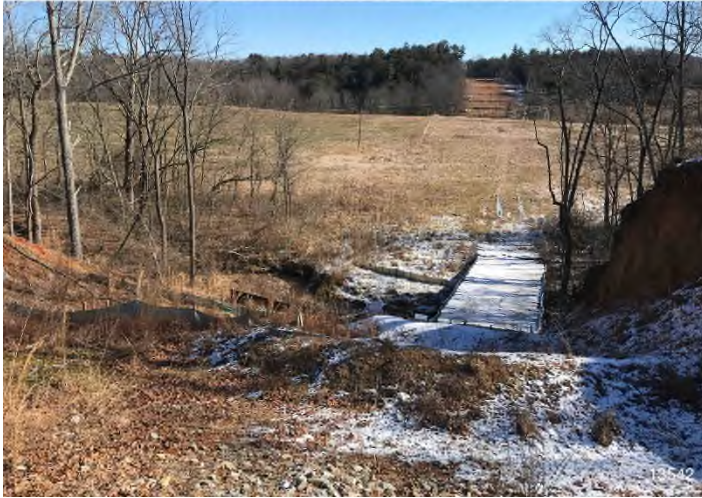
**Figure 1: STA 13542+00** – Controls in place and functioning properly.

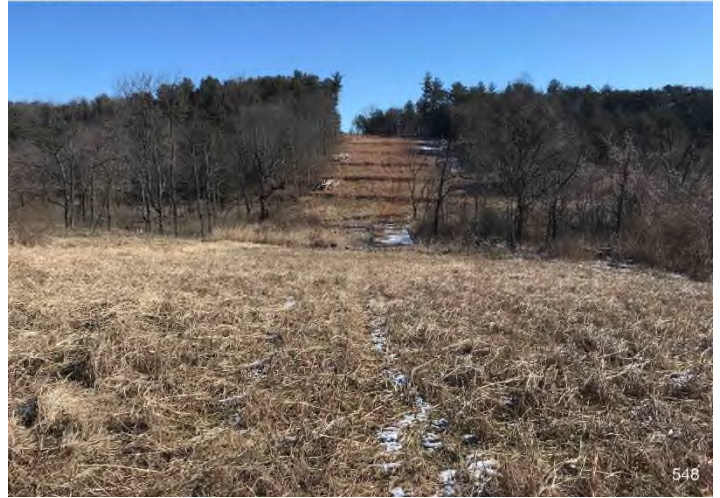
**Figure 2: STA 13548+00** – Controls in place and functioning properly.

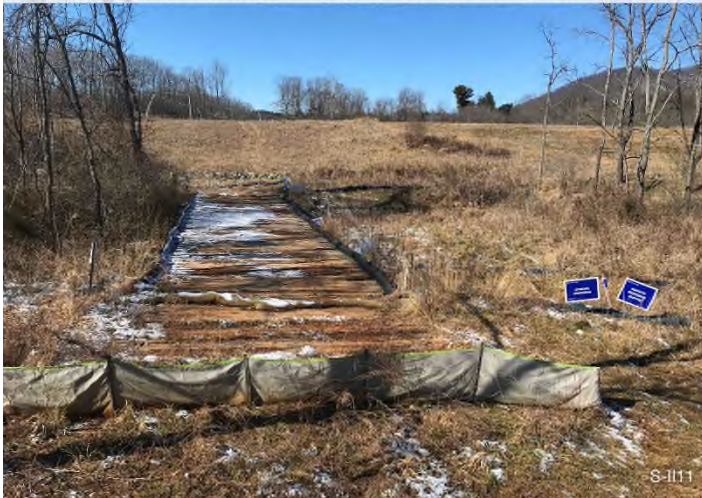
**Figure 3: Stream S-II11** – Controls in place and functioning properly.

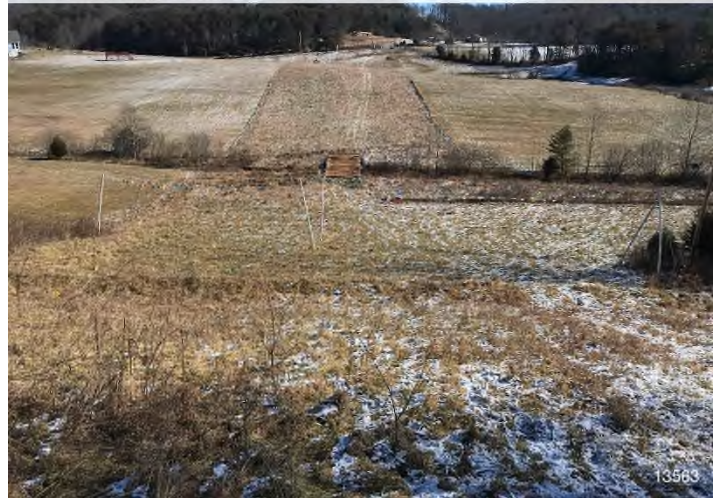
**Figure 4: STA 13563+00** – Controls in place and functioning properly.
