FIELD INSPECTION REPORT

Project Name:	Mountain Valley Pipeline	Inspector:	Marshall Willis
Inspection Date:	Friday, January 29, 2021	Project Contact:	Brian Clauto, Cory Chalmers
Spread H: Franklin County	STA 13339+00 – 13350+00 STA 13310+50 – 13316+50	Weather:	Wet

FIELD INSPECTION PHOTO LOG

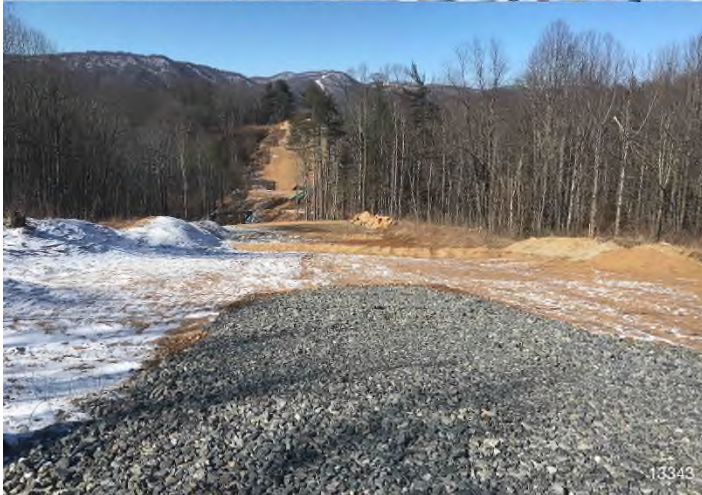
Figure 1: STA 13343+00 – Webster's Corner crossing looking NW. Controls in place and functioning properly. Area stabilized with erosion matting and straw.

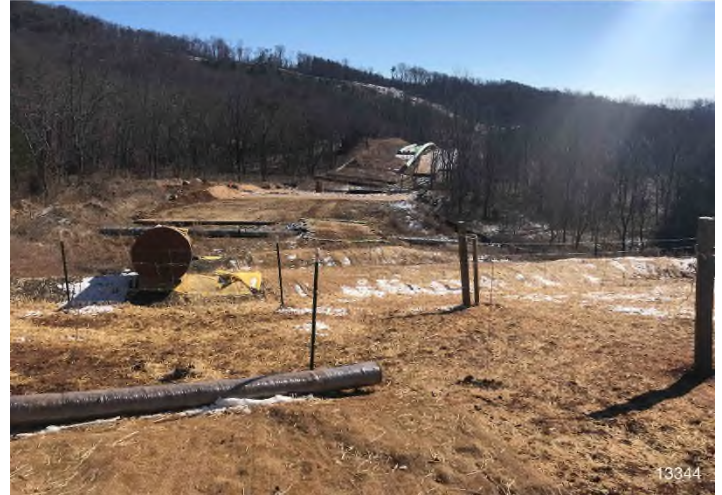
Figure 2: STA 13344+00 – Webster's Corner crossing looking SE. Controls in place and functioning properly. Area stabilized with erosion matting and straw.

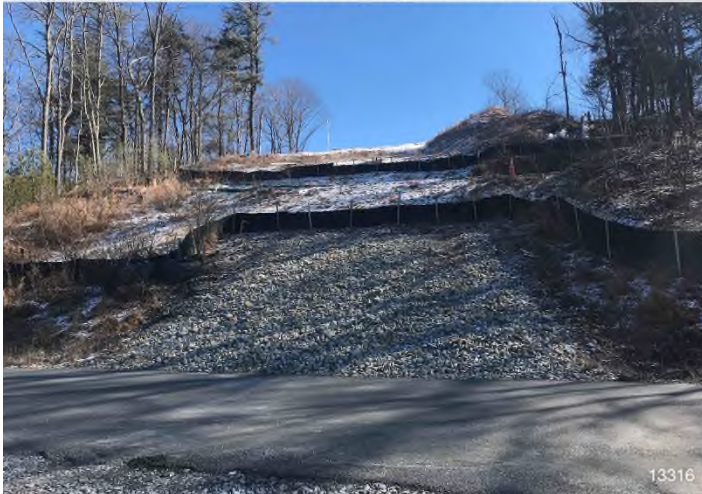
Figure 3: STA 13316+00 – Wades Gap crossing looking NW. Controls in place and functioning properly.

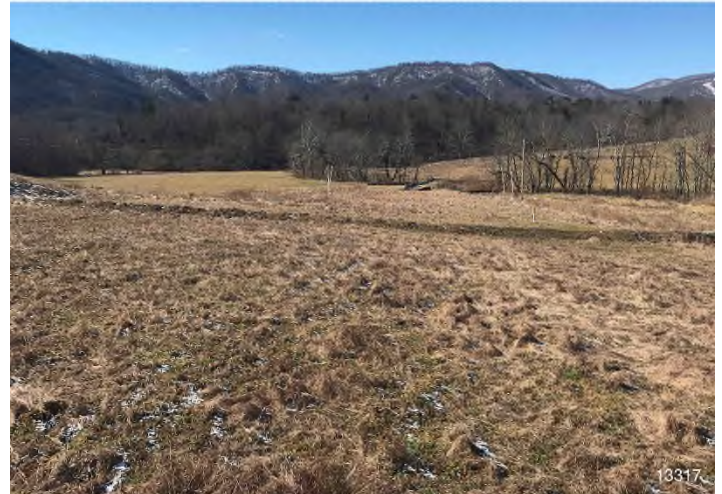
Figure 4: STA 13316+00 – Wades Gap crossing looking W. Controls in place and functioning properly.
