FIELD INSPECTION REPORT

Project Name:	Mountain Valley Pipeline	Inspector:	Marshall Willis
Inspection Date:	Wednesday, January 27, 2021	Project Contact:	Brian Clauto, Cory Chalmers
Spread I: Franklin County	STA 14018+17 – 14062+17 STA 13996+56 – 14009+20 MVP-FR-306.02	Weather:	Wet

FIELD INSPECTION PHOTO LOG

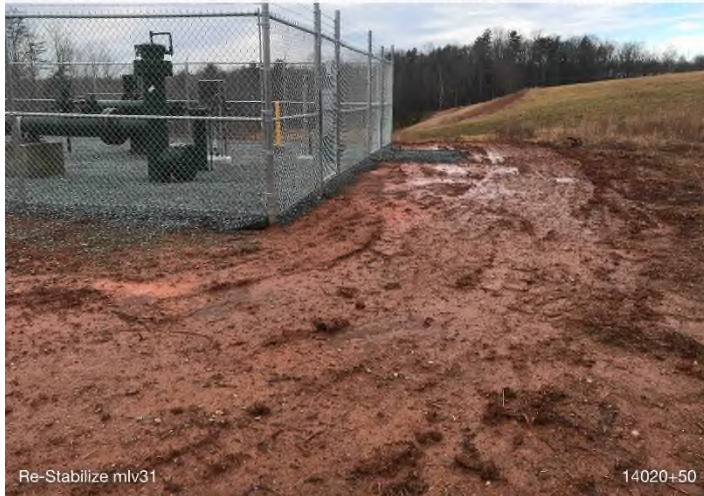
- STA 14020+50: Re-stabilize MLV-31.

Figure 1: STA 14020+50 – Re-stabilize around MLV-31.

Re-Stabilize mlv31

Recommended Corrective Action: Maintain and install all controls per the approved PSS&S.

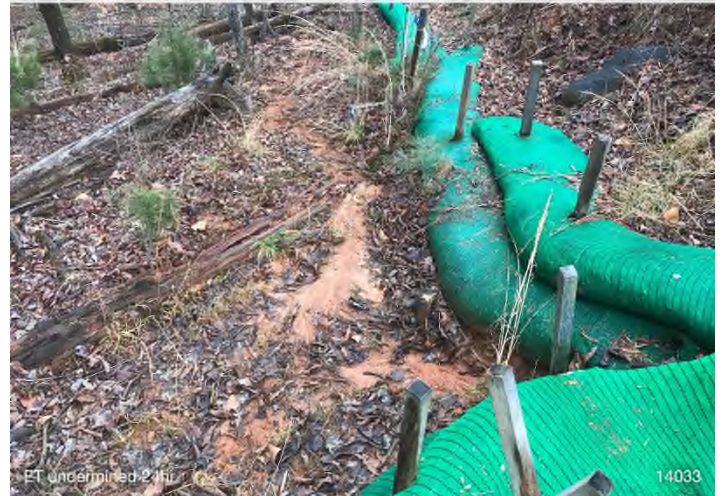
- STA 14033+00: End-treatment CFS undermined.

Figure 2: STA 14033+00 – End-treatment undermined. Repair needed.

ET Undermined 24 ft

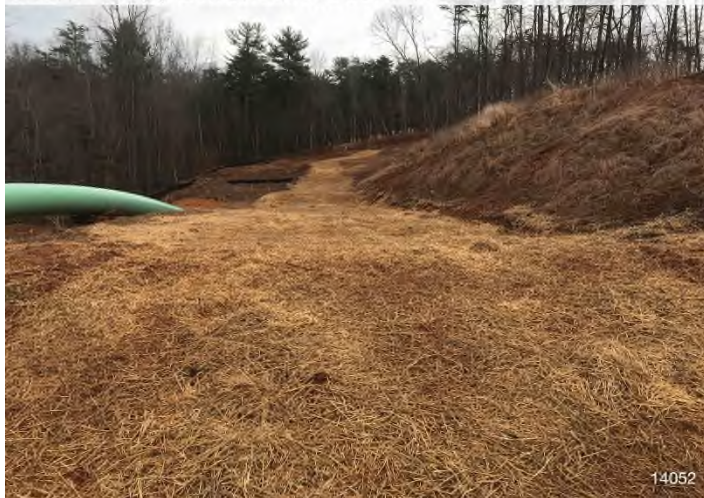
Figure 3: STA 14052+00 – Controls in place and functioning properly. Area stabilized with straw.

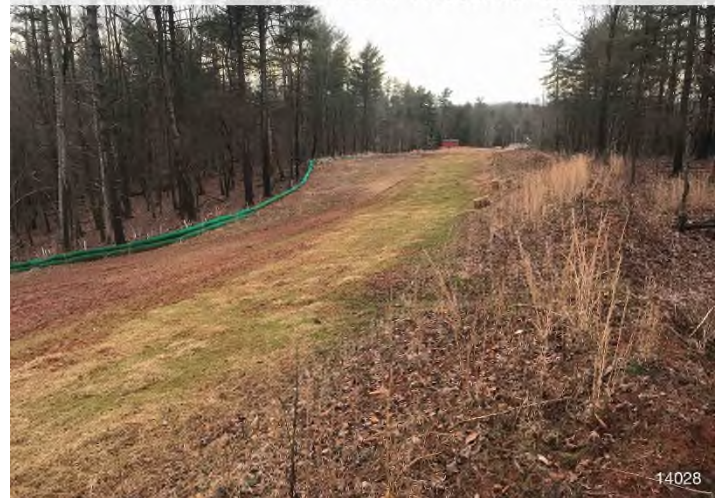
Figure 4: STA 14028+00 – Controls in place and functioning properly. Area stabilized with straw.
