FIELD INSPECTION REPORT

Project Name:	Mountain Valley Pipeline	Inspector:	Marshall Willis
Inspection Date:	Thursday, January 21, 2021	Project Contact:	Brian Clauto, Cory Chalmers
Spread I: Pittsylvania County	STA 15142+66 – 15210+25 MVP-PI-326	Weather:	Dry

FIELD INSPECTION PHOTO LOG

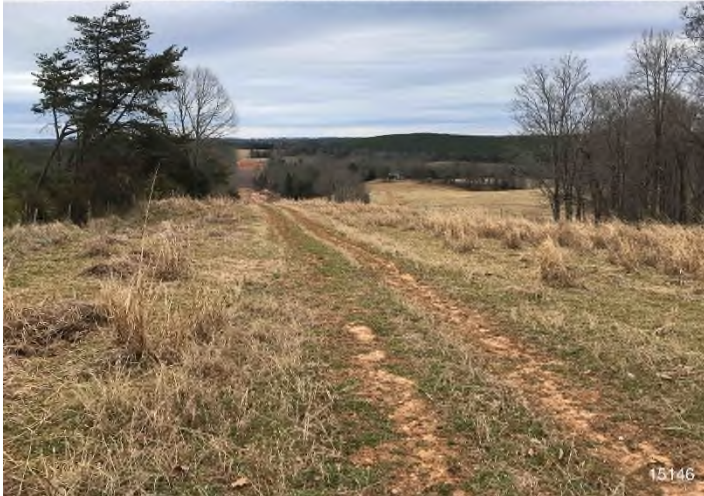
Figure 1: STA 15146+00 – Controls in place and functioning properly.

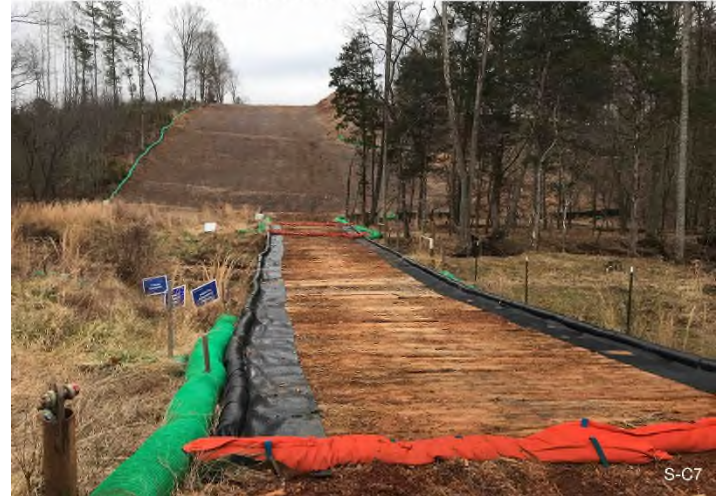
Figure 2: Stream S-C7 – Controls in place and functioning properly around stream C-C7 crossing.

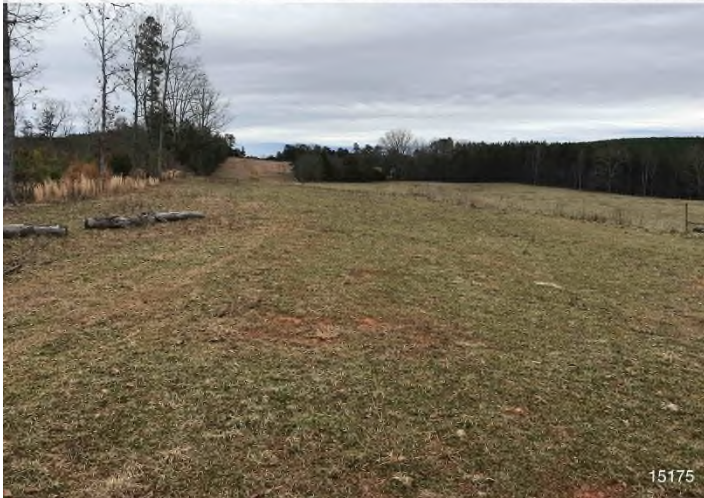
Figure 3: STA 15175+00 – Controls in place and functioning properly.

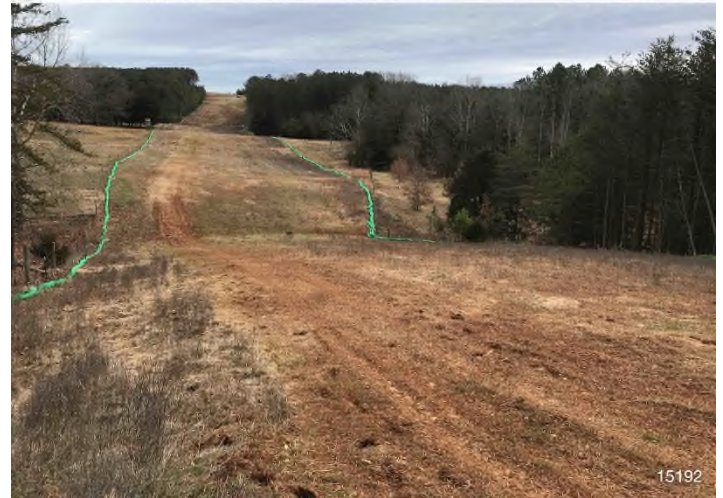
Figure 4: STA 15192+00 – Controls in place and functioning properly. Area stabilized with straw.
