FIELD INSPECTION REPORT

| Project Name: | Mountain Valley Pipeline | Inspector: | Marshall Willis |
| Inspection Date: | Wednesday, January 20, 2021 | Project Contact: | Brian Clauto, Cory Chalmers |
| Spread H: Montgomery County | STA 12445+19 – 12544+27 MVP-MN-278.01 MVP-MLV-AR-28 | Weather: | Dry |

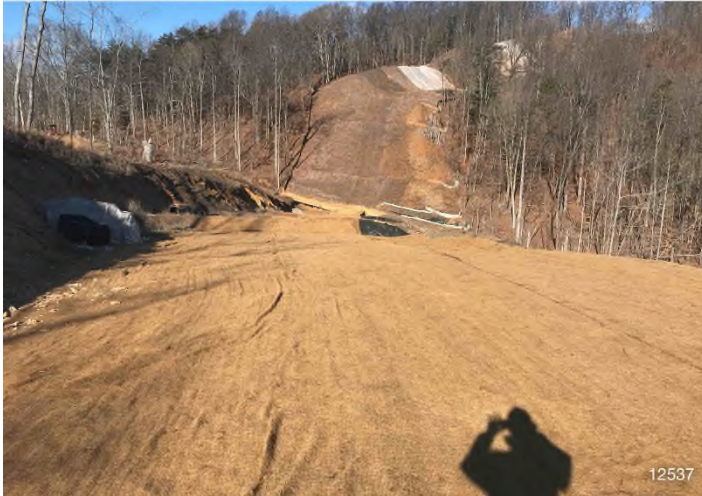
Figure 1: STA 12537+00 – Controls in place and functioning properly. Area Stabilized with straw and erosion control fabric.
BRG: 312°NW (T) LAT: 37.211547 LON: -80.195502 ±98ft ALT: 1681ft

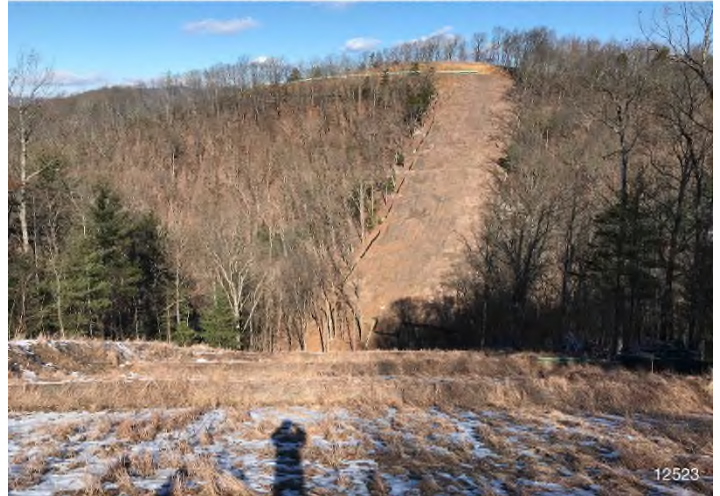
Figure 2: STA 12523+00 – Controls in place and functioning properly. Area Stabilized with straw and erosion control fabric.
BRG: 355°N (T) LAT: 37.197756 LON: -80.233750 ±9843ft ALT: 1787ft

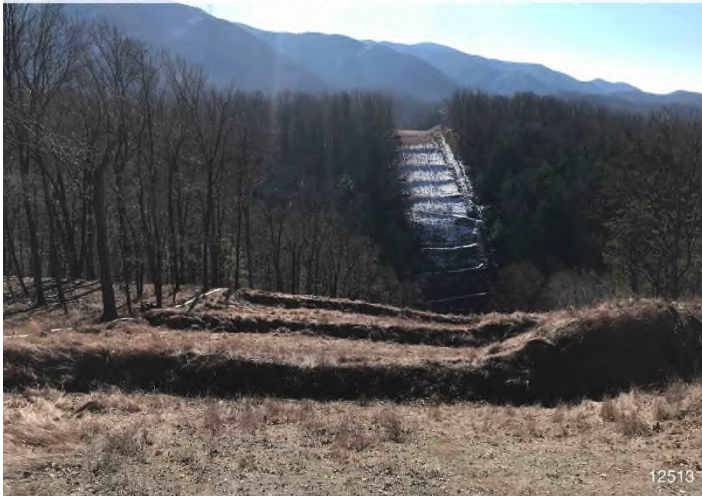
Figure 3: STA 12513+00 – Controls in place and functioning properly. Area Stabilized with straw and erosion control fabric.
BRG: 178°S (T) LAT: 37.217770 LON: -80.197356 ±32ft ALT: 1934ft

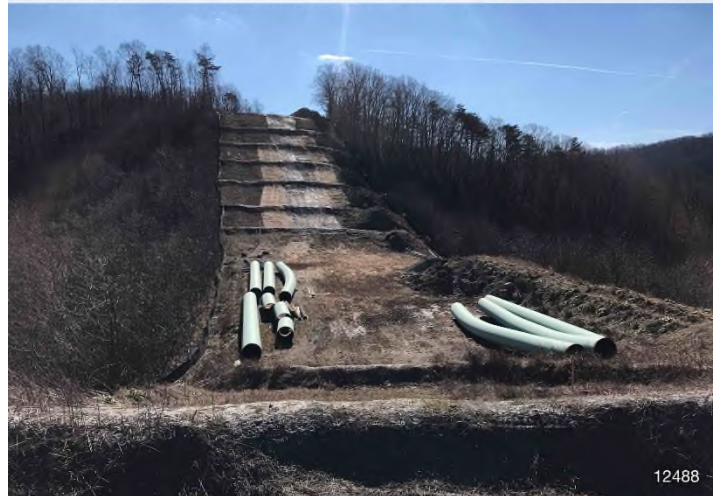
Figure 4: STA 12488+00 – Controls in place and functioning properly. Area Stabilized with straw and erosion control fabric.
BRG: 156°SE (T) LAT: 37.226162 LON: -80.203033 ±8067ft ALT: 1537ft
