## FIELD INSPECTION REPORT

Project Name:	Mountain Valley Pipeline	Inspector:	Marshall Willis
Inspection Date:	Friday, October 9, 2020	Project Contact:	Brian Clauto, Cory Chalmers
Spread H: Montgomery County	STA 12001+72 – 12071+80 MVP-MN-270/268/268.01	Weather:	Dry

## FIELD INSPECTION PHOTO LOG

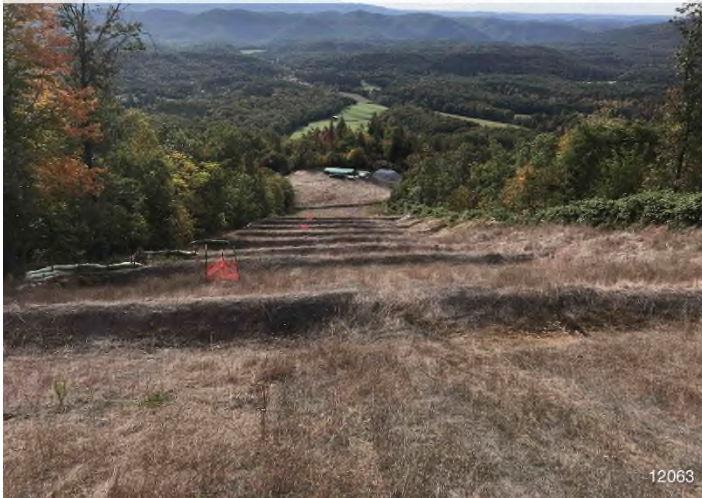
**Figure 1: STA 12063+00** – Controls in place and functioning properly. Area stabilized with erosion matting and straw.

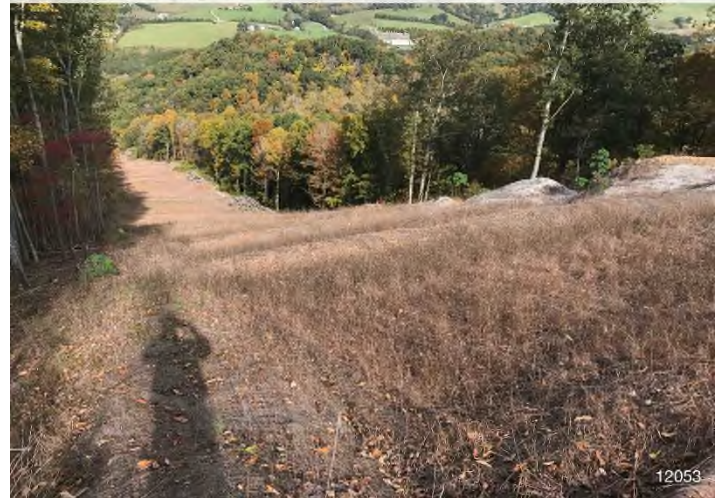
**Figure 2: STA 12053+00** – Controls in place and functioning properly. Area stabilized with erosion matting and straw.

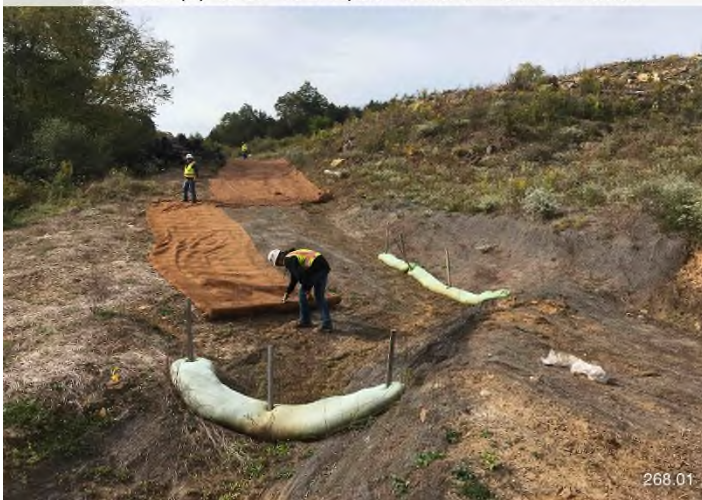
**Figure 3: MVP-MN-268.01** – PPL crews installing erosion control matting and applying temporary seed along MN-268.01.

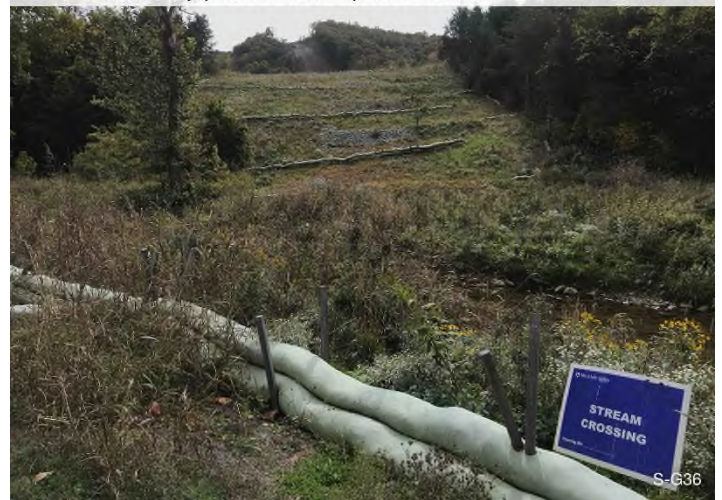
**Figure 4: Stream S-G36** – Controls in place and functioning properly around N. Fork Roanoke River crossing.
