## FIELD INSPECTION REPORT

| Project Name: | Mountain Valley Pipeline | Inspector: | Marshall Willis |
| Inspection Date: | Thursday, October 8, 2020 | Project Contact: | Brian Clauto, Cory Chalmers |
| Spread I:<br>Franklin County | STA 13730+00 – 13770+00<br>ATWS 568/1444/566 | Weather: | Dry |

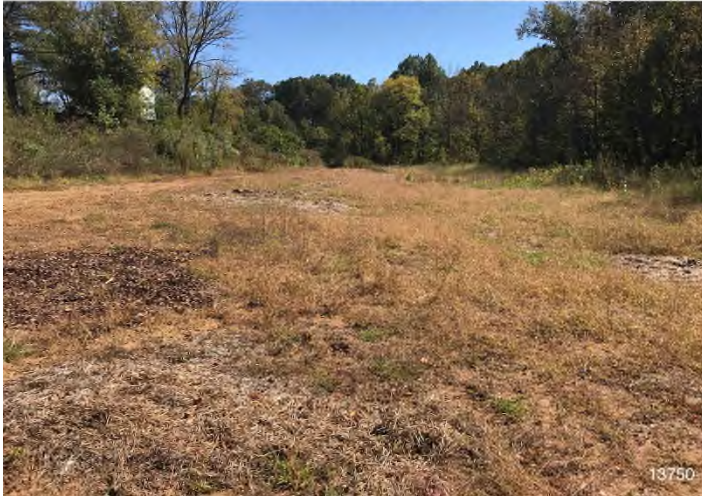
**Figure 1: STA 13750+00** – Controls in place and functioning properly.

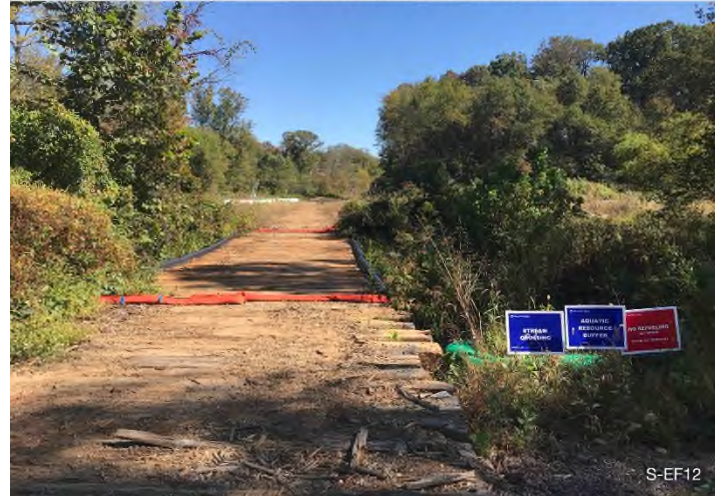
**Figure 2: Stream S-EF12** – Controls in place and functioning properly around S-EF12 crossing.

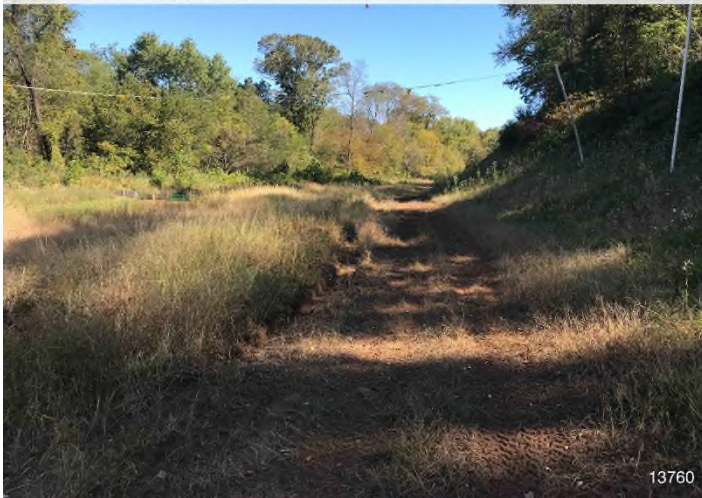
**Figure 3: STA 13760+00** – Controls in place and functioning properly.

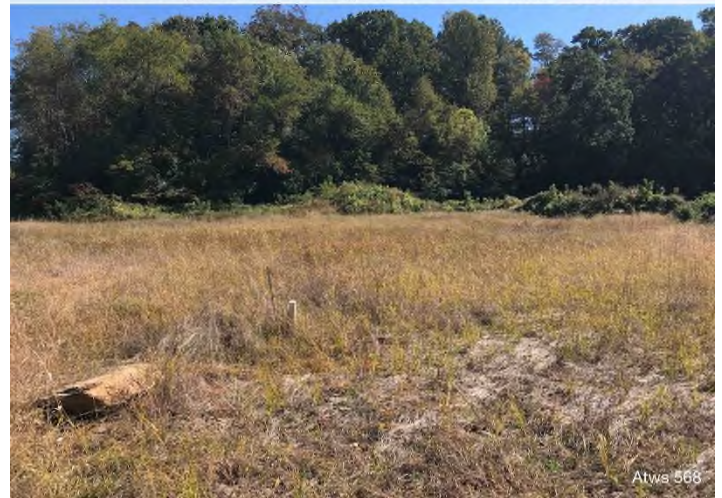
**Figure 4: ATWS 568** – Controls in place and functioning properly.
