## FIELD INSPECTION REPORT

| Project Name: | Mountain Valley Pipeline | Inspector: | Marshall Willis |
| Inspection Date: | Wednesday, October 7, 2020 | Project Contact: | Brian Clauto, Cory Chalmers |
| Spread I:<br>Franklin County | STA 14546+75 – 14599+24<br>ATWS 362/363/530/1043/531 | Weather: | Dry |

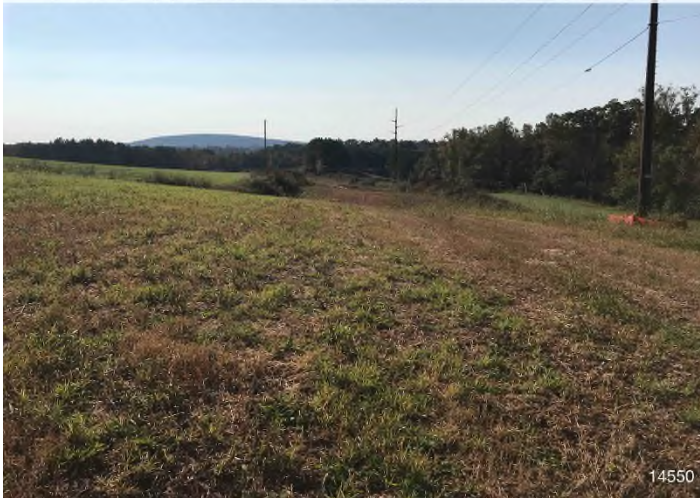
14550

**Figure 1: STA 14550+00** – Controls in place and functioning properly. Area stabilized with straw.

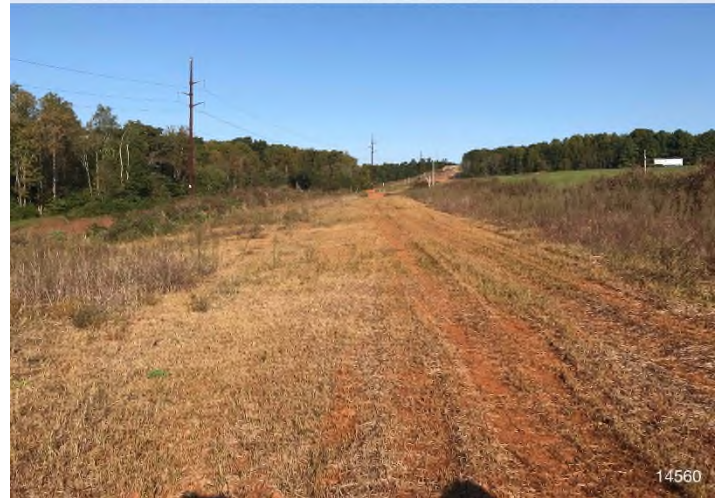
14560

**Figure 2: STA 14560+00** – Controls in place and functioning properly. Area stabilized with straw.

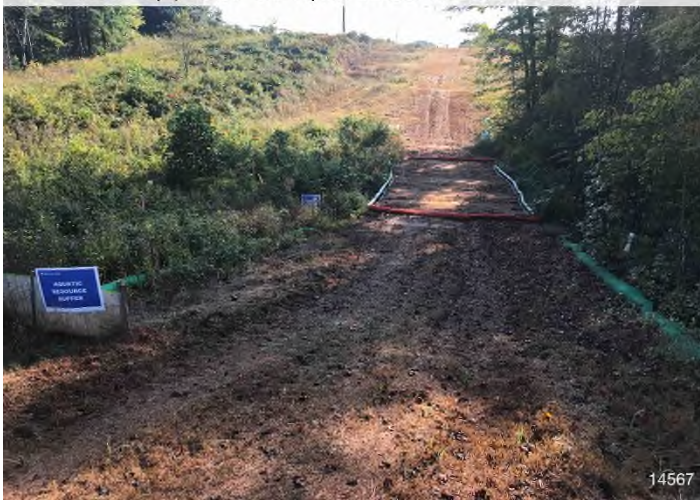
14567

**Figure 3: STA 14567+00** – Controls in place and functioning properly. Area stabilized with straw.

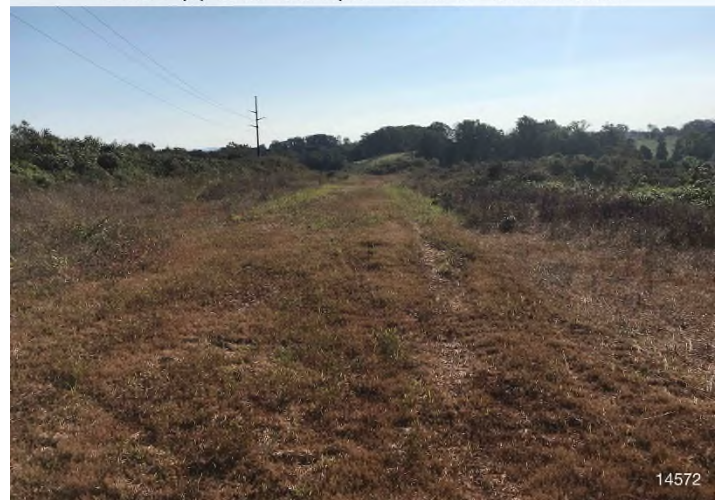
14572

**Figure 4: STA 14572+00** – Controls in place and functioning properly. Area stabilized with straw.
