FIELD INSPECTION REPORT

Project Name:	Mountain Valley Pipeline	Inspector:	Marshall Willis
Inspection Date:	Tuesday, October 6, 2020	Project Contact:	Brian Clauto, Cory Chalmers
Spread H: Montgomery County	STA 12070+80 – 12119+17 STA 12151+28 – 12190+85 MVP-MN-270/273	Weather:	Dry

FIELD INSPECTION PHOTO LOG

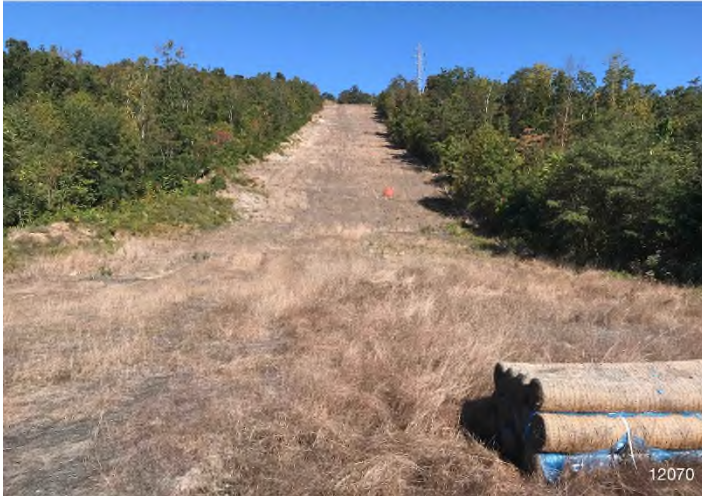
Figure 1: STA 12070+00 – Controls in place and functioning properly. Area stabilized with erosion matting and straw.

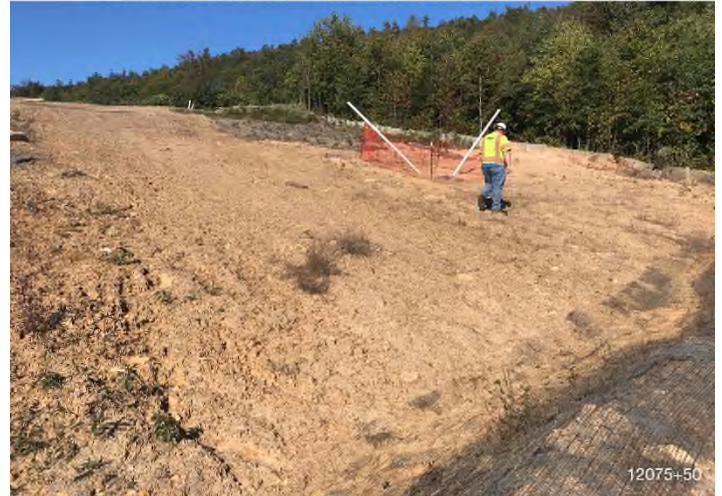
- STA 12073+00 to 12075+00: Re-stabilization needed.
- STA 12153+00 to 12154+00: Re-stabilization needed.

Figure 2: STA 12073+00 to 12075+00 – Re-stabilization needed.

Recommended Corrective Action: Maintain and install all controls per the approved PSS&S.

Deadline: Within 72-Hour of Notification

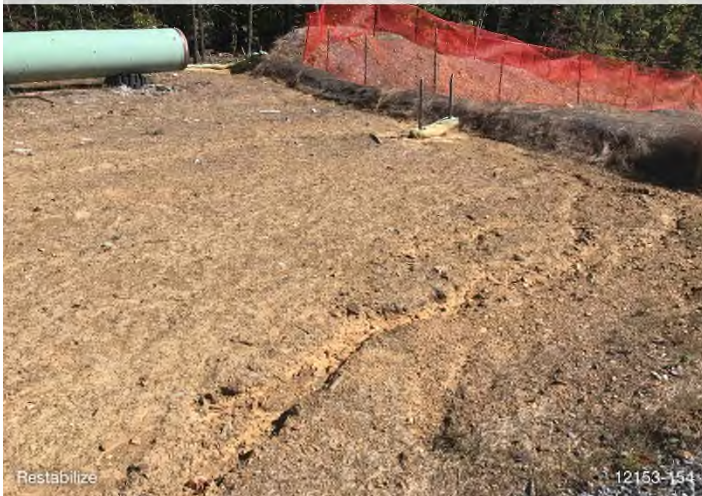
Figure 3: STA 12153+00 to 12154+00 – Re-stabilization needed.

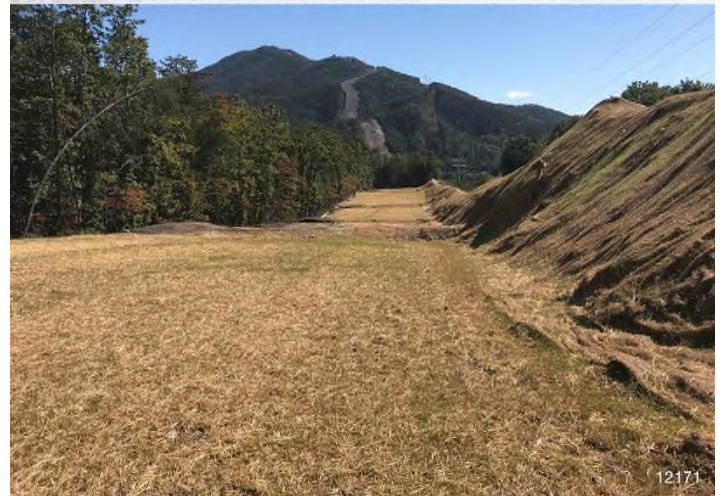
Figure 4: STA 12171+00 – Controls in place and functioning properly. Area stabilized with erosion matting and straw.
