## FIELD INSPECTION REPORT

| <b>Project Name:</b> | Mountain Valley Pipeline | <b>Inspector:</b> | Matthew Grant |
| <b>Inspection Date:</b> | Tuesday, July 7, 2020 | <b>Project Contact:</b> | Brian Clauto |

## FIELD INSPECTION PHOTO LOG

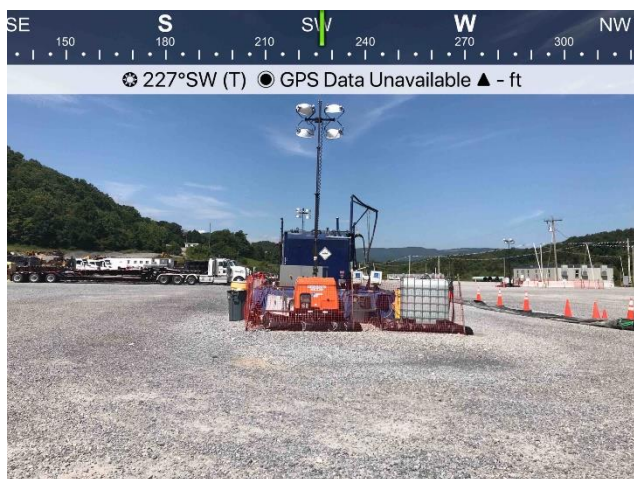
- Figure 1: Fueling station / protection is in place at the Ironto laydown yard.

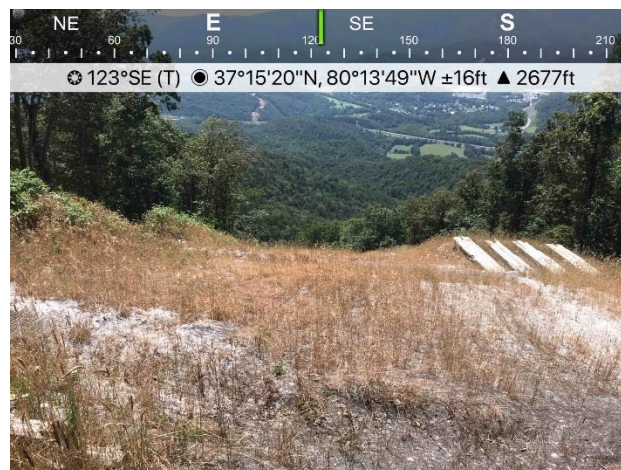
- Figure 2: Near MP 232.5 temporary stabilization is in place.

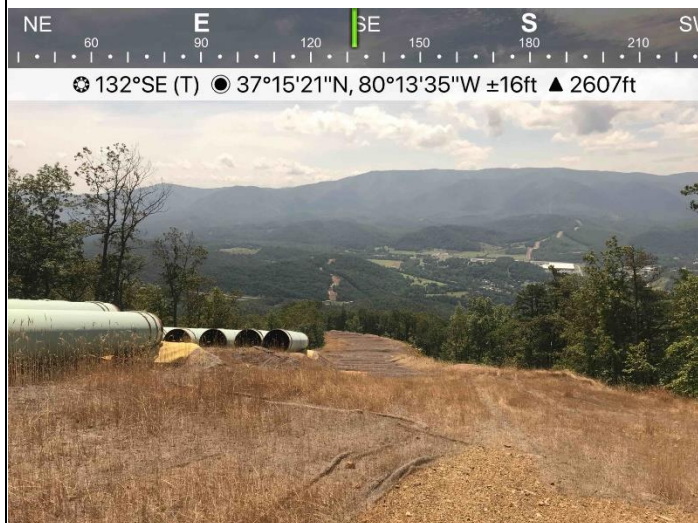
- Figure 3: Near MP 232.8, pipe has been stockpiled, waterbars remain matted and temporary stabilization is in place.

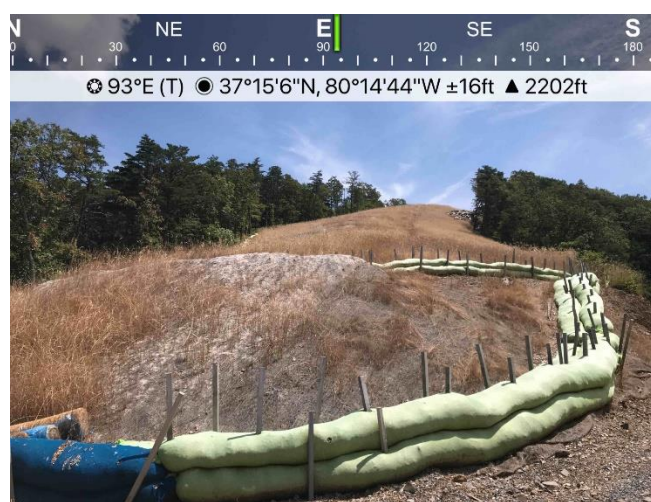
- Figure 4: Near MP 231.5 ECD's and stabilization is in place and functioning.
