## FIELD INSPECTION REPORT

| <b>Project Name:</b> | Mountain Valley Pipeline | <b>Inspector:</b> | Marshall Willis |
| <b>Inspection Date:</b> | Thursday, June 25, 2020 | <b>Project Contact:</b> | Brian Clauto, Cory Chalmers |
| <b>Spread H:<br/>Franklin County</b> | STA 12994+00 – 13063+00<br>MVP-FR-290<br>ATWS 954/1038/1039 | <b>Weather:</b> | Dry |

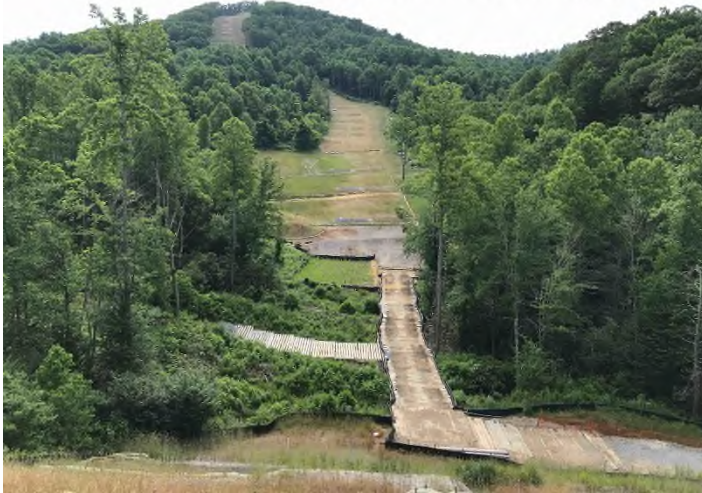
**Figure 1: STA 13060+00** – Controls in place and functioning properly.

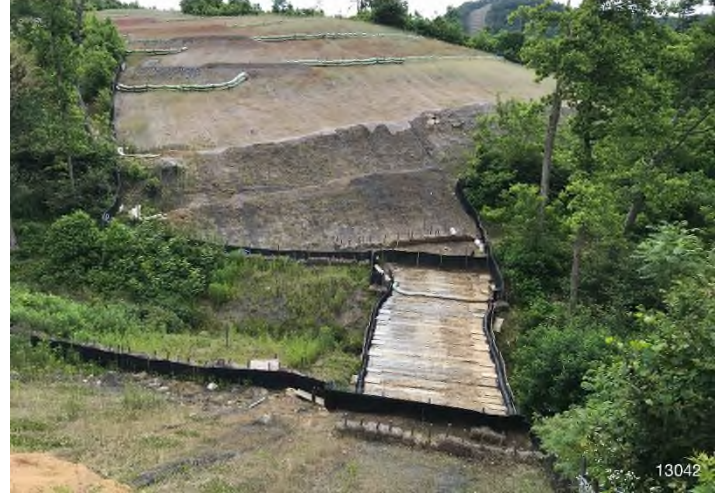
**Figure 2: STA 13042+00** – Controls in place and functioning properly. Area stabilized with erosion fabric and vegetation.

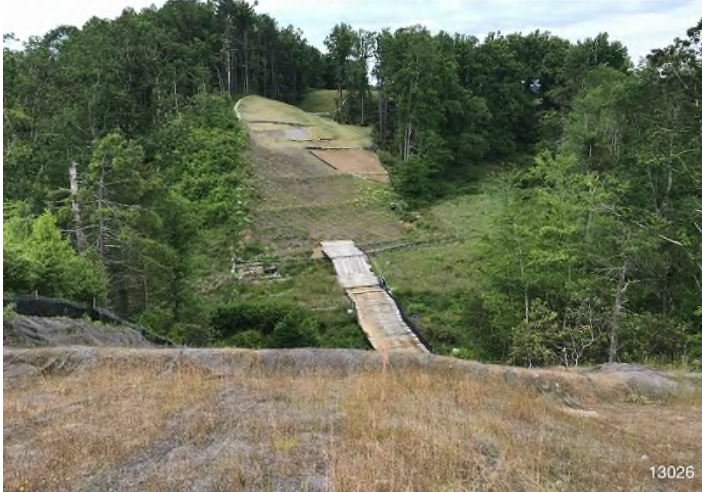
**Figure 3: STA 13026+00** – Controls in place and functioning properly. Area stabilized with vegetation and erosion control fabric.

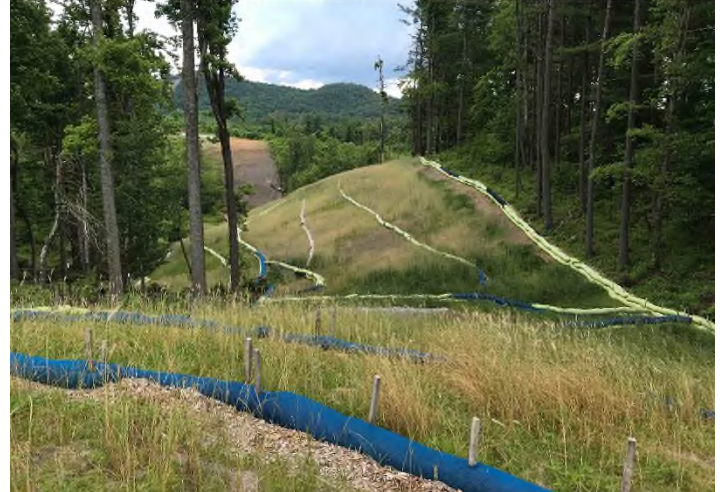
**Figure 4: STA 13020+00** – Controls in place and functioning properly. Area stabilized.
