FIELD INSPECTION

Project Name:	Mountain Valley Pipeline	Inspector:	Marshall Willis
Inspection Date:	Friday, January 3, 2020	Project Contact:	Brian Clauto, Cory Chalmers
Spread I: Franklin County	STA 13850+00 – 13958+31 ATWS 697/698A/1299A MVP-FR-303.01/305	Weather (Wet/Dry/Rain):	Rainy

FIELD INSPECTION PHOTO LOG

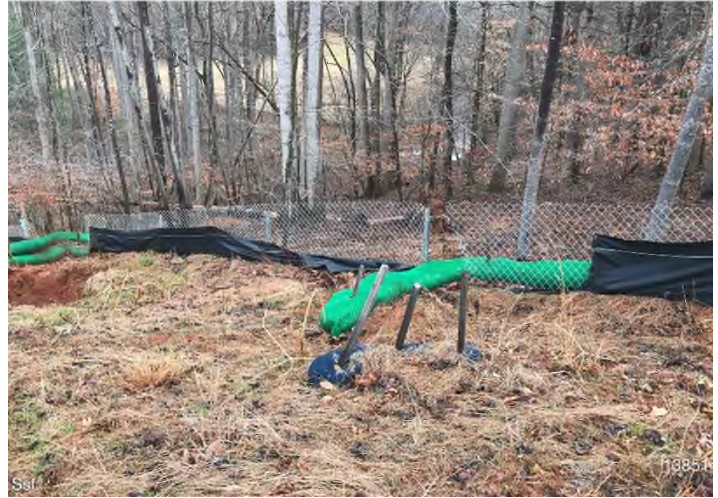
- STA 13851+00: SSF maintenance needed.

Fig. 2: **STA 13851+00** – SSF maintenance needed.

Recommended Corrective Action: Maintain and install all controls per the approved plans and PSS&S.

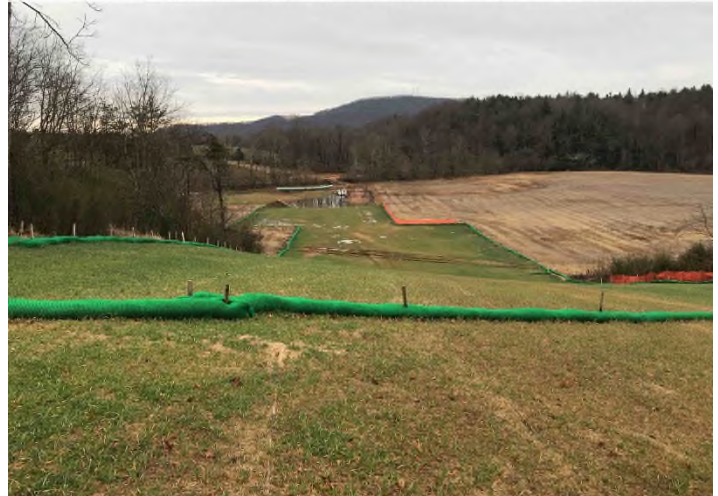
Fig. 4: **STA 13906+50** – Controls in place and functioning properly. Area stabilized.
