## FIELD INSPECTION

| Project Name: | Mountain Valley Pipeline | Inspector: | Marshall Willis |
| Spread I:<br>Franklin County | STA 13644+82 – 13748+30<br>ATWS 1067/1362/566 | Weather (Wet/Dry/Rain): | Dry |

## FIELD INSPECTION PHOTO LOG

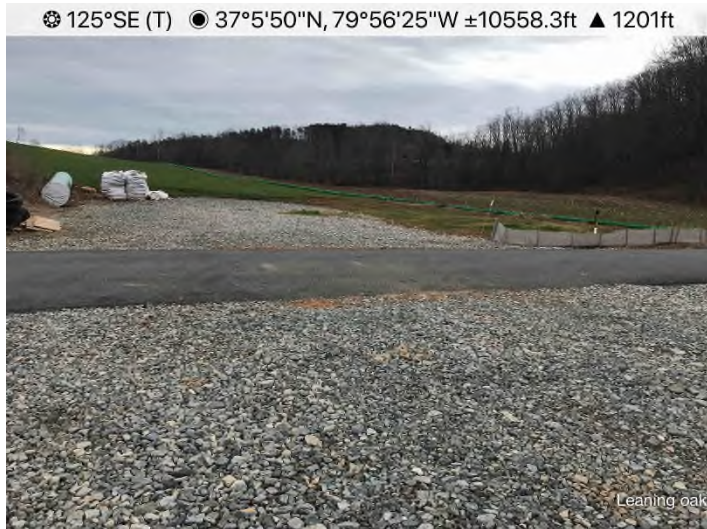
Fig. 1: **STA 13644+82** – Leaning Oak Road Crossing. Controls in place and functioning properly.

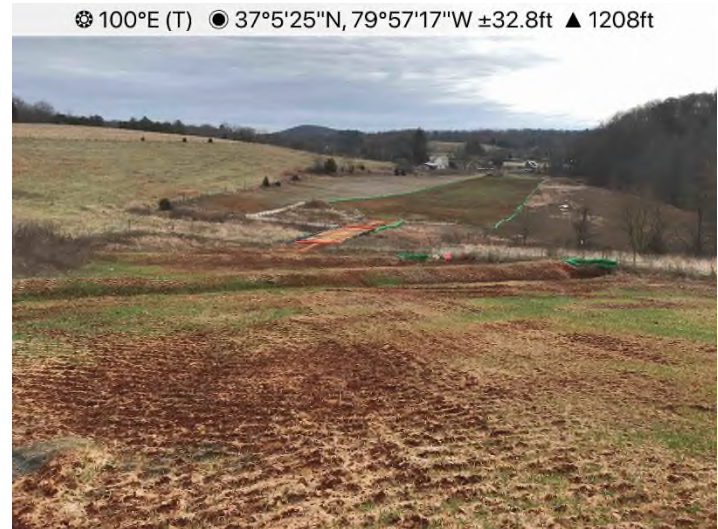
Fig. 2: **STA 13662+00** – Controls in place and functioning properly. Area stabilized with Flexterra.

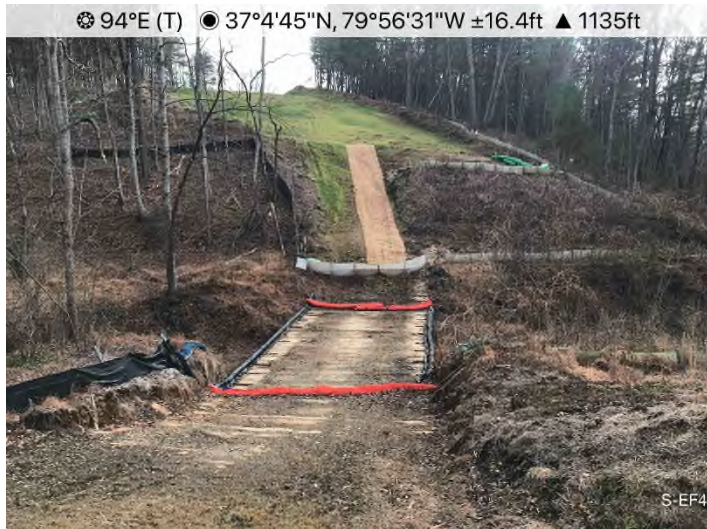
Fig. 3: **STA 13727+50** – Controls in place around Stream S-EF4 crossing. Area stabilized.

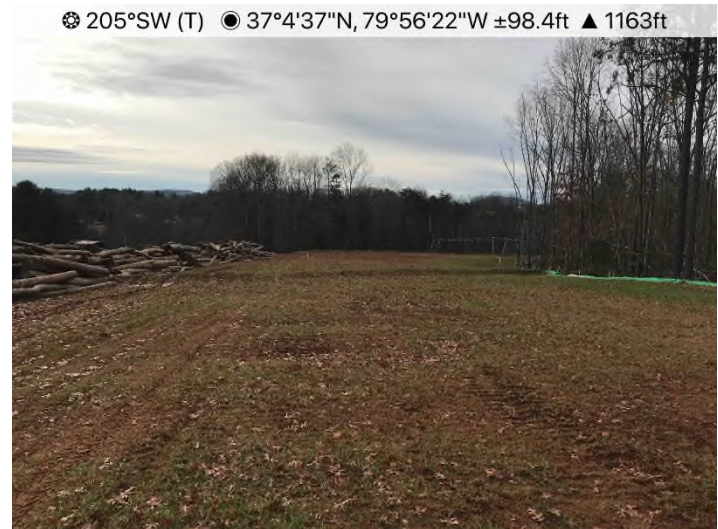
Fig. 4: **STA 13738+00** – Controls in place and functioning properly. Area stabilized with Flexterra.
