## FIELD INSPECTION REPORT

| <b>Project Name:</b> | Mountain Valley Pipeline | <b>Inspector:</b> | Marshall Willis |
| <b>Inspection Date:</b> | Friday, January 24, 2020 | <b>Project Contact:</b> | Brian Clauto, Cory Chalmers |

## FIELD INSPECTION PHOTO LOG

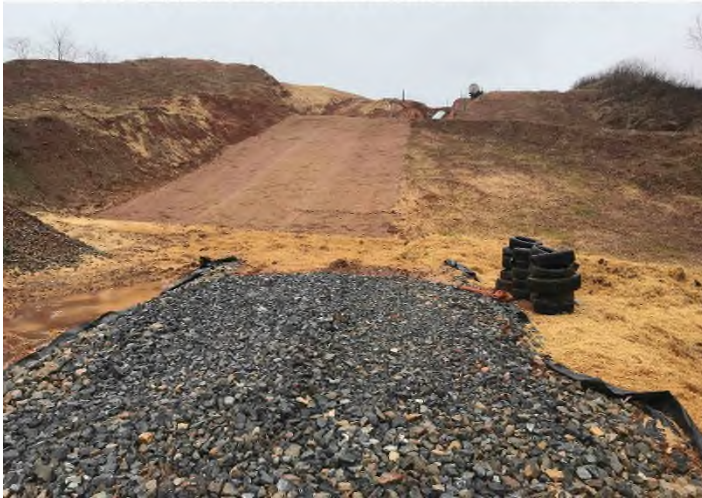
**Figure 1: STA 13416+00** – Controls in place and functioning properly. Area stabilized with straw and erosion matting.

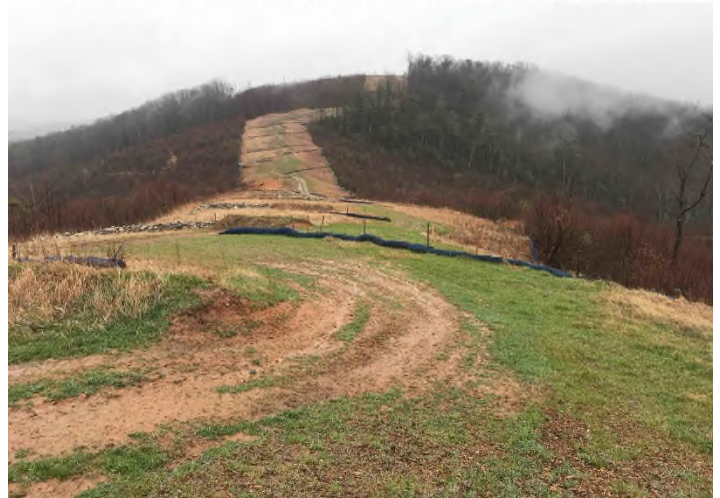
**Figure 2: STA 13438+00** – Controls in place and functioning properly.

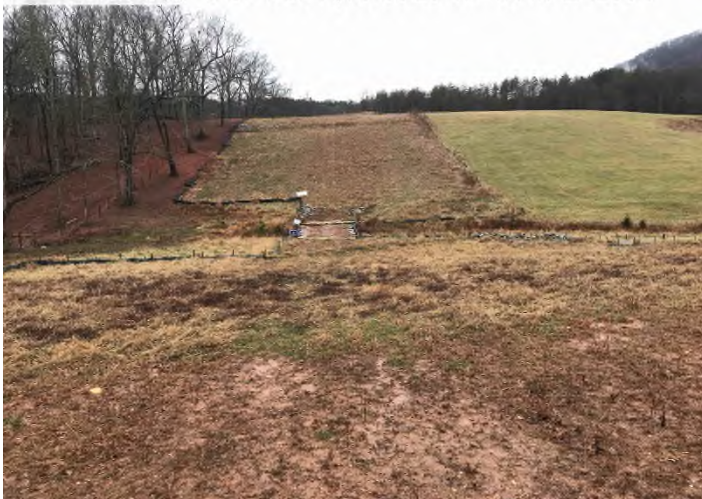
**Figure 3: STA 13541+00** – Controls in place and functioning properly.

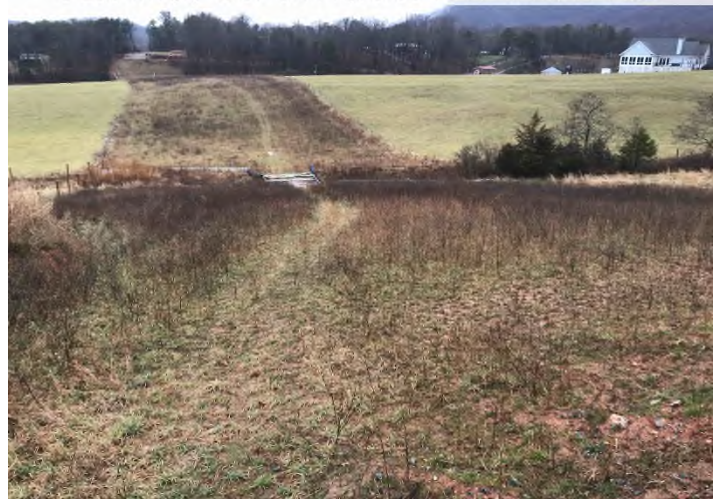
**Figure 4: STA 13574+00** – Controls in place and functioning properly.
