## FIELD INSPECTION REPORT

| <b>Project Name:</b> | Mountain Valley Pipeline | <b>Inspector:</b> | Marshall Willis |

## FIELD INSPECTION PHOTO LOG

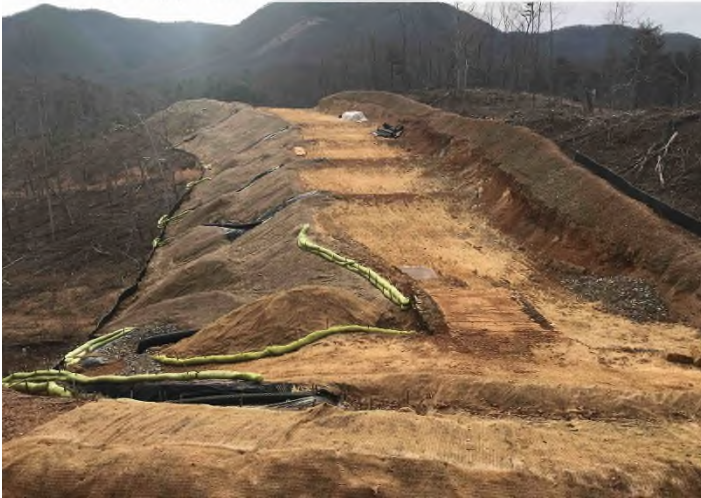
**Figure 1: STA 12532+00** – Controls in place and functioning properly. Area stabilized with straw, hydro-mulch and erosion matting.

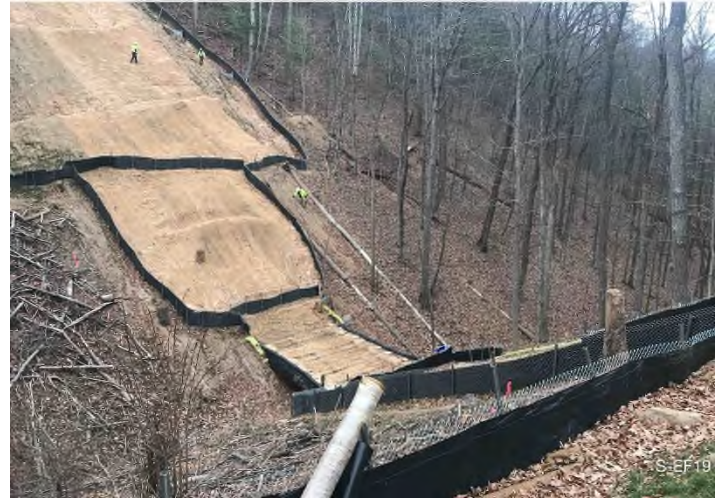
**Figure 2: Stream S-EF19** – Controls in place and functioning properly.

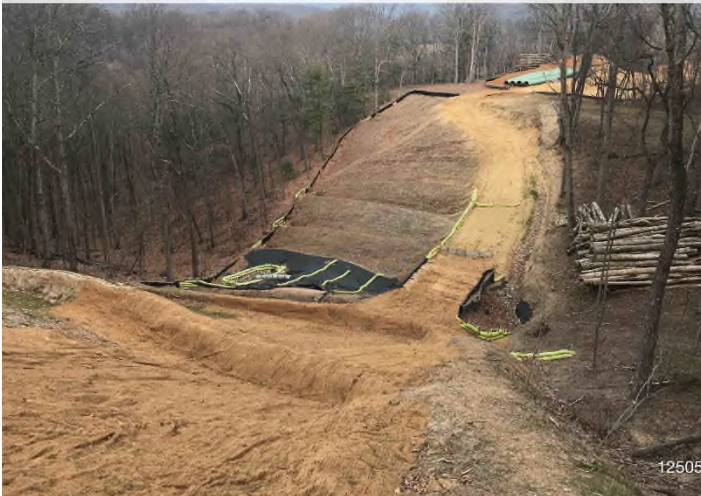
**Figure 3: STA 12505+00** – Controls in place and functioning properly. Area stabilized with straw, hydro-mulch and erosion matting.

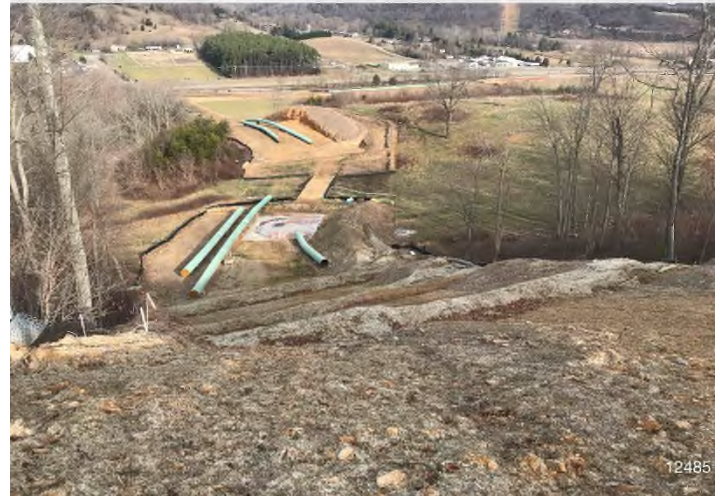
**Figure 4: STA 12485+00** – Controls in place and functioning properly. Area stabilized with straw, hydro-mulch and erosion matting.
