## FIELD INSPECTION

| <b>Project Name:</b> | Mountain Valley Pipeline | <b>Inspector:</b> | Matthew Grant |
| <b>Inspection Date:</b> | Tuesday, January 14, 2020 | <b>Project Contact:</b> | Brian Clauto |

## FIELD INSPECTION PHOTO LOG

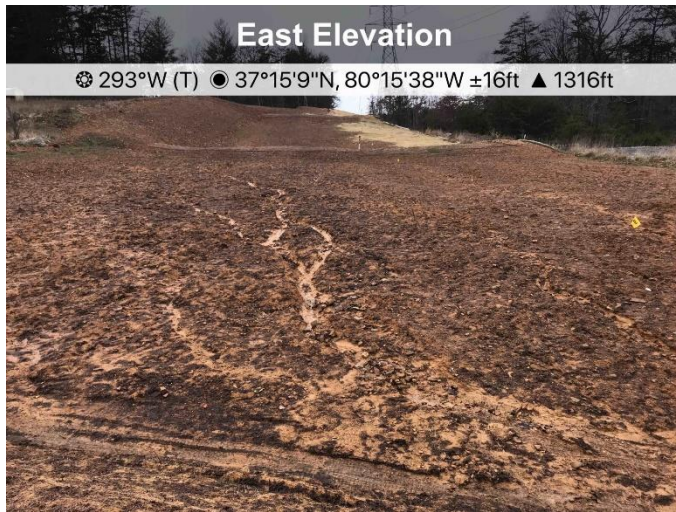
- Fig. 1. Approximately MP 230.6 – 230.8 requires additional stabilization.

**Recommend Corrective Action:** Maintain all controls per the approved plan.

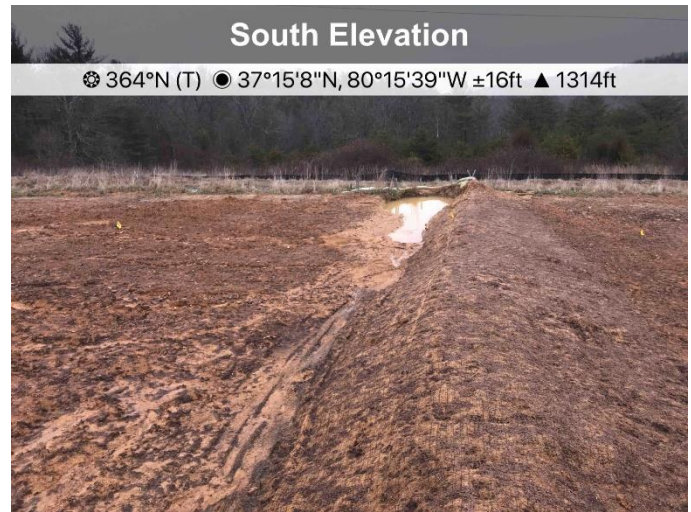
- Fig. 2. St 12186+00 waterbar flow path requires maintenance

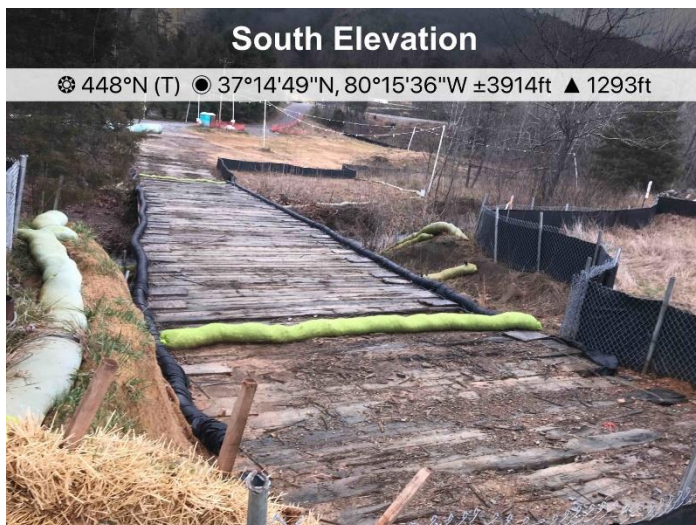
- Fig. 3. Designated crossing S-C21, ECD's are in place and functioning.

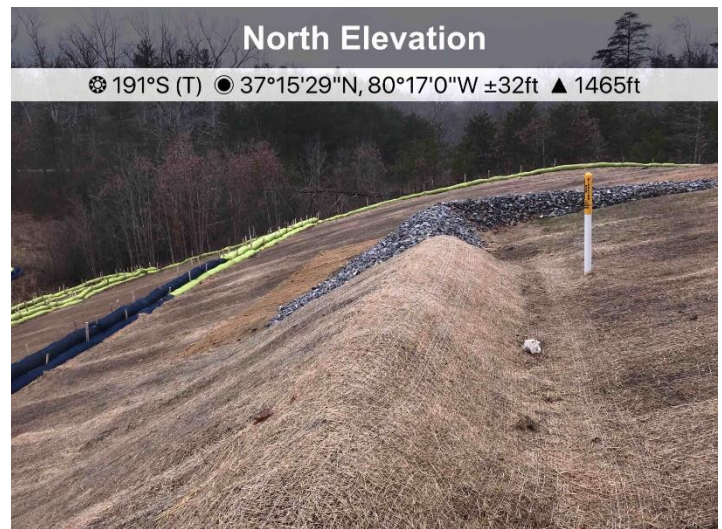
- Fig. 4. St12116+00 permanent style waterbar has been installed and is functioning.
