## COMPLAINT INSPECTION REPORT

| Project Name: | Mountain Valley Pipeline | Inspector: | Marshall Willis |
| Inspection Date: | Monday, January 13, 2020 | Project Contact: | Brian Clauto, Cory Chalmers |
| Spread G:<br>Montgomery County | STA 11972+00 – 11989+00<br>ATWS 1157A & ATWS 1157<br>MVP-MN-266 | Weather (Wet/Dry/Rain): | Wet |

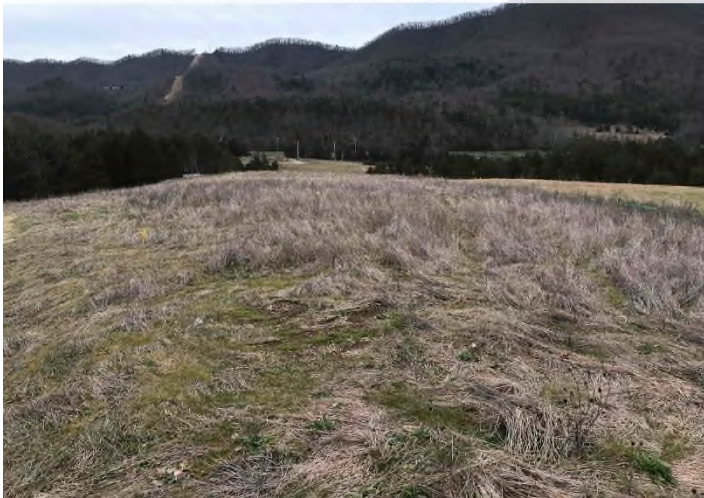
Fig. 1: **STA 11979+00** – Controls in place. Area stabilized with vegetative cover. No erosion evident.

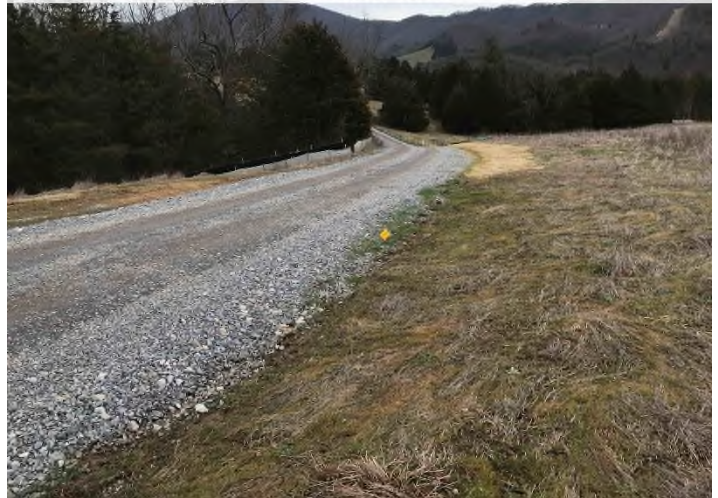
Fig. 2: **MVP-MN-266** – Controls in place along access road. Area stabilized with vegetative cover. No erosion evident.

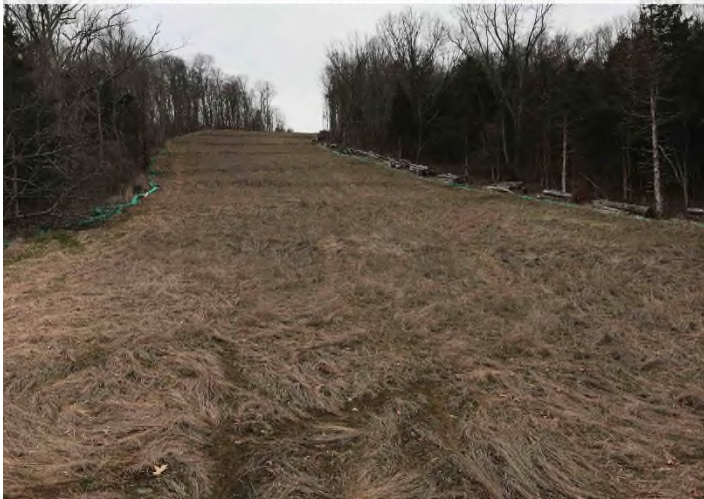
- Underground gravel filter bed is located approximately at STA 11975+60. See Figure 3.
- At the time of inspection, there was no evidence of sediment discharge from the MVP ROW.

Fig. 3: **STA 11977+00** – Looking north towards underground gravel filter bed. Controls in place. Area stabilized with vegetative cover. No erosion evident.

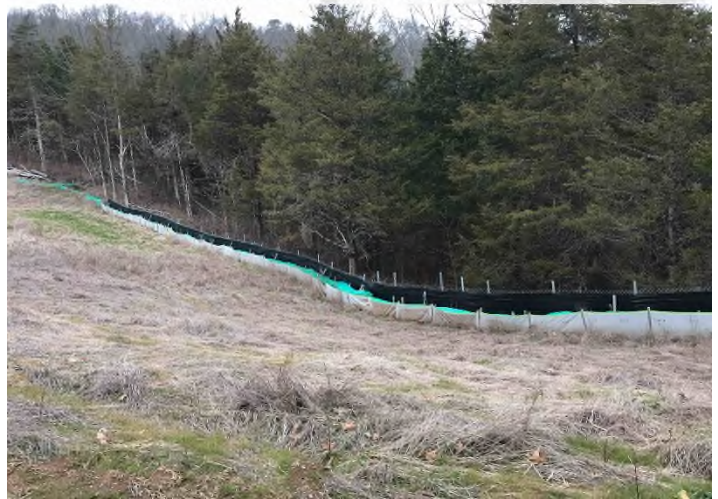
Fig. 4: **STA 11978+00** – Controls in place above karst feature on the east of ROW. Area stabilized with vegetative cover. No erosion evident.

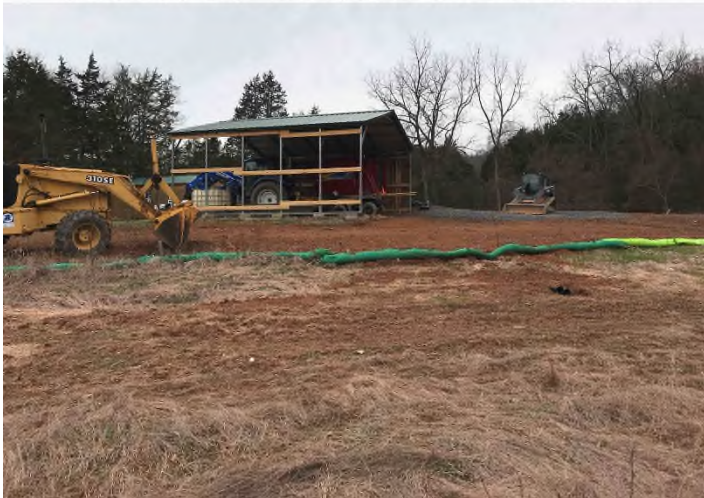
- Continued land disturbing activities not associated with the project were noted off-ROW during the inspection near STA 11976+00 and along MVP-MN-266. LDA is located west of MVP ROW and upslope of potential sinkhole. See Figures 5-8.

Fig. 5: **STA 11978+00** – Land disturbance not associated with MVP project. Adjacent to approx. STA 11976+00 to STA 11978+00.

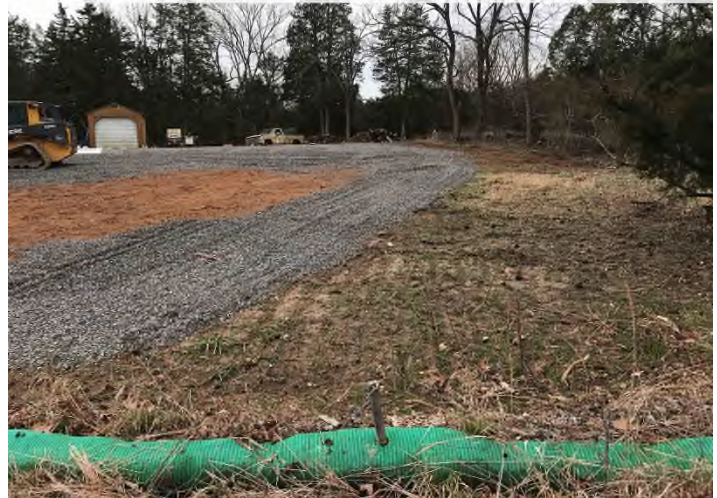
Fig. 6: **STA 11977+00** – Land disturbance not associated with MVP project. Adjacent to approx. STA 11976+00 to STA 11978+00.

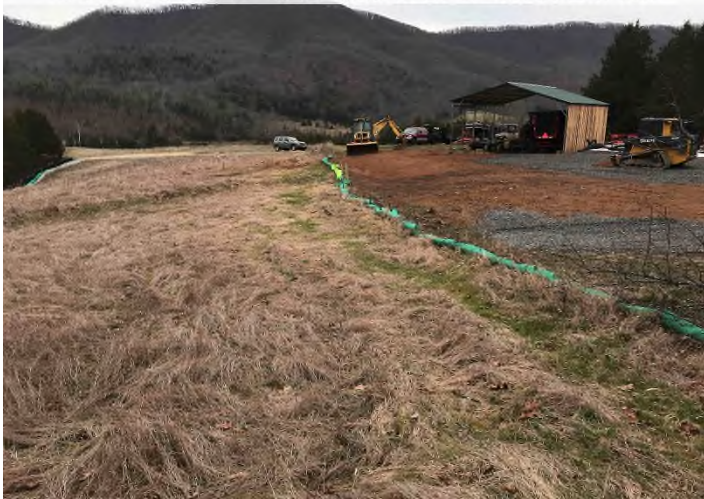
Fig. 7: **STA 11976+00** – Land disturbance not associated with MVP project. Adjacent to approx. STA 11976+00 to STA 11978+00.

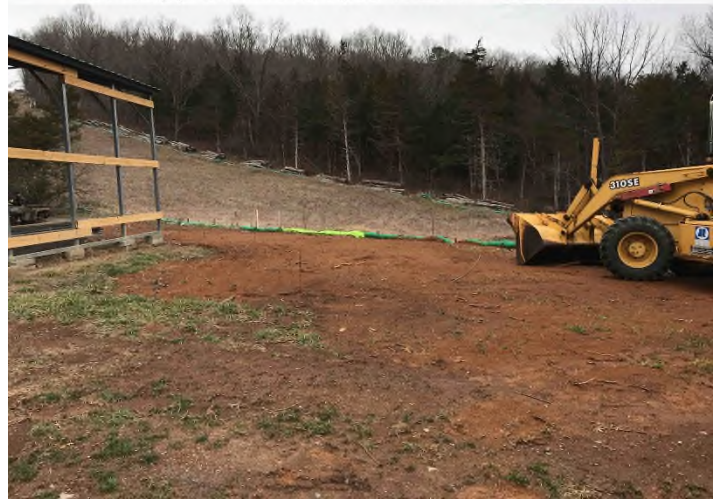
Fig. 8: **MVP-MN-266** – Land disturbance not associated with MVP project. Adjacent to approx. STA 11976+00 to STA 11978+00.

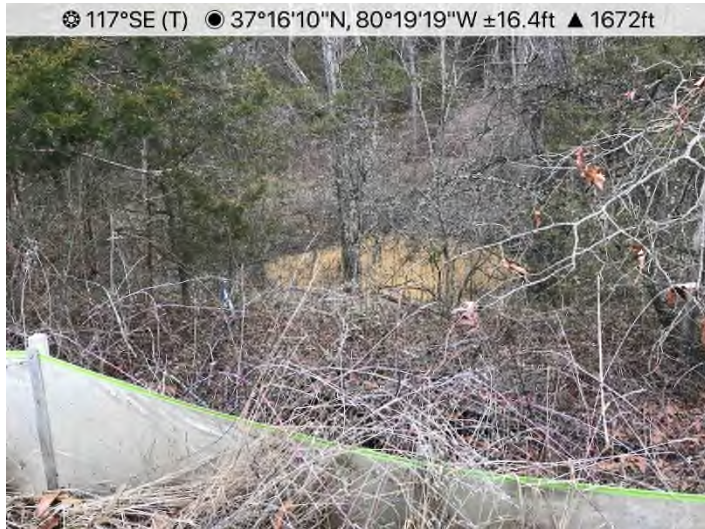
- Ponded turbid water was observed in a karst feature off ROW along MVP-MN-266, north of MVP ROW. Muddy landowner access road was observed above feature. See Figures 9 and 10.

Fig. 9: **MVP-MN-266** – Turbid water pooled in sinkhole off east side of ROW, north of MN-266.

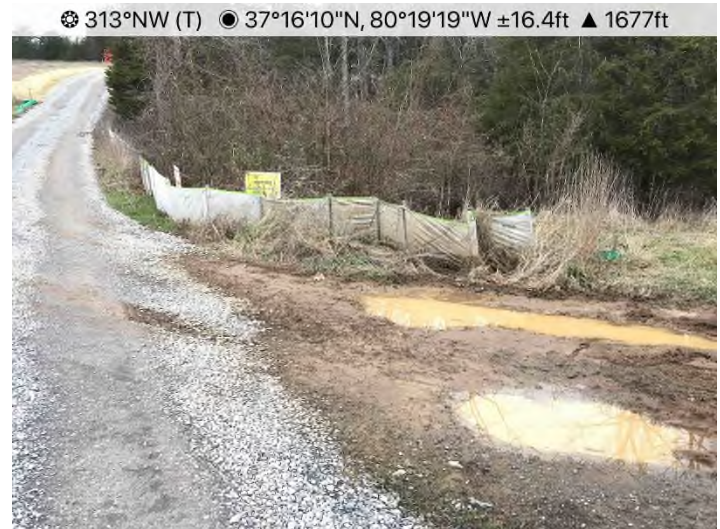
Fig. 10: **MVP-MN-266** – Muddy landowner access road above turbid sinkhole (Figure 9).

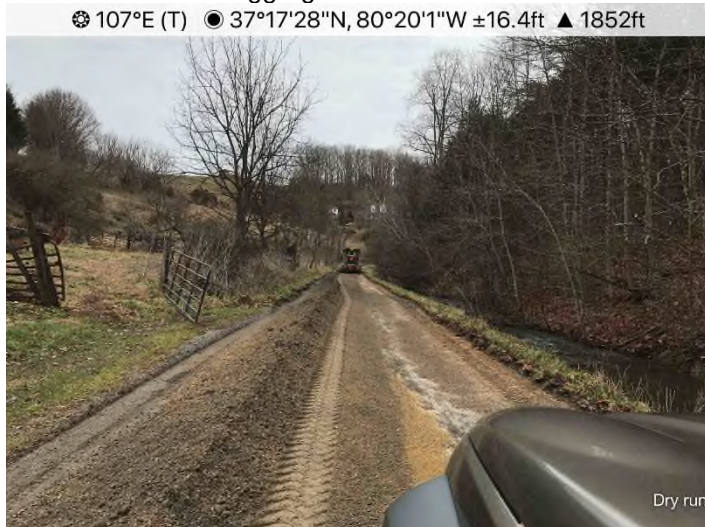
- Dry Run Road significantly impacted by erosion and high flow conditions of Dry Run. VDOT actively regrading and adding stone to road at the time of inspection. See Figure 11.

Fig. 11: **Dry Run Road** – VDOT repairing Dry Run Road from Catawba Rd. to Mt. Tabor Rd. Rain event caused significant erosion to road along Dry Run depositing sediment and road aggregate into stream.

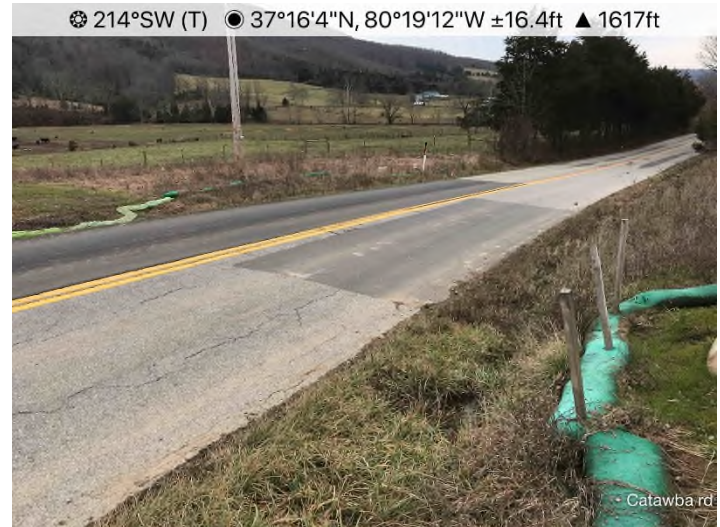
Fig. 12: **Catawba Road Crossing** – Controls in place and functioning at Catawba Road.
