## FIELD INSPECTION

| <b>Project Name:</b> | Mountain Valley Pipeline | <b>Inspector:</b> | Marshall Willis |
| <b>Inspection Date:</b> | Wednesday, January 8, 2020 | <b>Project Contact:</b> | Brian Clauto, Cory Chalmers |

## FIELD INSPECTION PHOTO LOG

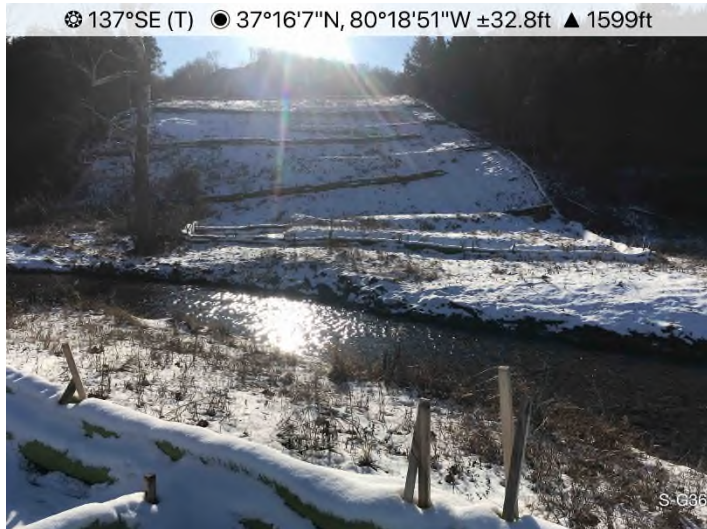
Fig. 1: **Stream S-G36** – Controls in place and functioning properly along the North Fork Roanoke River.

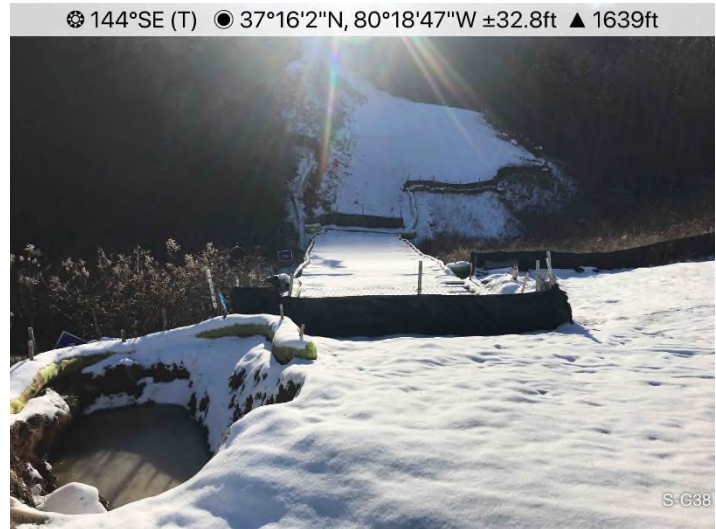
Fig. 2: **Stream S-G38** – Controls in place and functioning properly.

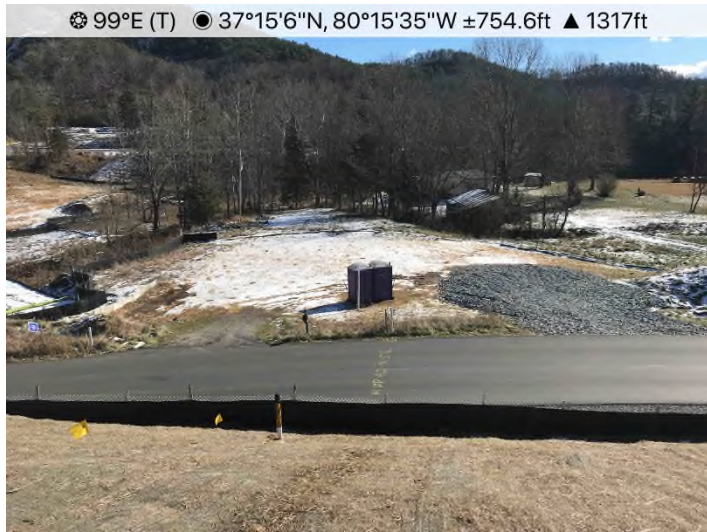
Fig. 3: **STA 12190+00** – Bradshaw Road crossing controls in place and functioning properly.

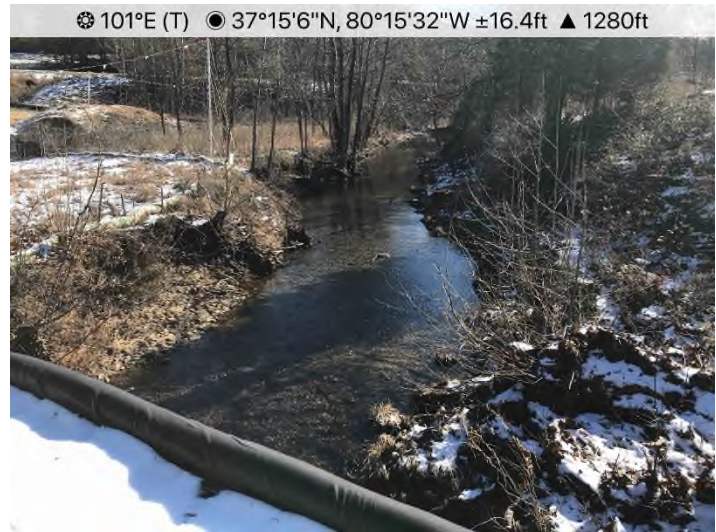
Fig. 4: **Stream S-C21** – Controls in place and functioning properly at Bradshaw Creek crossing.
