## FIELD INSPECTION REPORT

| Project Name: | Mountain Valley Pipeline | Inspector: | Marshall Willis |
| Inspection Date: | Friday, February 14, 2020 | Project Contact: | Brian Clauto, Cory Chalmers |
| Spread I:<br>Franklin County | STA 14272+62 – 14333+27<br>ATWS MVP-FR-313<br>ATWS 353/354 | Weather: | Wet |

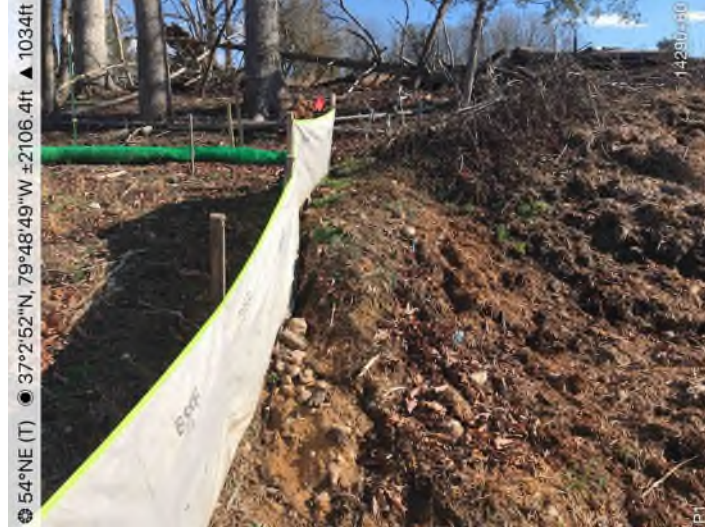
- STA 14290+60: P1 undermined from offsite run-on. Repair needed.
- STA 14320+25: Repair CWD plunge pool berm. Onsite stormwater discharge entering plunge pool.
- STA 14322+00: CFS undermined. Repair needed.

**Figure 1: STA 14290+60 – P1 undermined from offsite run-on. Repair needed.**

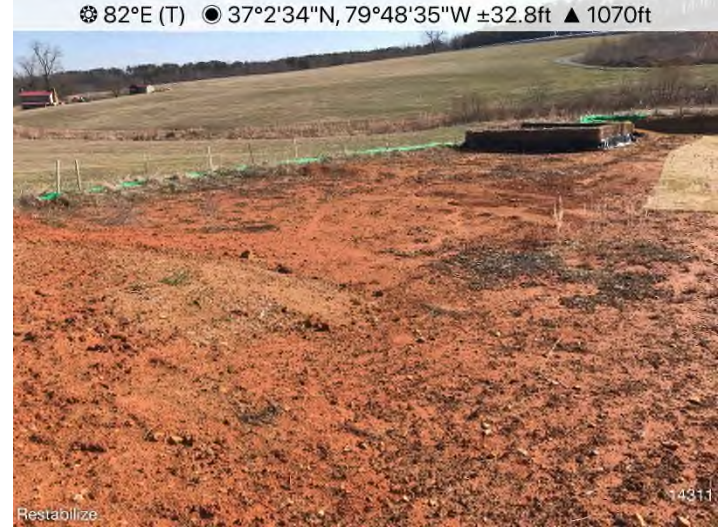
- STA 14311+00 to 14314+00: Re-stabilize ROW.
- STA 14320+25: Re-stabilize ROW.
- STA 14322+00: Re-stabilize ROW.

**Figure 2: STA 14311+00 to 14314+00 – Re-stabilization needed.**

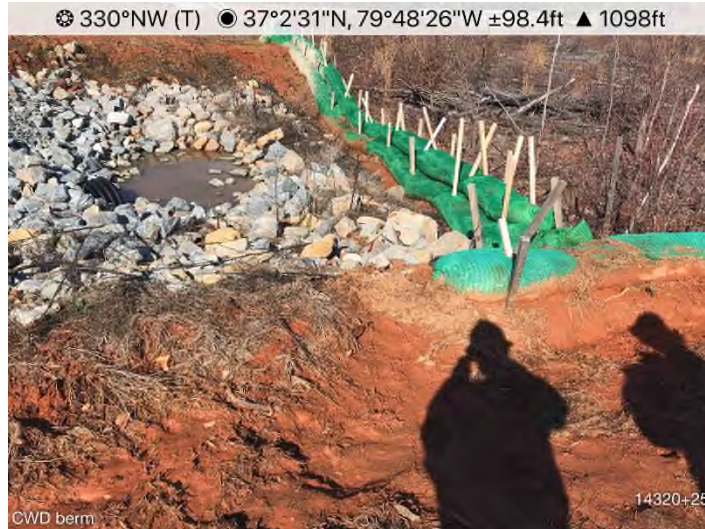
**Figure 3: STA 14320+25 – Plunge pool diversion berm repair needed.**

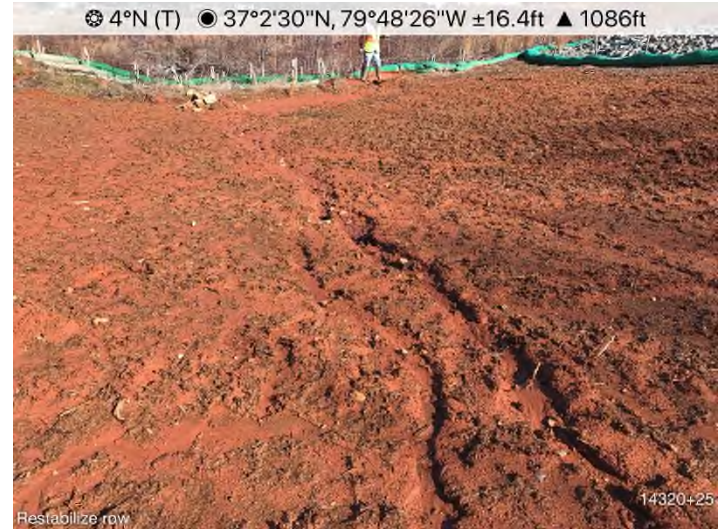
**Figure 4: STA 14320+25 – Re-stabilization needed.**

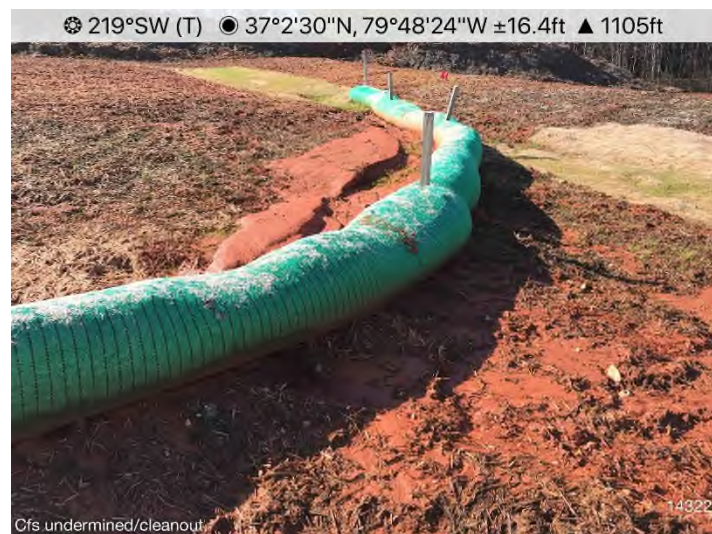
**Figure 5: STA 14322+00 – CFS undermined. Repair needed.**

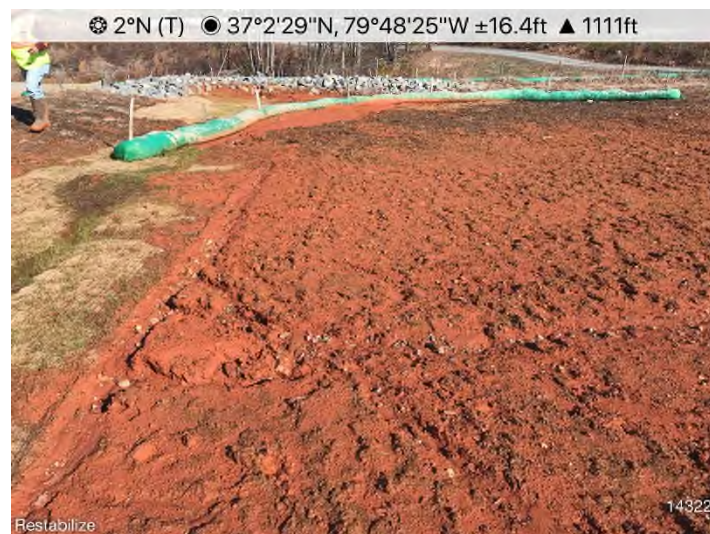
**Figure 6: STA 14322+00 – Re-stabilization needed.**
