## FIELD INSPECTION REPORT

| <b>Project Name:</b> | Mountain Valley Pipeline | <b>Inspector:</b> | Matthew Grant |
| <b>Inspection Date:</b> | Thursday, February 13, 2020 | <b>Project Contact:</b> | Brian Clauto, |
| <b>Spread I: Franklin</b> | MP 269-269.6<br>ATWS 523, 693, 693A, 351, 351A<br>MLV-AR-32 | <b>Weather:</b> | Rainy |

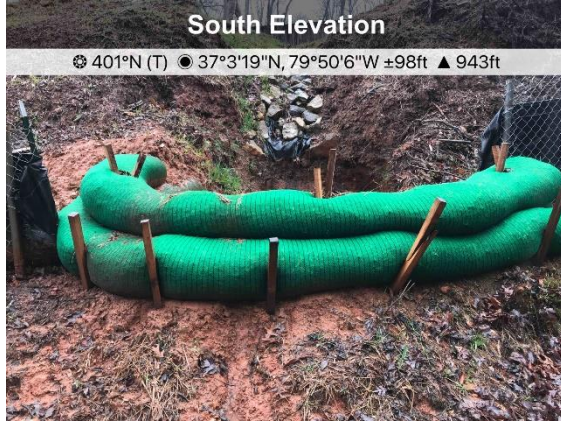
- St14219+80 sump triple stack has undermined and requires repair.

- Figure 1: St14219+80 sump triple stack has undermined and requires repair

**Recommended Corrective Action:** Maintain and install all controls per the approved PSS&S.

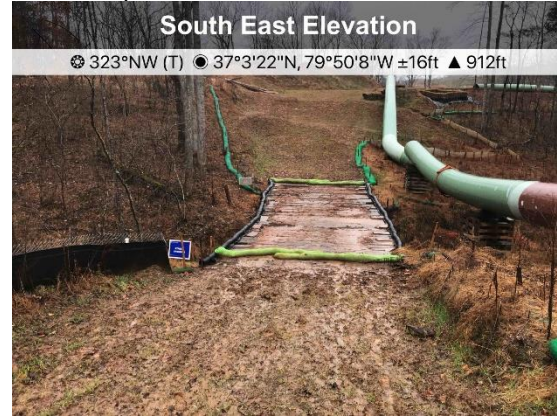
- Figure 2: Designated crossing S-HH4, ECD's are in place

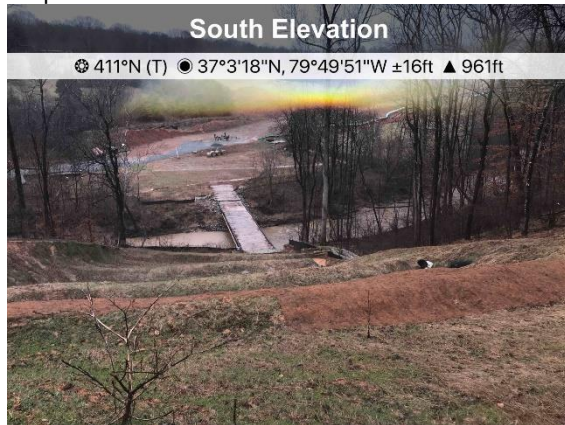
- Figure 3: Designated stream S-C19, ECD's are in place.

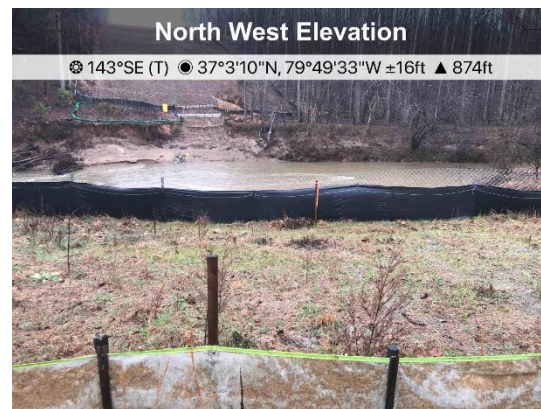
- Figure 4: Designated stream S-F11, ECD's are in place.
