## FIELD INSPECTION REPORT

| Project Name: | Mountain Valley Pipeline | Inspector: | Marshall Willis |
| Inspection Date: | Wednesday, February 12, 2020 | Project Contact: | Brian Clauto, Cory Chalmers |
| Spread I:<br>Franklin County | STA 14018+47 – 14171+36<br>MVP-FR-309.05/309.06/309<br>ATWS 1470/1471/1472/1473/1478 | Weather: | Rainy |

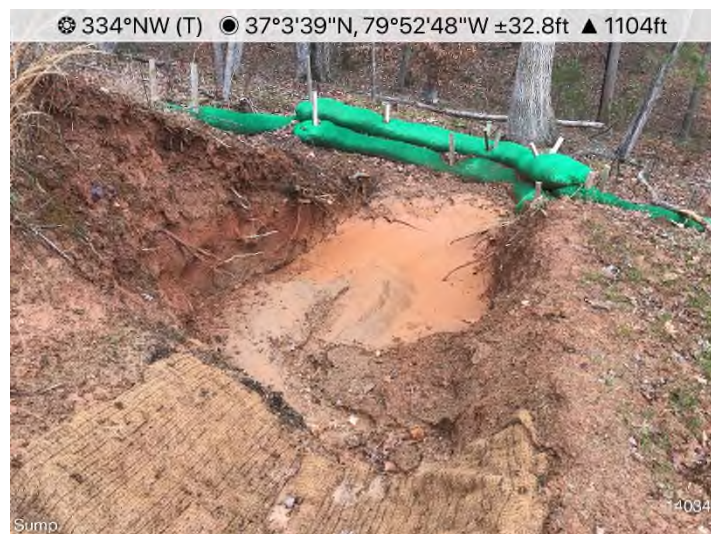
**Figure 1: STA 14034+00 – Sump maintenance needed.**

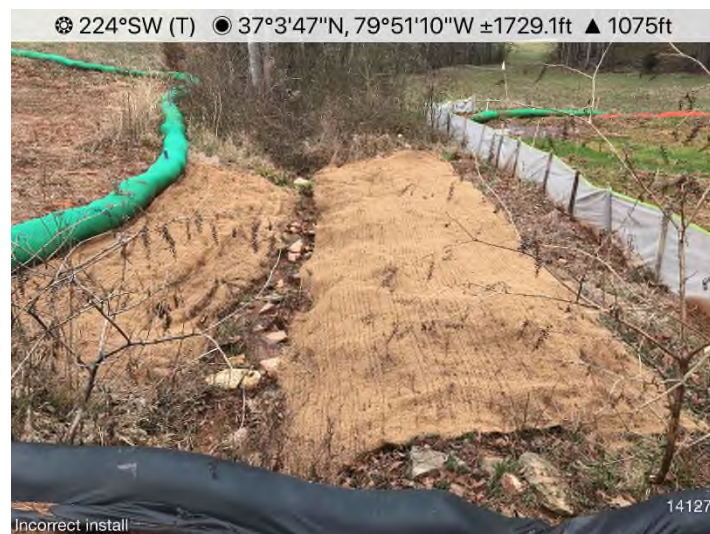
**Figure 2: STA 14127+00 – Erosion matting improperly installed.**

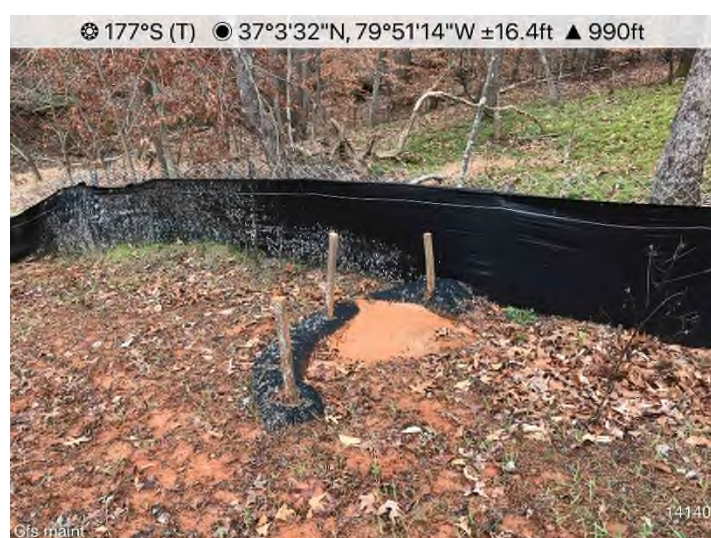
**Figure 3: STA 14140+00 – CFS maintenance needed.**

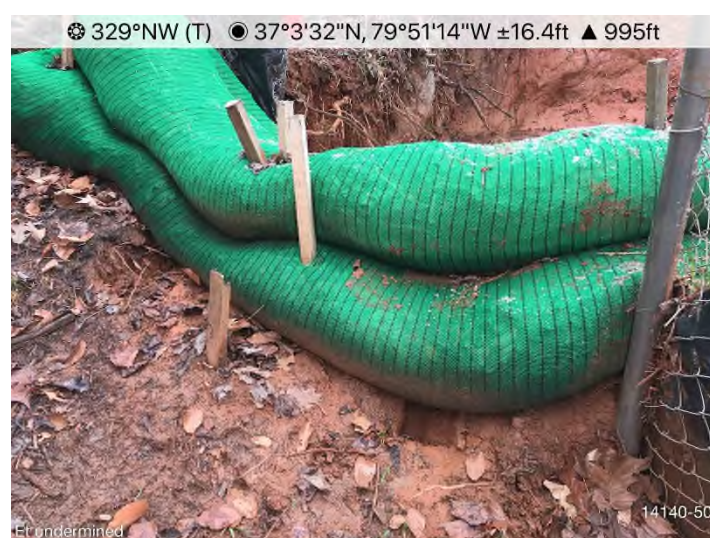
**Figure 4: STA 14140+50 – End Treatment undermined.**  
Maintenance needed.

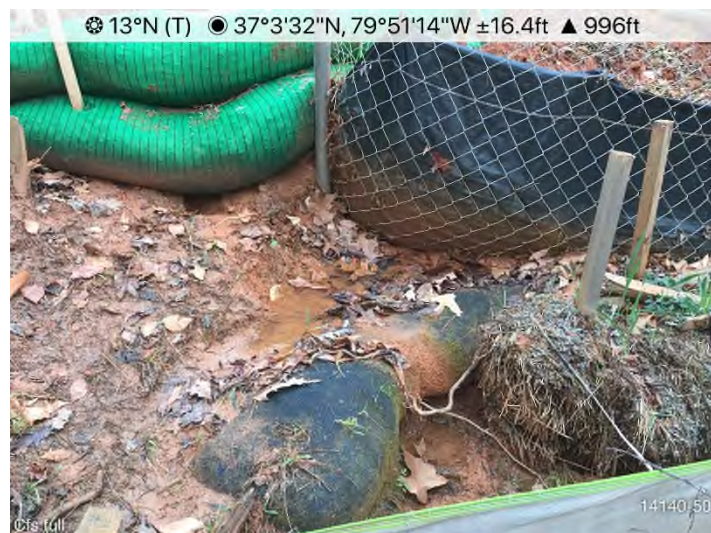
**Figure 5: STA 14140+50 – CFS maintenance needed.**

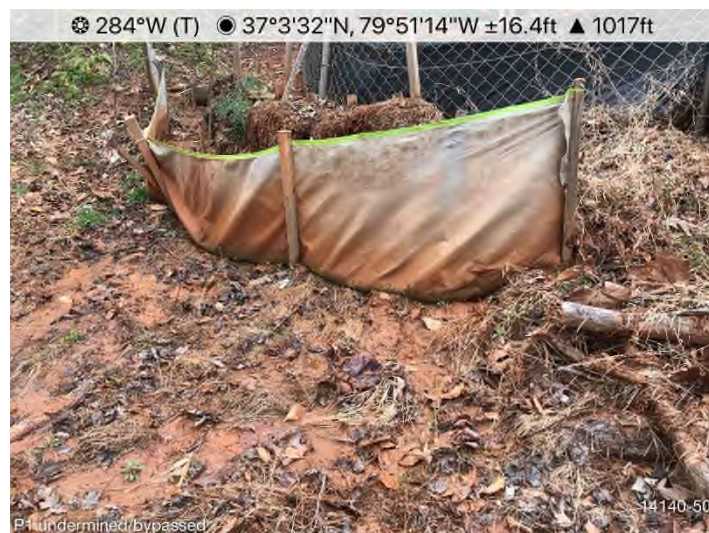
**Figure 6: STA 14140+50 – P1 undermined and bypassed. Maintenance needed.**

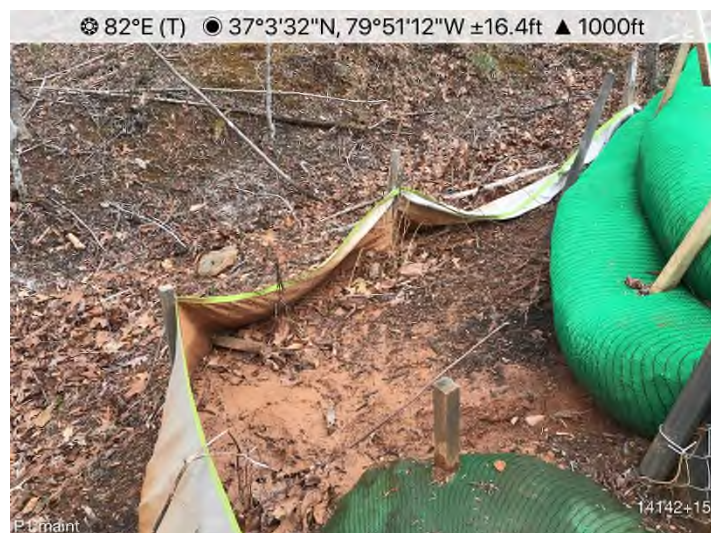
**Figure 7: STA 14142+15 – P1 maintenance needed.**

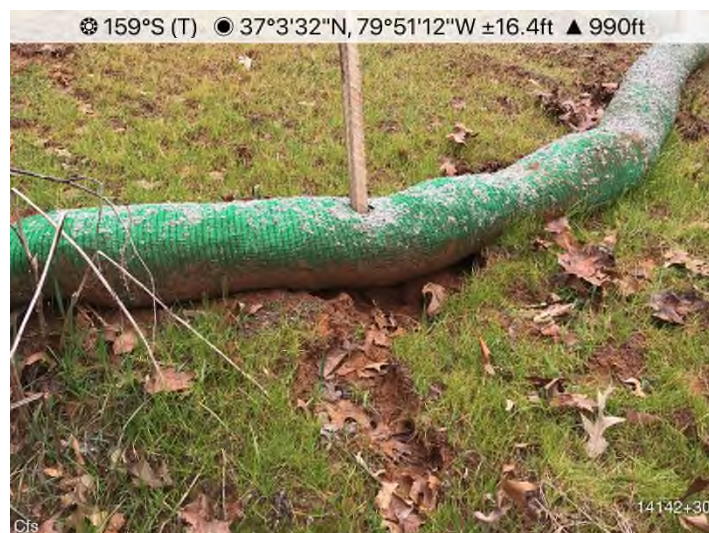
**Figure 8: STA 14142+30 – CFS undermined. Maintenance needed.**

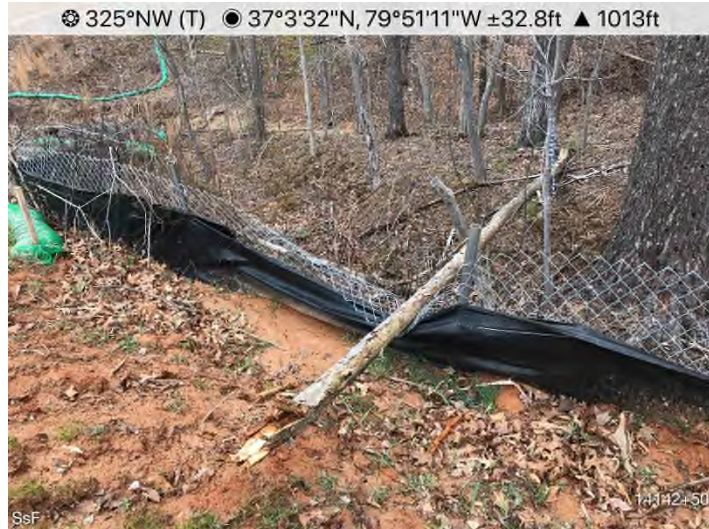
- STA 14142+50: SSF damaged by tree. Maintenance needed.

**Figure 9: STA 14142+50 – SSF maintenance needed.**

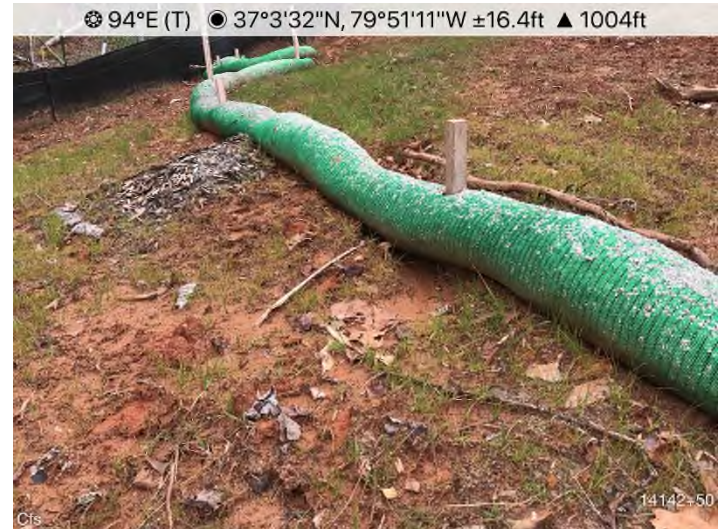
**Figure 10: STA 14142+50 – CFS undermined. Maintenance needed.**

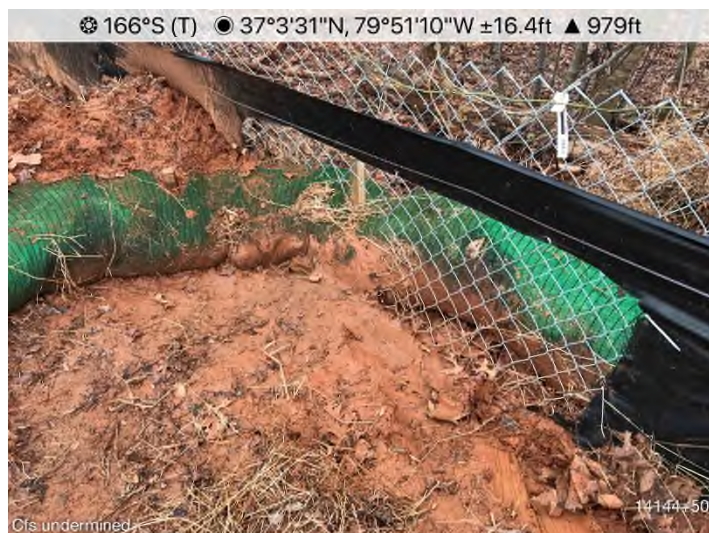
**Figure 11: STA 14144+50 – CFS undermined. Maintenance needed.**

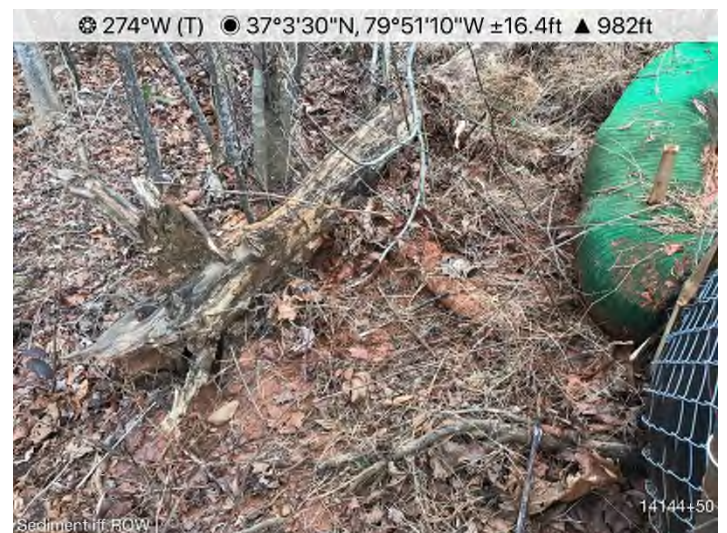
**Figure 12: STA 14144+50 – Sediment off ROW. Retrieve and stabilize sediment.**

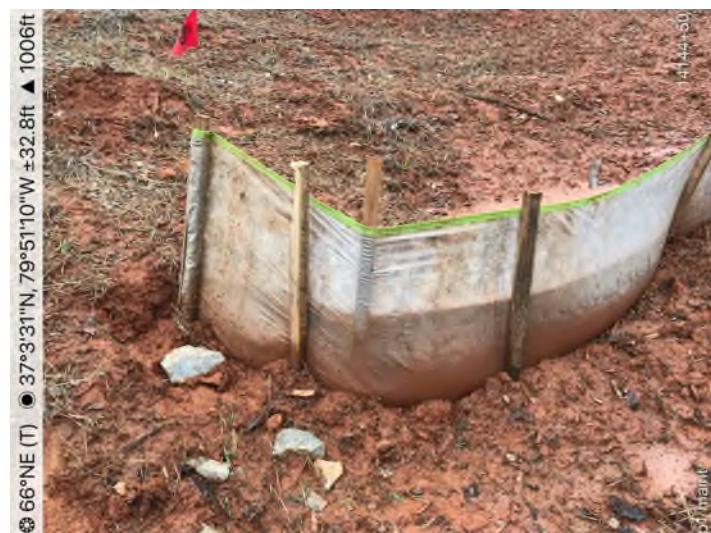
**Figure 13: STA 14144+50 – P1 bypassed. Maintenance needed.**

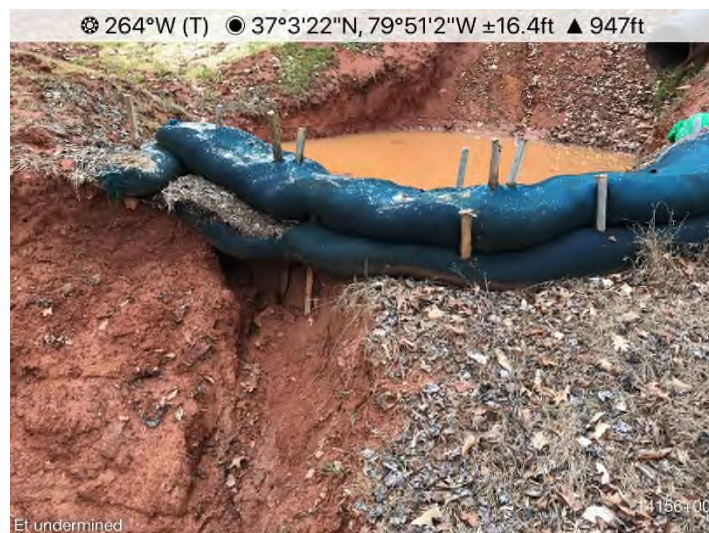
**Figure 14: STA 14156+00 – End Treatment undermined. Maintenance needed.**

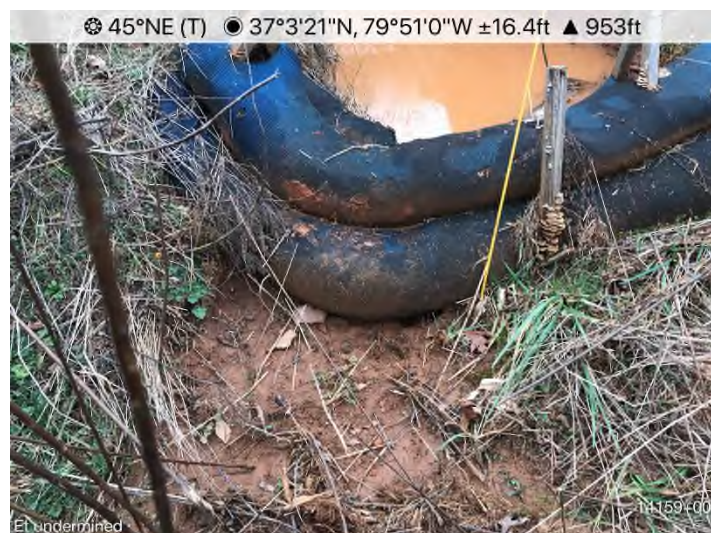
**Figure 15: STA 14150+00 – End Treatment undermined. Maintenance needed.**
