## FIELD INSPECTION REPORT

| Project Name: | Mountain Valley Pipeline | Inspector: | Marshall Willis |
| Spread I:<br>Franklin County | STA 14049+00 – 14062+17 | Weather: | Rainy |

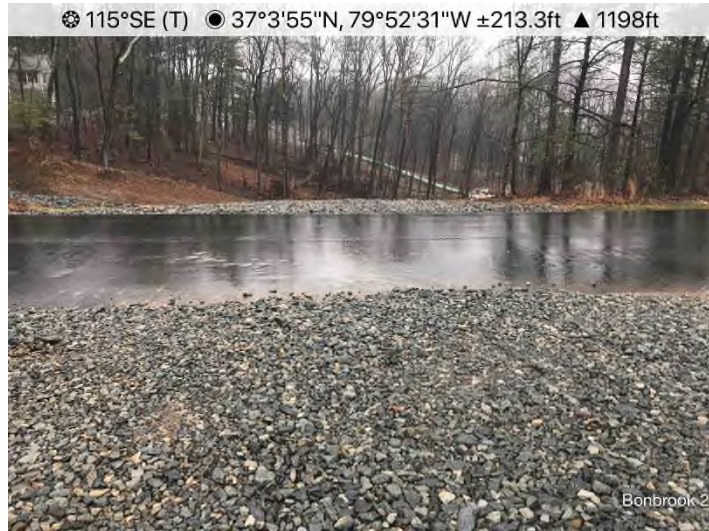
**Figure 1: Bonbrook Mill Road** – Controls in place and functioning properly.

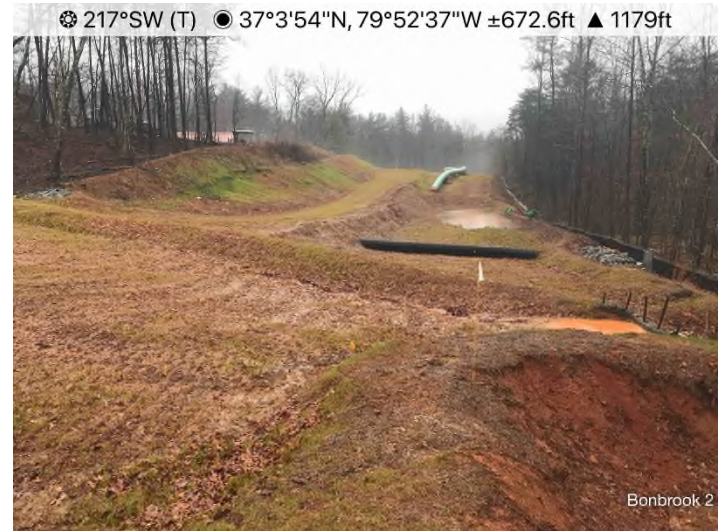
**Figure 2: STA 14057+25** – Controls in place and functioning properly. No sediment discharge off ROW observed.

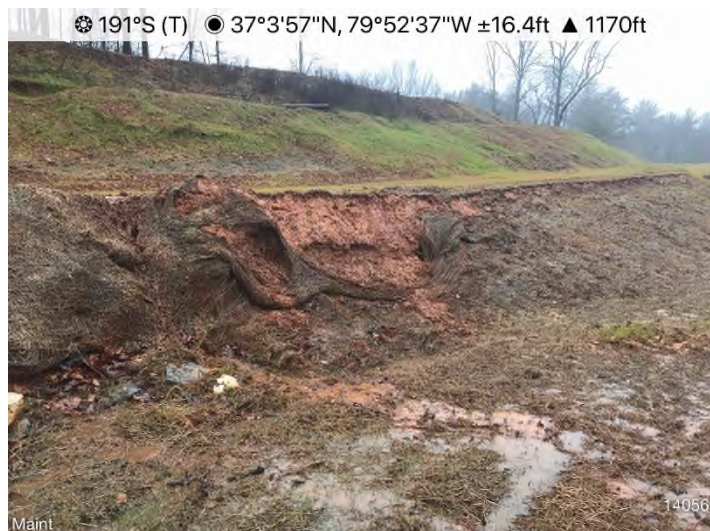
- STA 14056+00: Erosion matting maintenance needed.

**Figure 3: STA 14056+00** – Erosion matting repair needed.

**Recommended Corrective Action:** Maintain and install all controls per the approved PSS&S.

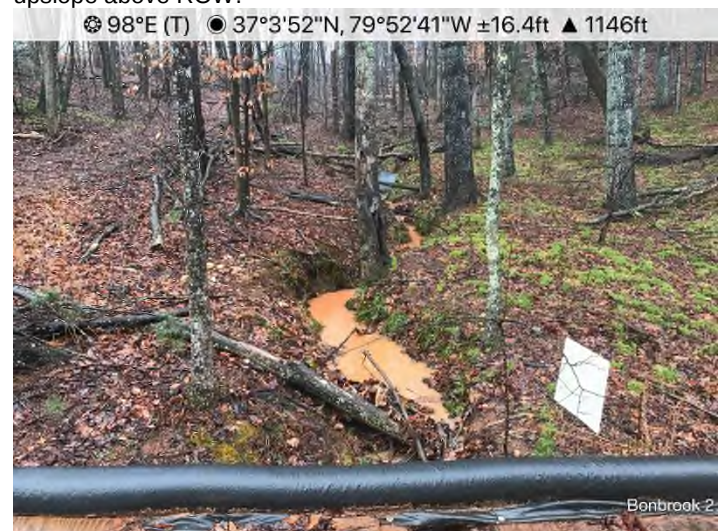
**Figure 4: Stream S-YZ4** – Looking upstream from S-YZ4 crossing. Turbid water observed flowing down S-YZ4 from upslope above ROW.
