## FIELD INSPECTION REPORT

| <b>Project Name:</b> | Mountain Valley Pipeline | <b>Inspector:</b> | Matthew Grant |
| <b>Inspection Date:</b> | Tuesday, February 11, 2020 | <b>Project Contact:</b> | Brian Clauto, |
| <b>Spread H: Montgomery</b> | MP 230-229<br>ATWS 701,1168, 1167,<br>AR-270, 272, 273 | <b>Weather:</b> | Rainy |

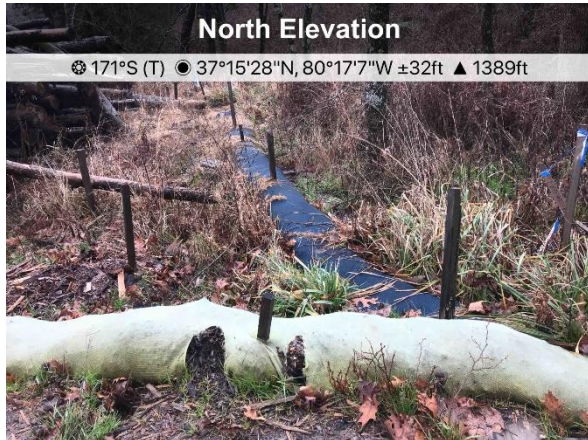
- Figure 1: St12109+70 CFS requires maintenance.

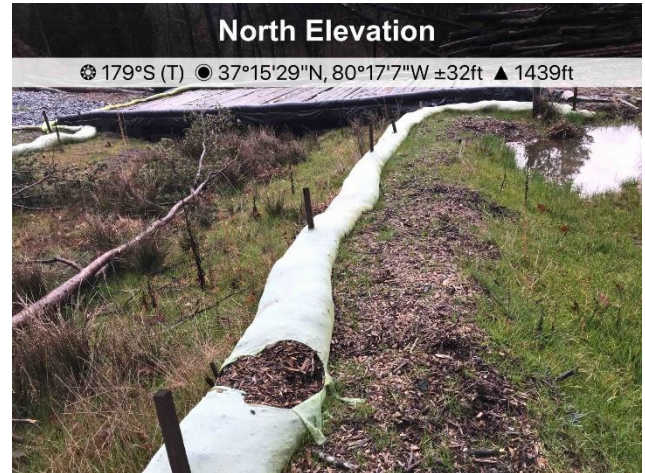
- Figure 2: St12110+00 CFS requires maintenance.

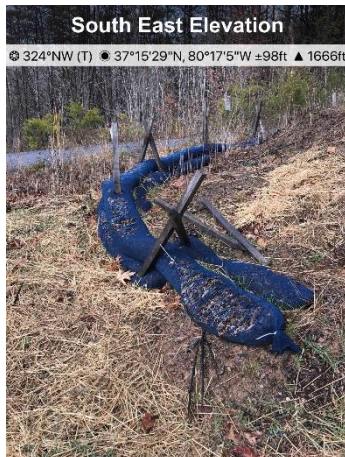
- Figure 3: St1211+50 CFS triple stack requires maintenance

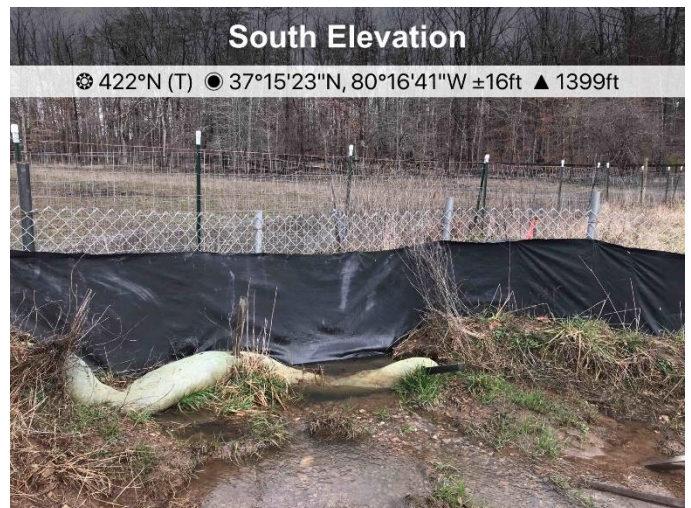
- St17132+00 silt fence has been undermined and requires repair.

- Figure 4: St17132+00 silt fence has been undermined and requires repair.

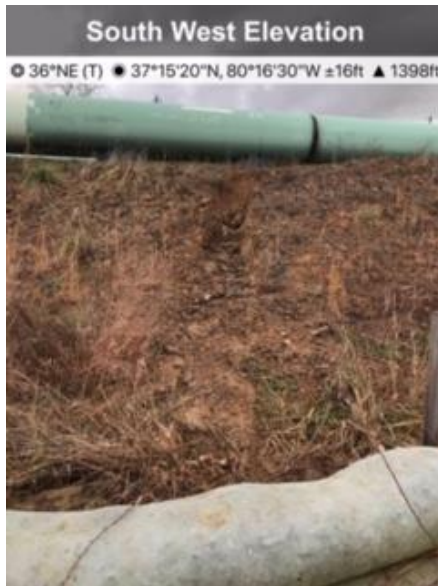
- **Figure 5:** St12141+00 fill slope has eroded and requires repair & stabilization.
