## FIELD INSPECTION REPORT

| Project Name: | Mountain Valley Pipeline | Inspector: | Marshall Willis |
| Spread I:<br>Franklin County | STA 13690+91 – 13748+30<br>ATWS 562/1362 | Weather: | Rainy |

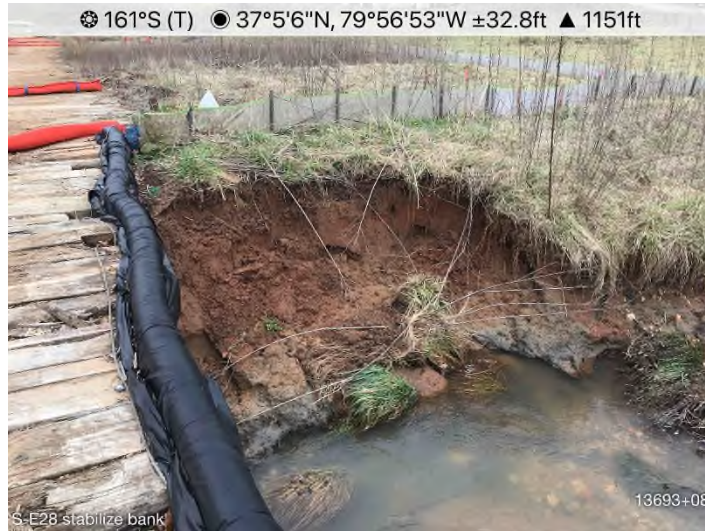
- STA 13693+08: Bank scour at S-E28 crossing from high flow conditions. Bank stabilization needed.
- STA 13704+90: Bank scour at S-E28 crossing from high flow conditions. Bank stabilization needed.

**Figure 1: STA 13693+08** – Bank scour along S-E28 crossing from high flow conditions. Bank stabilization needed.

**Recommended Corrective Action:** Stabilize bank scour.

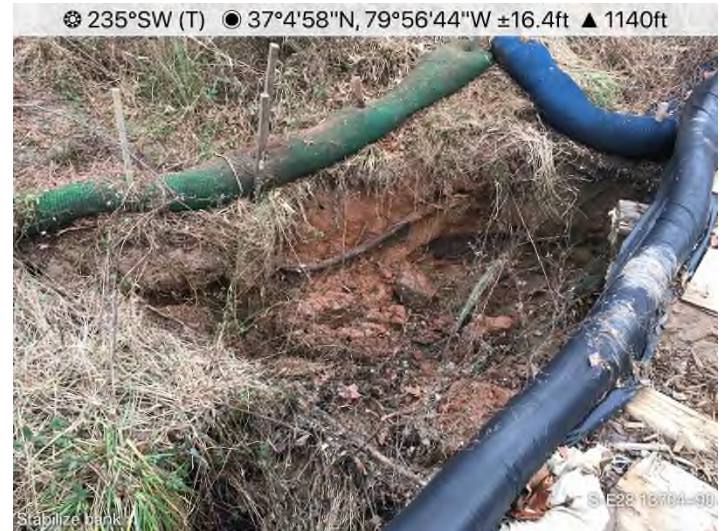
**Figure 2: STA 13704+90** – Bank scour along S-E28 crossing from high flow conditions. Bank stabilization needed.

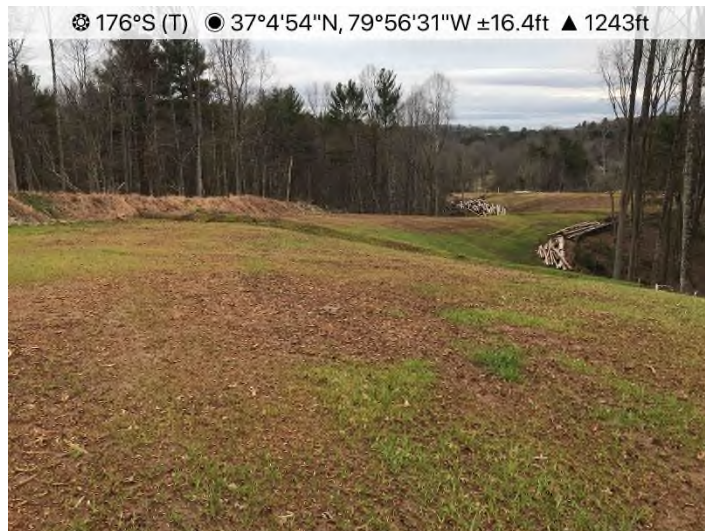
**Figure 3: STA 13721+00** – Controls in place and functioning properly.

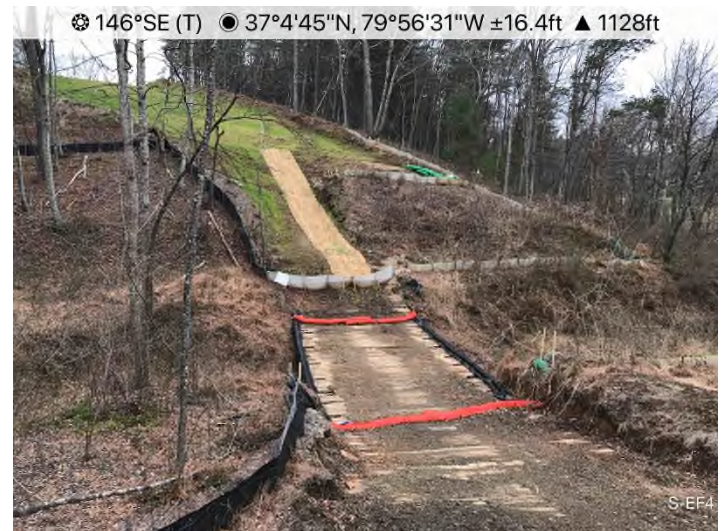
**Figure 4: Stream S-EF4** – Controls in place and functioning properly at stream S-EF4.
