## COMPLAINT INVESTIGATION REPORT

| Project Name: | Mountain Valley Pipeline | Inspector: | Marshall Willis |
| Inspection Date: | Friday, February 7, 2020 | Project Contact: | Brian Clauto, Cory Chalmers |
| Spread G:<br>Craig County | STA 11475+00 – 11490+00 | Weather: | Rainy |

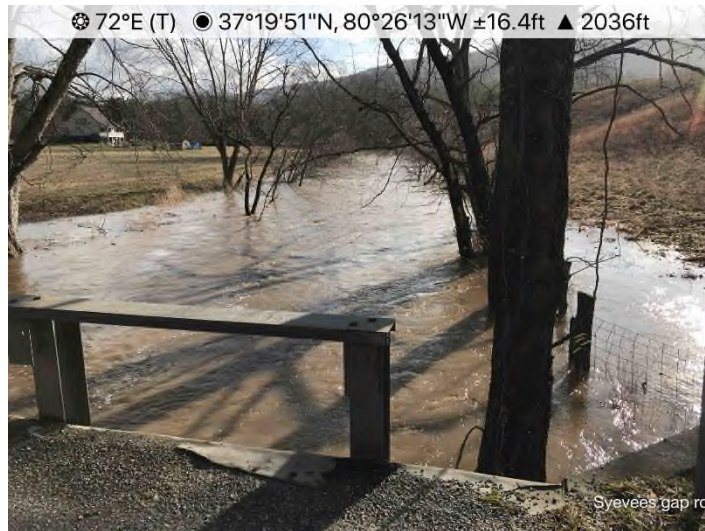
- Approximately 3.88" precipitation recorded in the area. (2/5/2020 – 2/7/2020). Significant flooding evident throughout area. See Figures 1, 2, 3 and 4.

**Figure 1: Stevers Gap Road** – Flooding of Sinking Creek along Stevers Gap. Facing E looking upstream.

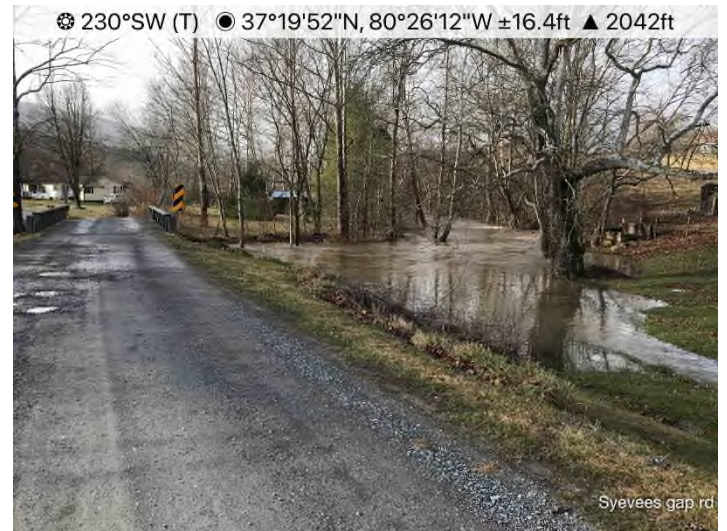
**Figure 2: Stevers Gap Road** – Flooding of Sinking Creek along Stevers Gap. Facing SW looking downstream.

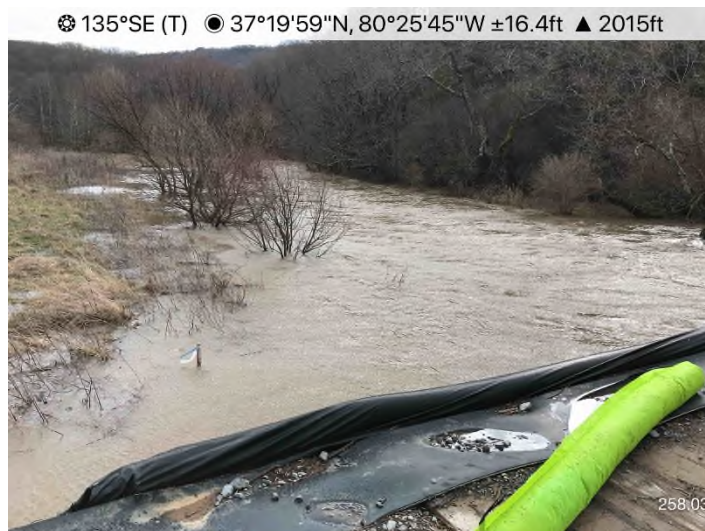
**Figure 3: Stream S-QQ2** – Flooding along Sinking Creek at MVP-CR-258.03 crossing. Upstream of Stevers Gap Trail looking upstream.

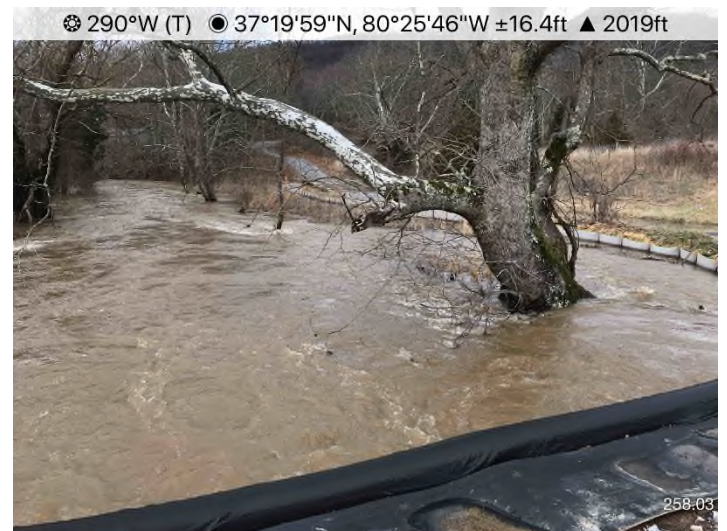
**Figure 4: Stream S-QQ2** – Flooding along Sinking Creek at MVP-CR-258.03 crossing. Upstream of Stevers Gap Trail looking downstream.

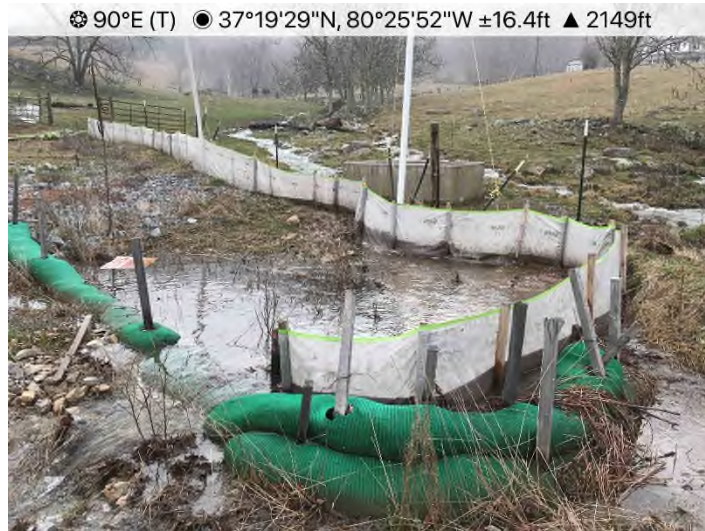
- Stormwater actively flowing down upper Stevers Gap Trail during time of inspection. See Figure 7.
- Streams S-PP1 and S-PP2 were in high flow conditions. S-PP2 was flowing outside its banks, through upslope ROW perimeter controls and onto the LOD. Perimeter P1 controls were overwhelmed and undermined at that location and stormwater run-on crossed over RCE and down into Stevers Gap Trail. See Figures 5, 6, 7 and 8.

**Figure 5: STA 11489+75** – Looking upstream at stream S-PP2. Overbank flow running onto ROW through perimeter P1 controls.

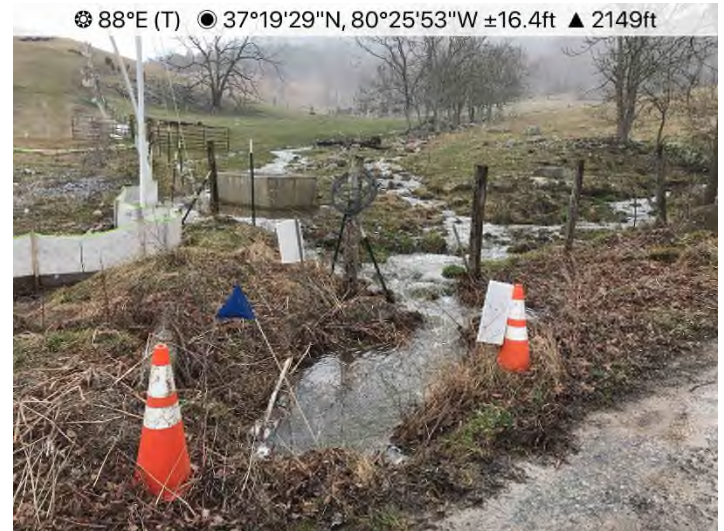
**Figure 6: STA 11489+70** – Looking upstream at S-PP1 and S-PP2. S-PP2 overbank flow impacting perimeter controls and entering ROW onto RCE.

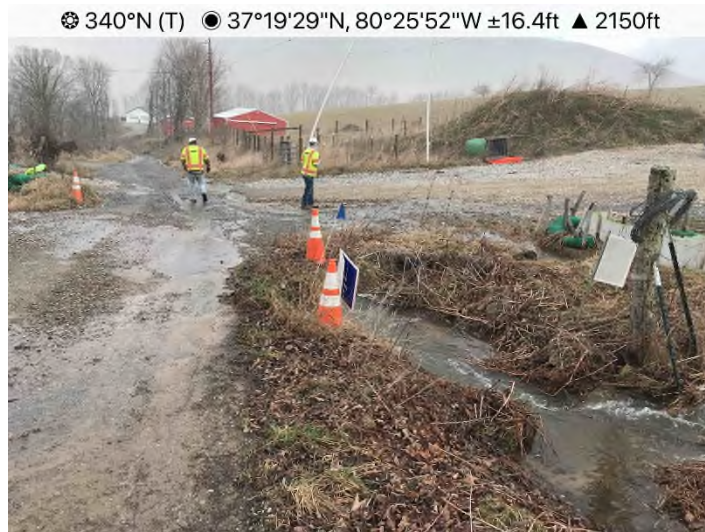
**Figure 7: STA 11489+70** – Looking N down Stevers Gap Trail. Stream S-PP1 flowing into existing culvert. Stream S-PP2 overbank flow across MVP RCE and down Stevers Gap Trail.

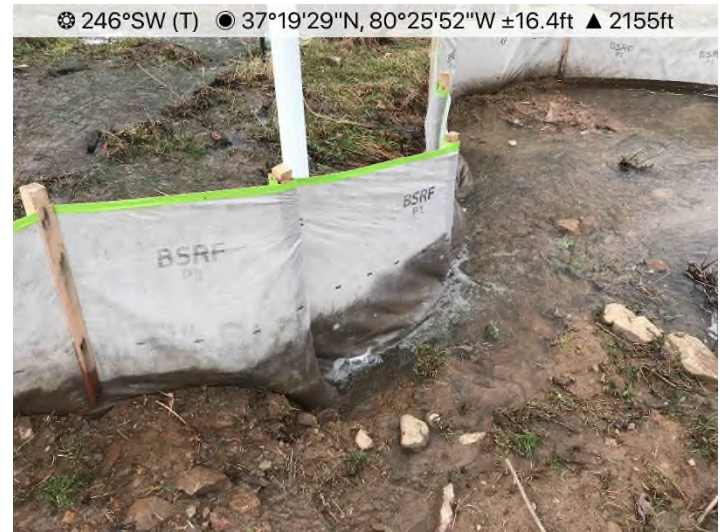
**Figure 8: STA 11489+80** – Perimeter P1 undermined due to onsite run-on from stream S-PP2.

- STA 11480+00: Stabilize drainage channel under CWD bridge.
- STA 11489+00: CFS end-treatment of CWD plunge pool undermined.
- STA 11488+00: Undermined P1.
- STA 11488+50: Waterbar end-treatment maintenance needed. Overwhelmed by offsite run-on.
- STA 11487+00: Offsite run-on unable enter CWD inlet due to landowner access road.
- STA 11489+80: Perimeter P1 undermined from stormwater run-on from S-PP2.

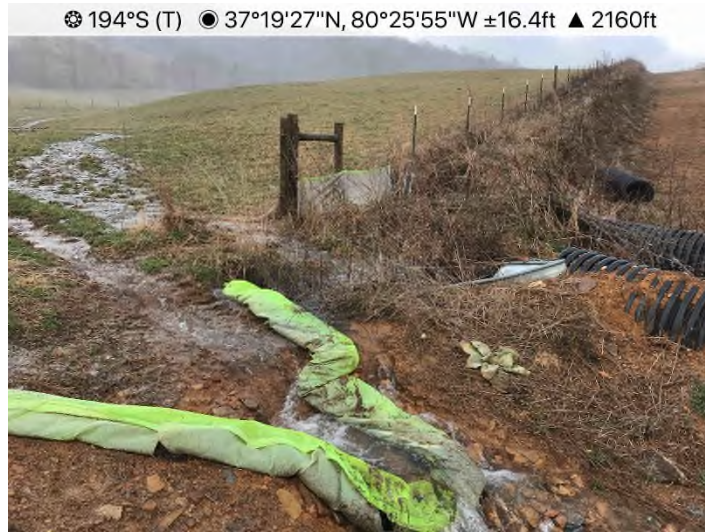
**Figure 9: STA 11487+00** – Offsite run-on bypassing CWD inlet and running down landowner access road entrance.

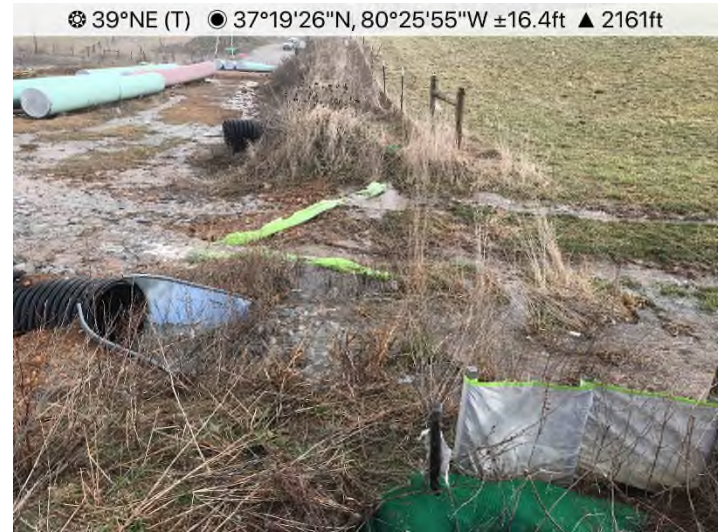
**Figure 10: STA 11487+00** – Offsite run-on bypassing CWD inlet and running down landowner access road entrance.

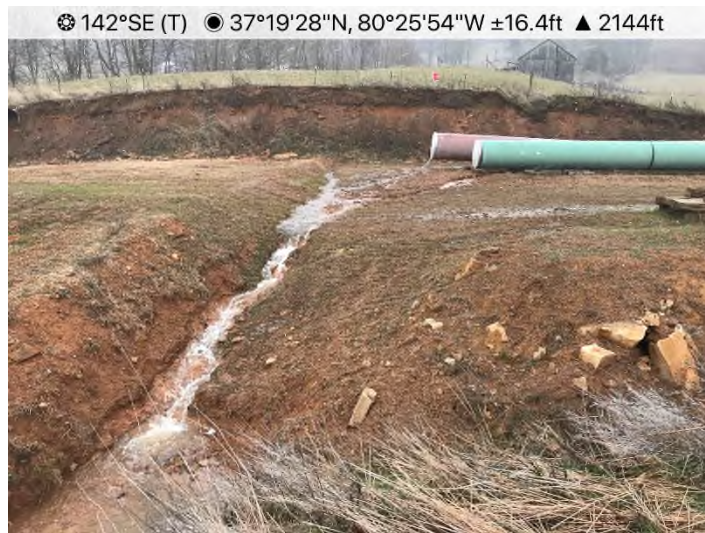
**Figure 11: STA 11488+50** – Offsite storm water run-on flowing down waterbar.

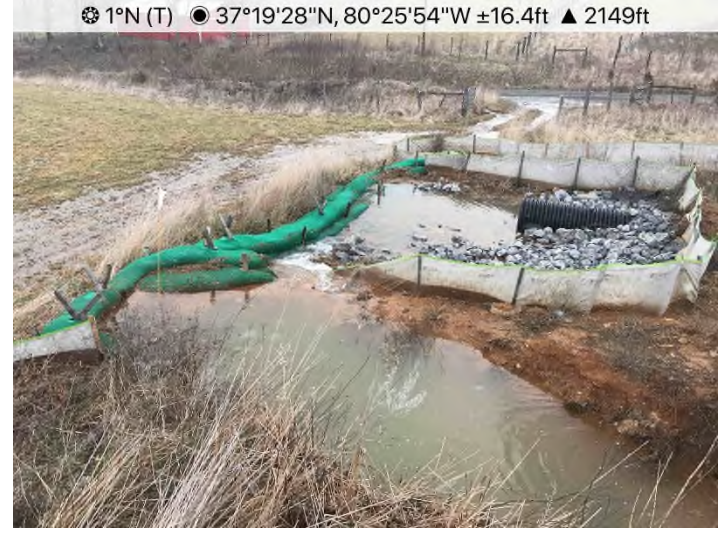
**Figure 12: STA 11488+50** – Waterbar end-treatment overwhelmed. Discharge entering CWD. STA 11489+00 CWD end-treatment undermined.

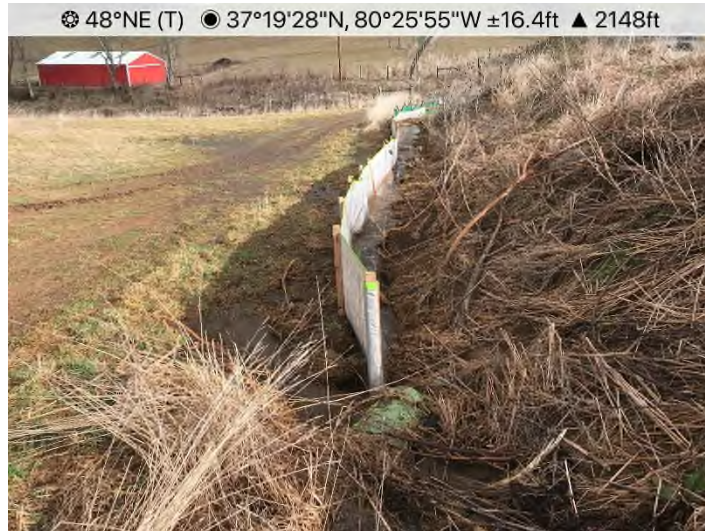
**Figure 13: STA 11488+00** – P1 undermined by CWD discharge. Discharge unable to get off ROW due to landowner access road.

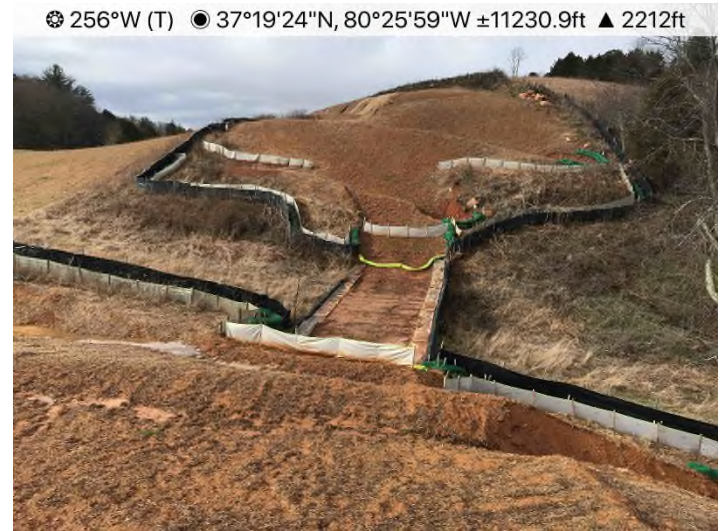
- No evidence of sediment discharge off ROW was found during the inspection.
- No evidence was found of sediment discharge into karst feature at approx. STA 11480+00. See Figures 14, 15, and 16.

**Figure 14: STA 11481+00** – Looking W at drainage feature crossing leading to karst “sinkhole” at STA 11480+00. No sediment off ROW evident during inspection.

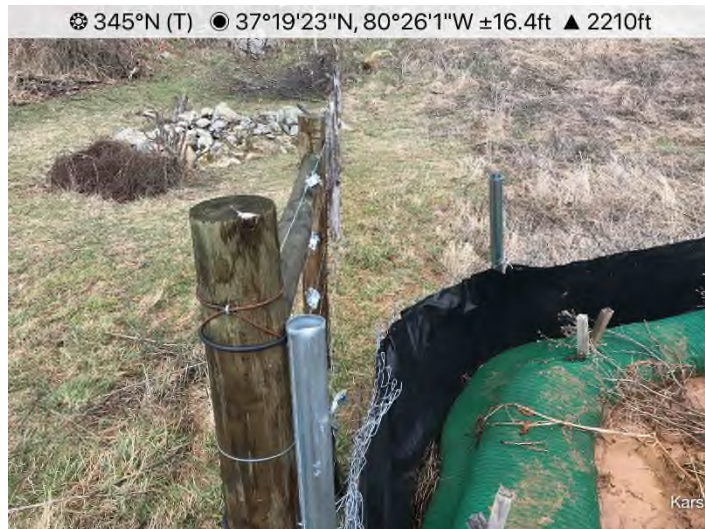
**Figure 15: STA 11480+50** – Controls in place and functioning properly above “sinkhole”. No offsite sediment discharge evident.

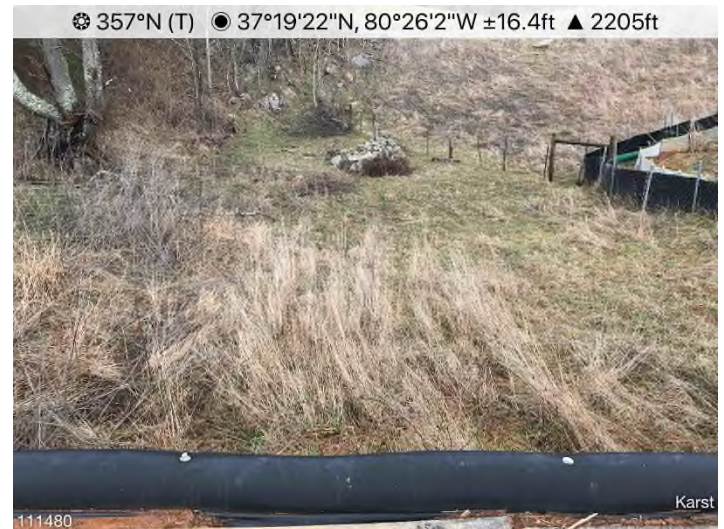
**Figure 16: STA 11480+00** – No offsite sediment discharge evident above karst “sinkhole” feature.

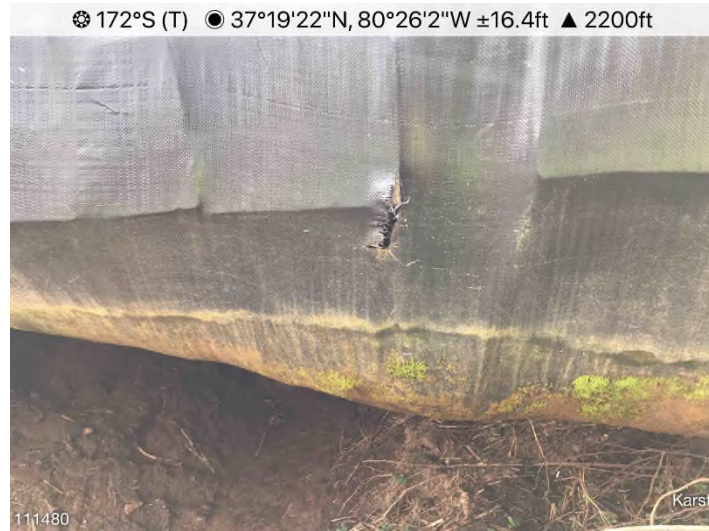
**Figure 17:** STA 11480+00 – Bridge underlayment repair needed.

- STA 11480+00: Bridge maintenance needed. Minor hole in fabric underlayment.

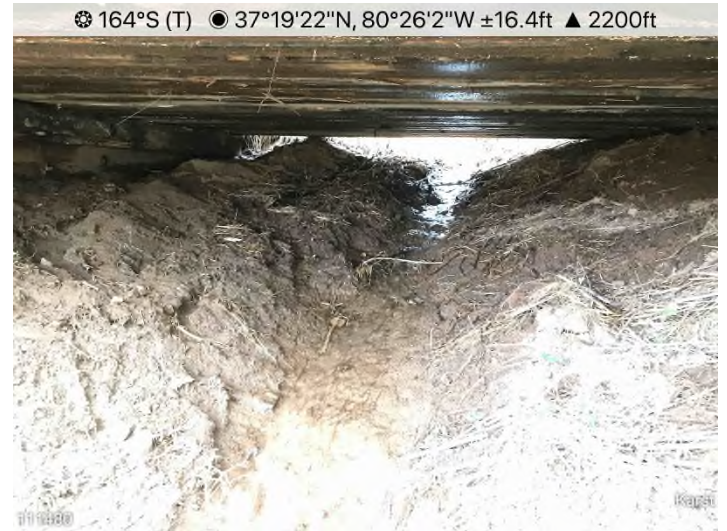
**Figure 18:** STA 11480+00 – Stabilize denuded drainage channel under bridge crossing.
