## FIELD INSPECTION REPORT

| <b>Project Name:</b> | Mountain Valley Pipeline | <b>Inspector:</b> | Marshall Willis |
| <b>Inspection Date:</b> | Thursday, February 6, 2020 | <b>Project Contact:</b> | Brian Clauto, Cory Chalmers |

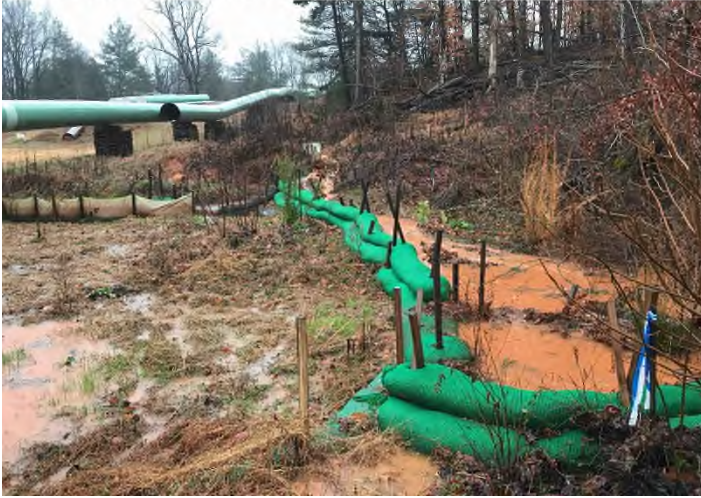
- Turbid stormwater run-on was documented entering the ROW at approx. STA 13996+00. Source of turbid discharge appears to be a logging operation located on private property above the ROW. Turbid water was treated by MVP ESCs prior to entering stream S-KL36. See Figures 1 and 2.

**Figure 1: STA 13996+50** – Turbid stormwater discharge from offsite and upslope logging operation. Run-on treated by MVP ESC prior to entering stream S-KL36.

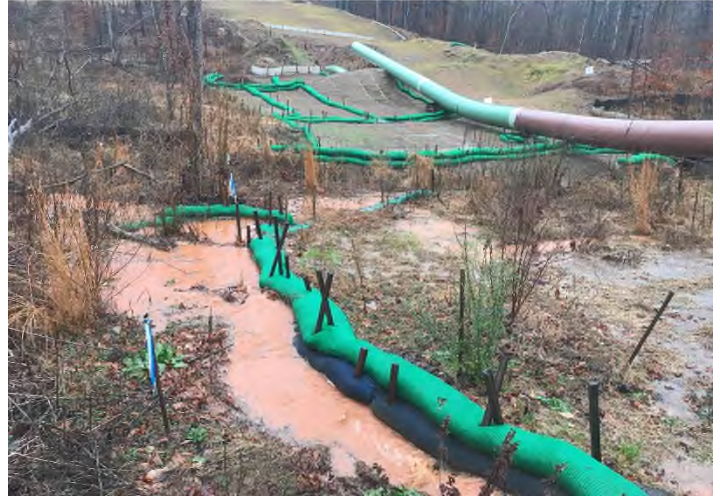
**Figure 2: STA 13996+50** – Turbid stormwater discharge from offsite and upslope logging operation. Run-on treated by MVP ESC prior to entering stream S-KL36.

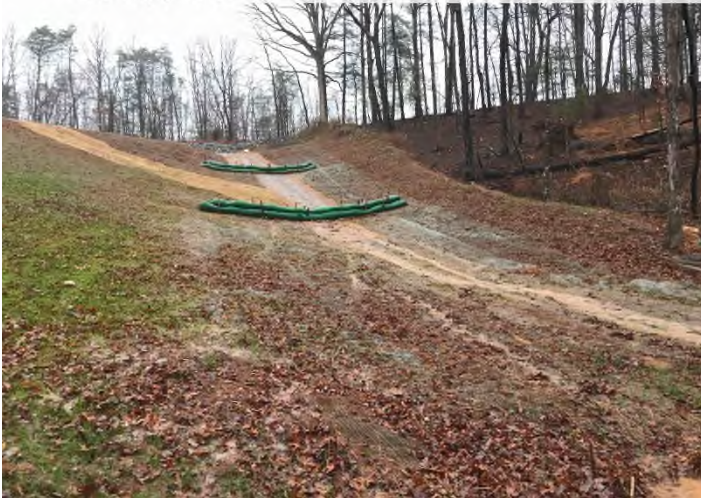
**Figure 3: STA 14064+50** – Controls in place and functioning properly.

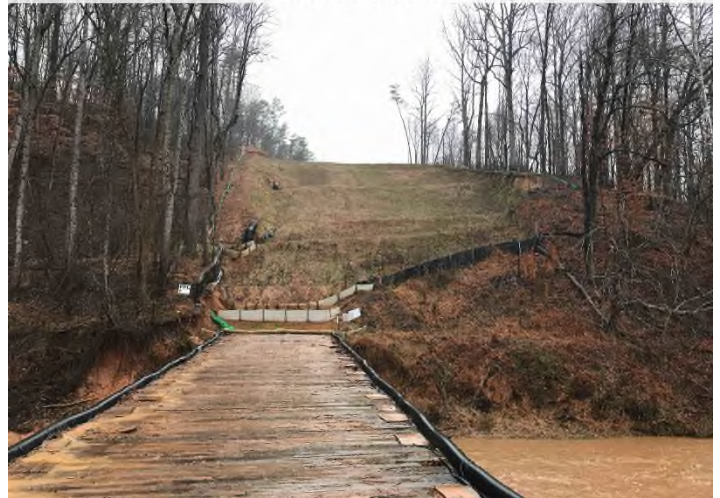
**Figure 4: STA 14233+50** – Maggodee Creek crossing looking W. Controls in place and functioning properly.
