## FIELD INSPECTION REPORT

| <b>Project Name:</b> | Mountain Valley Pipeline | <b>Inspector:</b> | Matthew Grant |
| <b>Inspection Date:</b> | Wednesday, February 5, 2020 | <b>Project Contact:</b> | Brian Clauto |
| <b>Spread H:<br/>Montgomery</b> | AR-MN 276.03<br>MLV AR- 27<br>ATWS 724 | <b>Weather:</b> | Rainy |

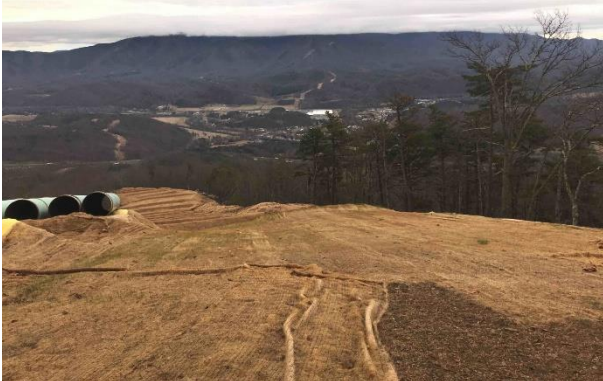
| <p>■ <b>Figure 1:</b> Near MP 232.4 areas has been stabilized with blanket matting.</p> <p style="text-align: center;"><b>North West Elevation</b></p> <p style="text-align: center;">☉ 150°SE (T) ☉ 37°15'21"N, 80°13'35"W ±16ft ▲ 2585ft</p> | <p>■ <b>Figure 2:</b> Near MP 234 area remains stabilized with ECD blanket matting.</p> <p style="text-align: center;"><b>North West Elevation</b></p> <p style="text-align: center;">☉ 137°SE (T) ☉ 37°14'46"N, 80°12'38"W ±32ft ▲ 1426ft</p> |

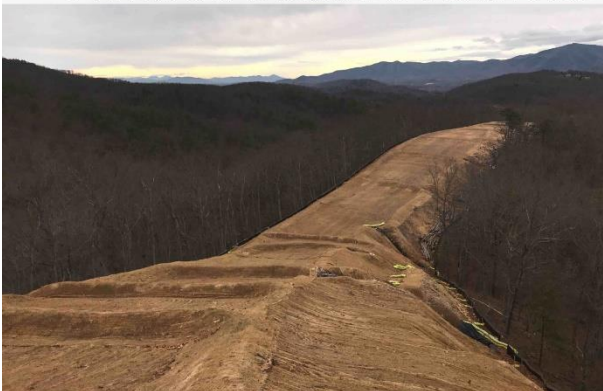
| <p>■ <b>Figure 3:</b> Near MP 233.4 are remains stabilized with ECD blanket matting.</p> <p style="text-align: center;"><b>South Elevation</b></p> <p style="text-align: center;">☉ 424°N (T) ☉ 37°15'10"N, 80°12'53"W ±32ft ▲ 1740ft</p> | <p>■ <b>Figure 4:</b> Near MLV AR 27 area is stabilized and ECD's are in place.</p> <p style="text-align: center;"><b>South Elevation</b></p> <p style="text-align: center;">☉ 395°N (T) ☉ 37°14'23"N, 80°11'57"W ±16ft ▲ 1391ft</p> |
