## FIELD INSPECTION REPORT

| <b>Project Name:</b> | Mountain Valley Pipeline | <b>Inspector:</b> | Marshall Willis |
| <b>Inspection Date:</b> | Tuesday, February 4, 2020 | <b>Project Contact:</b> | Brian Clauto, Cory Chalmers |
| <b>Spread I:<br/>Franklin County</b> | STA 13562+38 – 13644+82<br>MVP-FR-323<br>ATWS 1416/1417/1067 | <b>Weather:</b> | Dry |

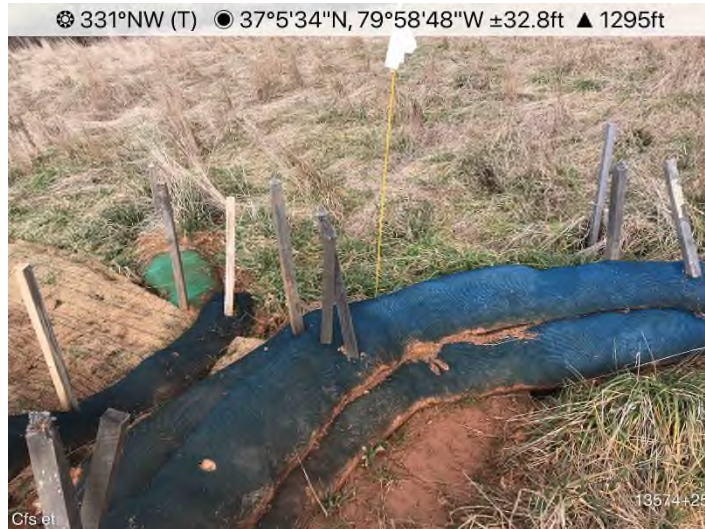
- STA 13574+25: End-treatment maintenance needed. CFS undermined.
- STA 13630+00: Permanent end-treatment maintenance needed. Level spreader undermined.
- STA 13629+50: CFS maintenance needed. CFS undermined.
- STA 13629+45: Permanent end-treatment maintenance needed. Level spreader undermined.

**Figure 1: STA 13574+25** – CFS end-treatment undermined. Maintenance needed.

**Recommended Corrective Action:** Maintain and install all controls per the approved PSS&S.

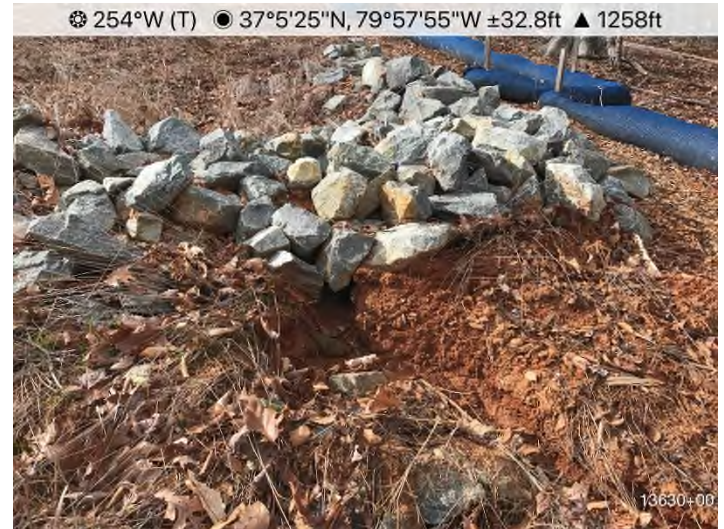
**Figure 2: STA 13630+00** – Permanent end-treatment level spreader undermined. Repair needed.

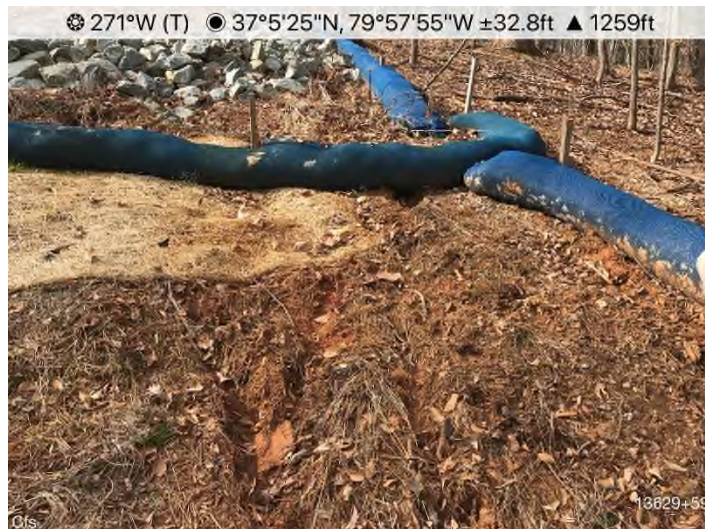
**Figure 3: STA 13629+50** – CFS undermined. Maintenance needed.

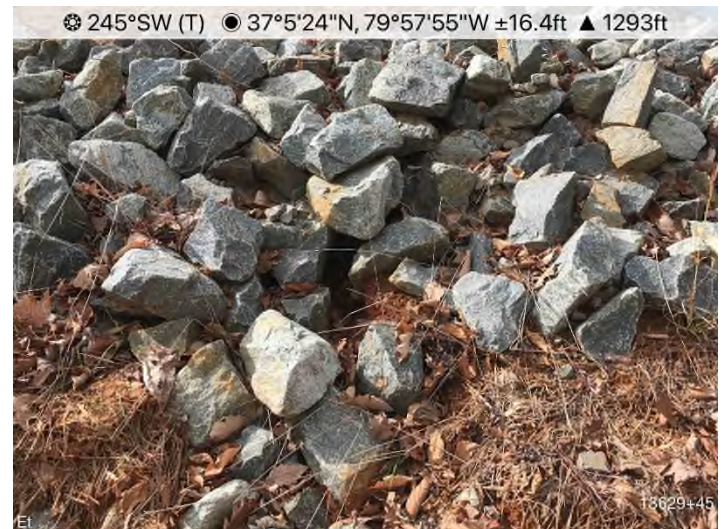
**Figure 4: STA 13629+45** – Permanent end-treatment level spreader undermined. Repair needed.
