## FIELD INSPECTION REPORT

| Project Name: | Mountain Valley Pipeline | Inspector: | Marshall Willis |
| Inspection Date: | Wednesday, January 29, 2020 | Project Contact: | Brian Clauto, Cory Chalmers |
| Spread H:<br>Franklin County | STA 13316+13 – 13415+51<br>ATWS 1352 | Weather: | Wet |

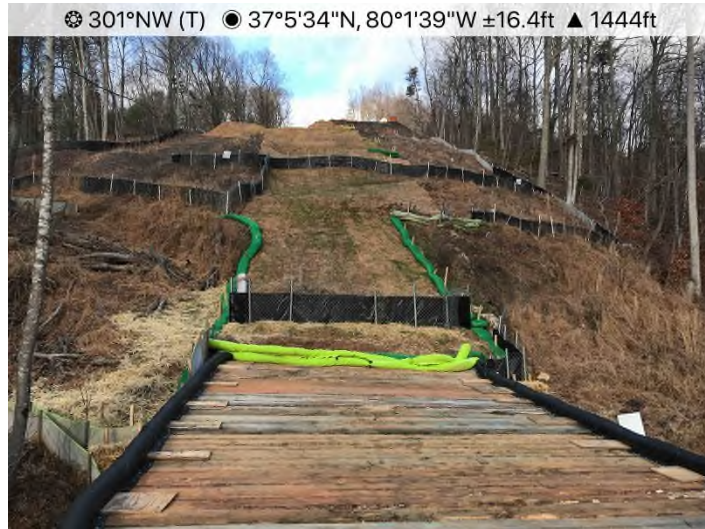
**Figure 1: STA 13413+00** – Controls in place and functioning properly around Stream S-IJ1.

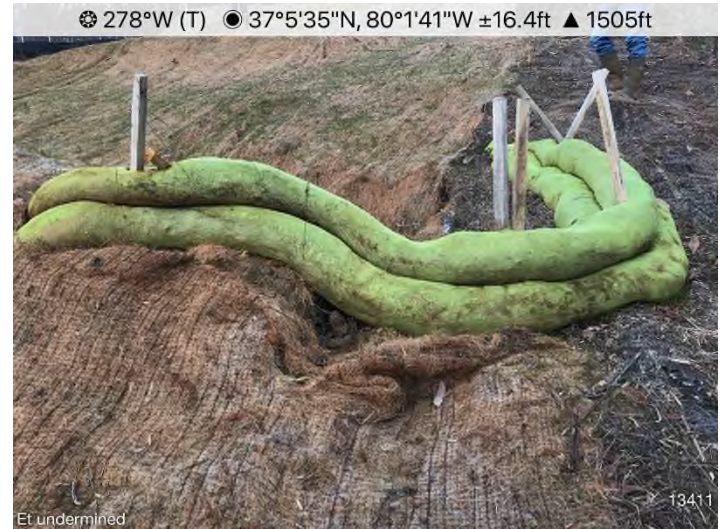
- STA 13411+00: End-treatment maintenance required. End treatment undermined.

**Figure 2: STA 13411+00** – End treatment CFS undermined. Maintenance needed.

**Recommended Corrective Action:** Maintain and install all controls per the approved PSS&S.

**Deadline:** Within 24-Hour of Notification

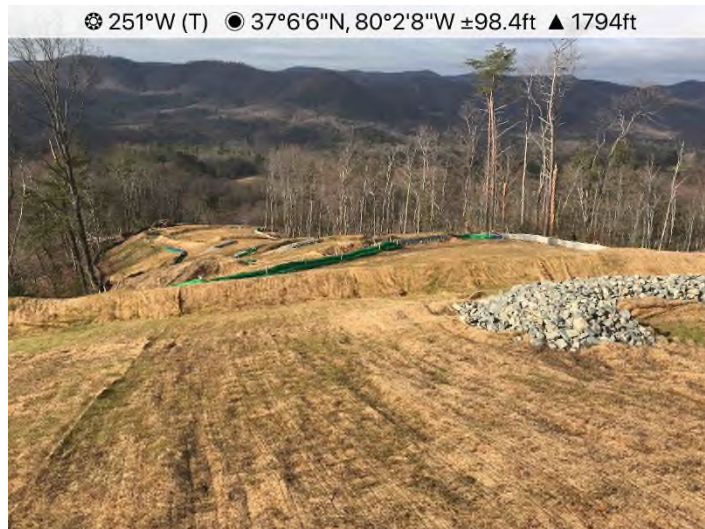
**Figure 3: STA 13371+00** – Controls in place and functioning properly. Area stabilized with erosion matting.

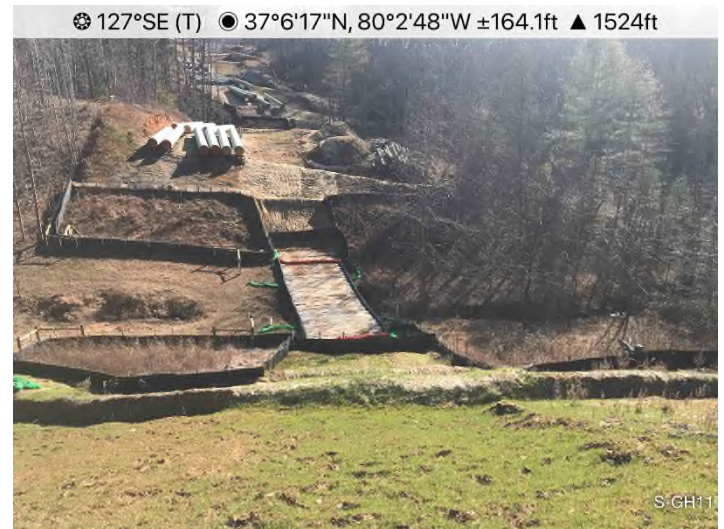
**Figure 4: STA 13333+00** – Controls in place and functioning properly above Stream S-GH11.
