## FIELD INSPECTION REPORT

| <b>Project Name:</b> | Mountain Valley Pipeline | <b>Inspector:</b> | Marshall Willis |
| <b>Inspection Date:</b> | Tuesday, January 28, 2020 | <b>Project Contact:</b> | Brian Clauto, Cory Chalmers |
| <b>Spread I:<br/>Pittsylvania County</b> | STA 15647+03 – 15743+08<br>MVP-PI-336.01/337<br>ATWS 1392/497/498/625/626/627 | <b>Weather:</b> | Wet |

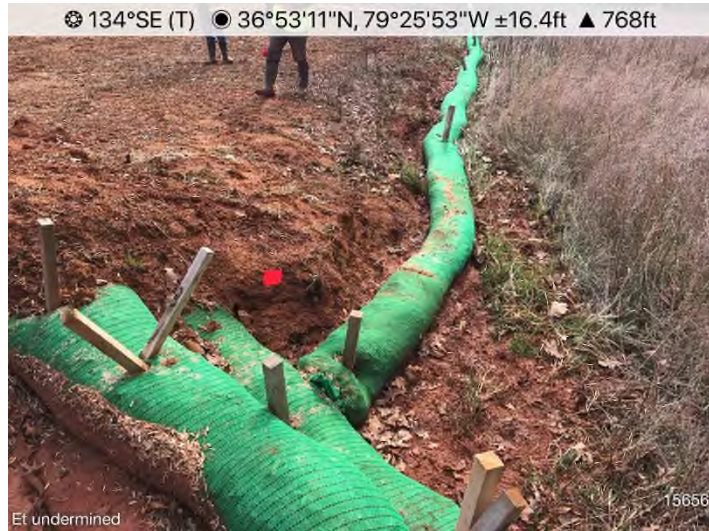
- STA 15656+00: CFS undermined. Maintenance needed.

**Figure 1: STA 15656+00** – CFS undermined. Maintenance needed.

**Recommended Corrective Action:** Maintain and install all controls per the approved PSS&S.

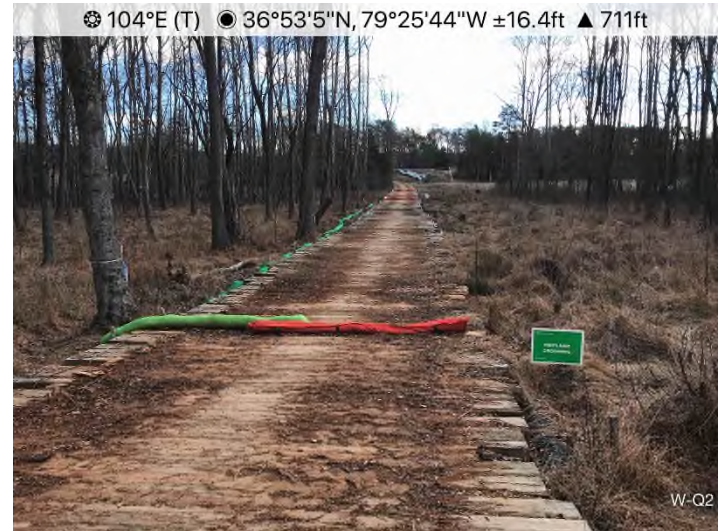
**Figure 2: Wetland W-Q2** – Controls in place and functioning properly.

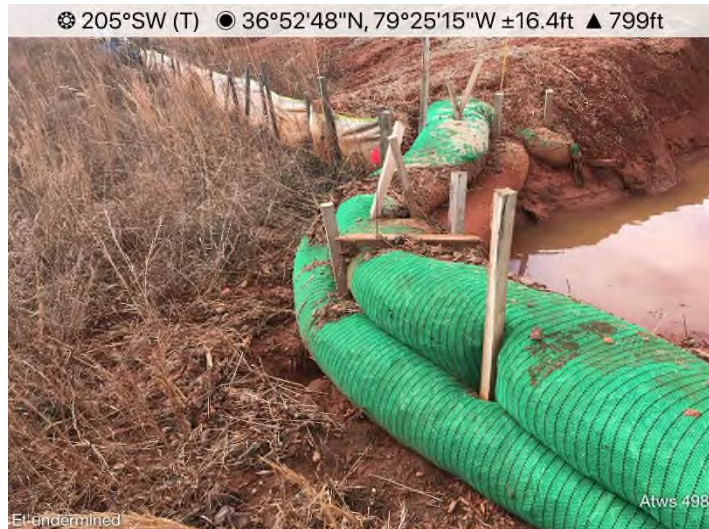
- ATWS 498: End-treatment maintenance needed. CFS undermined.

**Figure 3: ATWS 498** – End treatment CFS undermined. Maintenance needed.

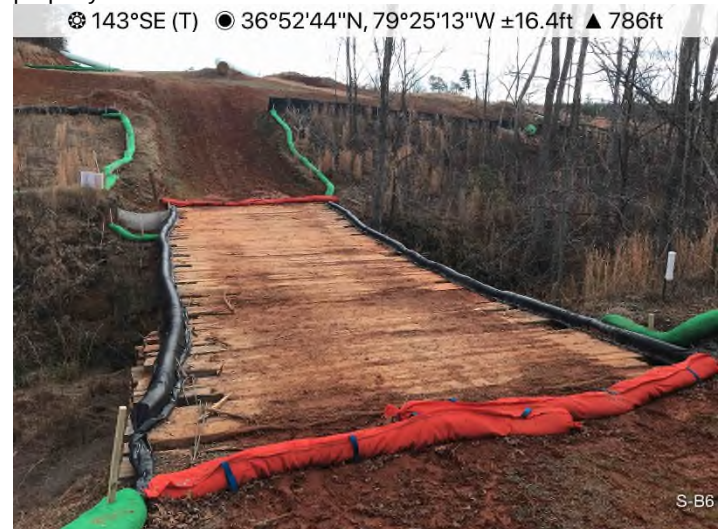
**Figure 4: Stream S-B6** – Controls in place and functioning properly.
