## FIELD INSPECTION REPORT

| Project Name: | Mountain Valley Pipeline | Inspector: | Marshall Willis |
| Inspection Date: | Monday, January 27, 2020 | Project Contact: | Brian Clauto, Cory Chalmers |
| Spread H:<br>Franklin County | STA 13333+96 – 13337+82 | Weather: | Wet |

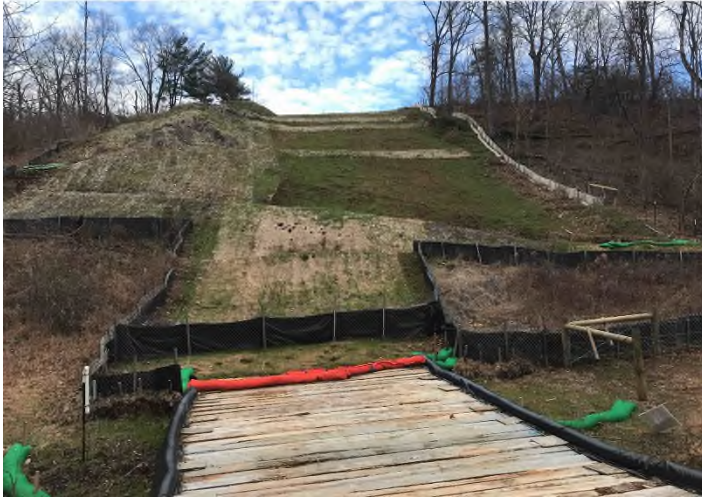
**Figure 1: Stream S-GH11** – Controls in place and functioning properly. Area stabilized with erosion matting and vegetation. No evidence of sediment discharge off ROW.

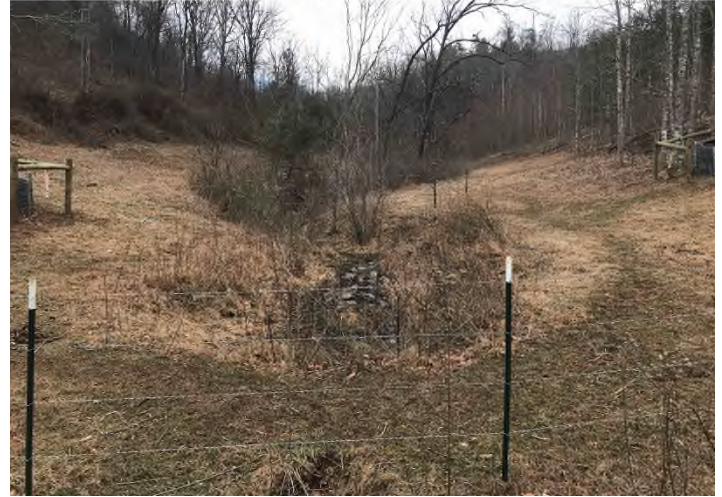
**Figure 2: Stream S-GH11** – Looking upstream of ROW at S-GH11 crossing.

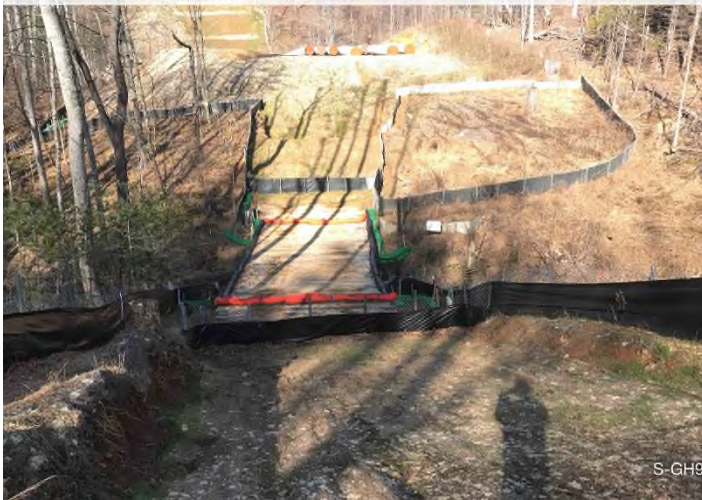
**Figure 3: Stream S-GH9** – Controls in place and functioning properly. Area stabilized with erosion matting. No evidence of sediment discharge off ROW.

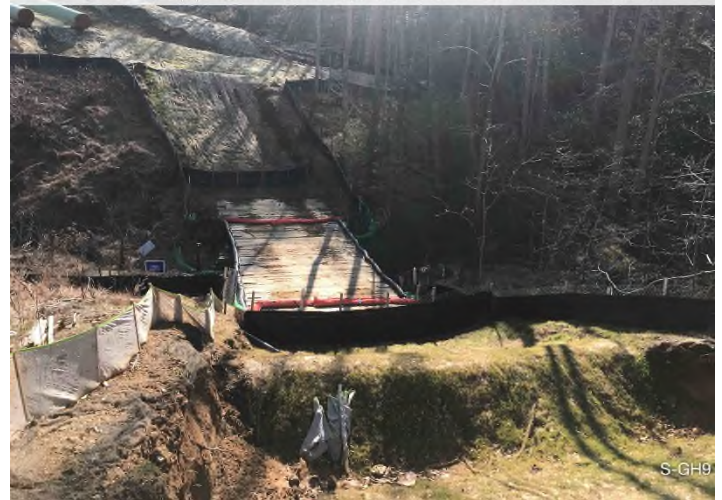
**Figure 4: Stream S-GH9** – Controls in place and functioning properly. Area stabilized with erosion matting. No evidence of sediment discharge off ROW.
